City of Redmond

Agenda Study Session

Facilities Condition Assessment Update

Facility Condition Assessment

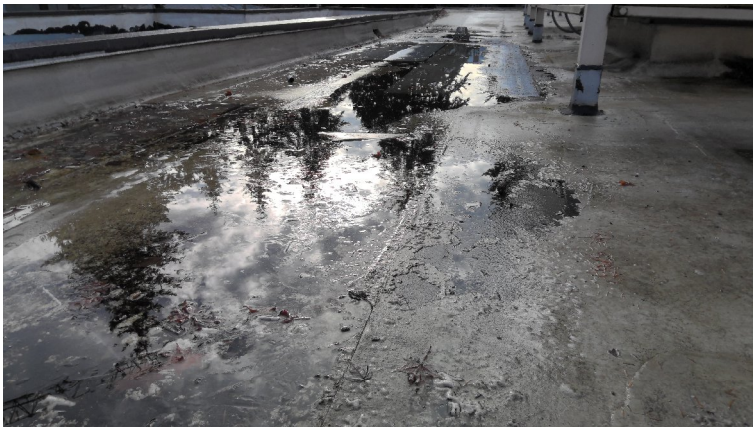
End-of-Life
Roofing
(Fire Station 11)

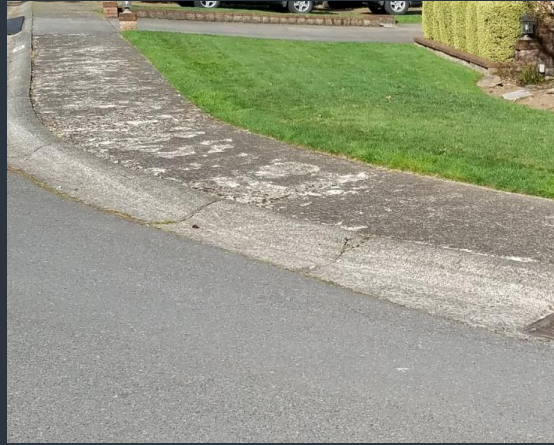
Uplift

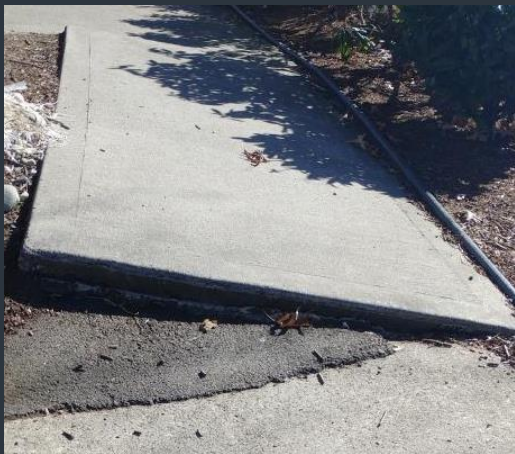
Degradation

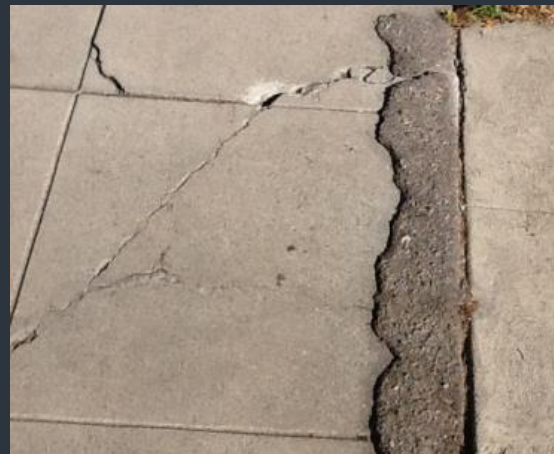
Buckling

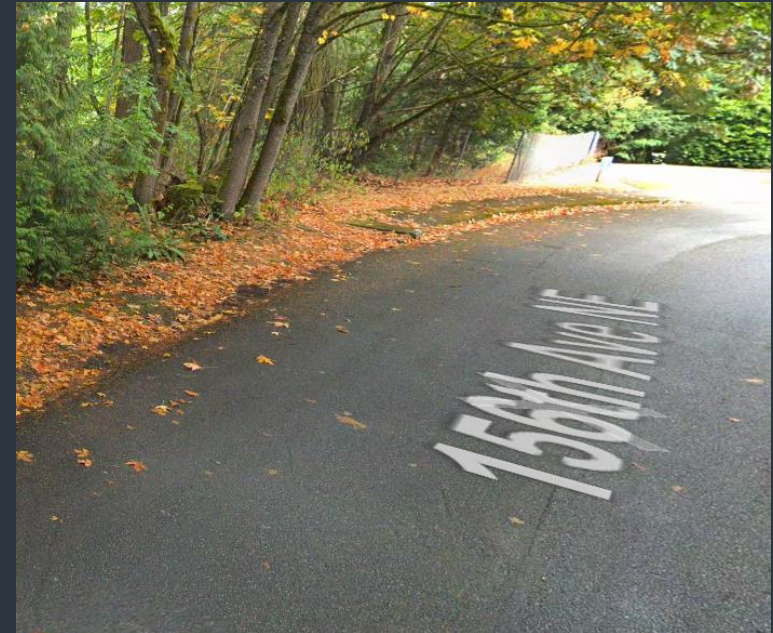
Cracking

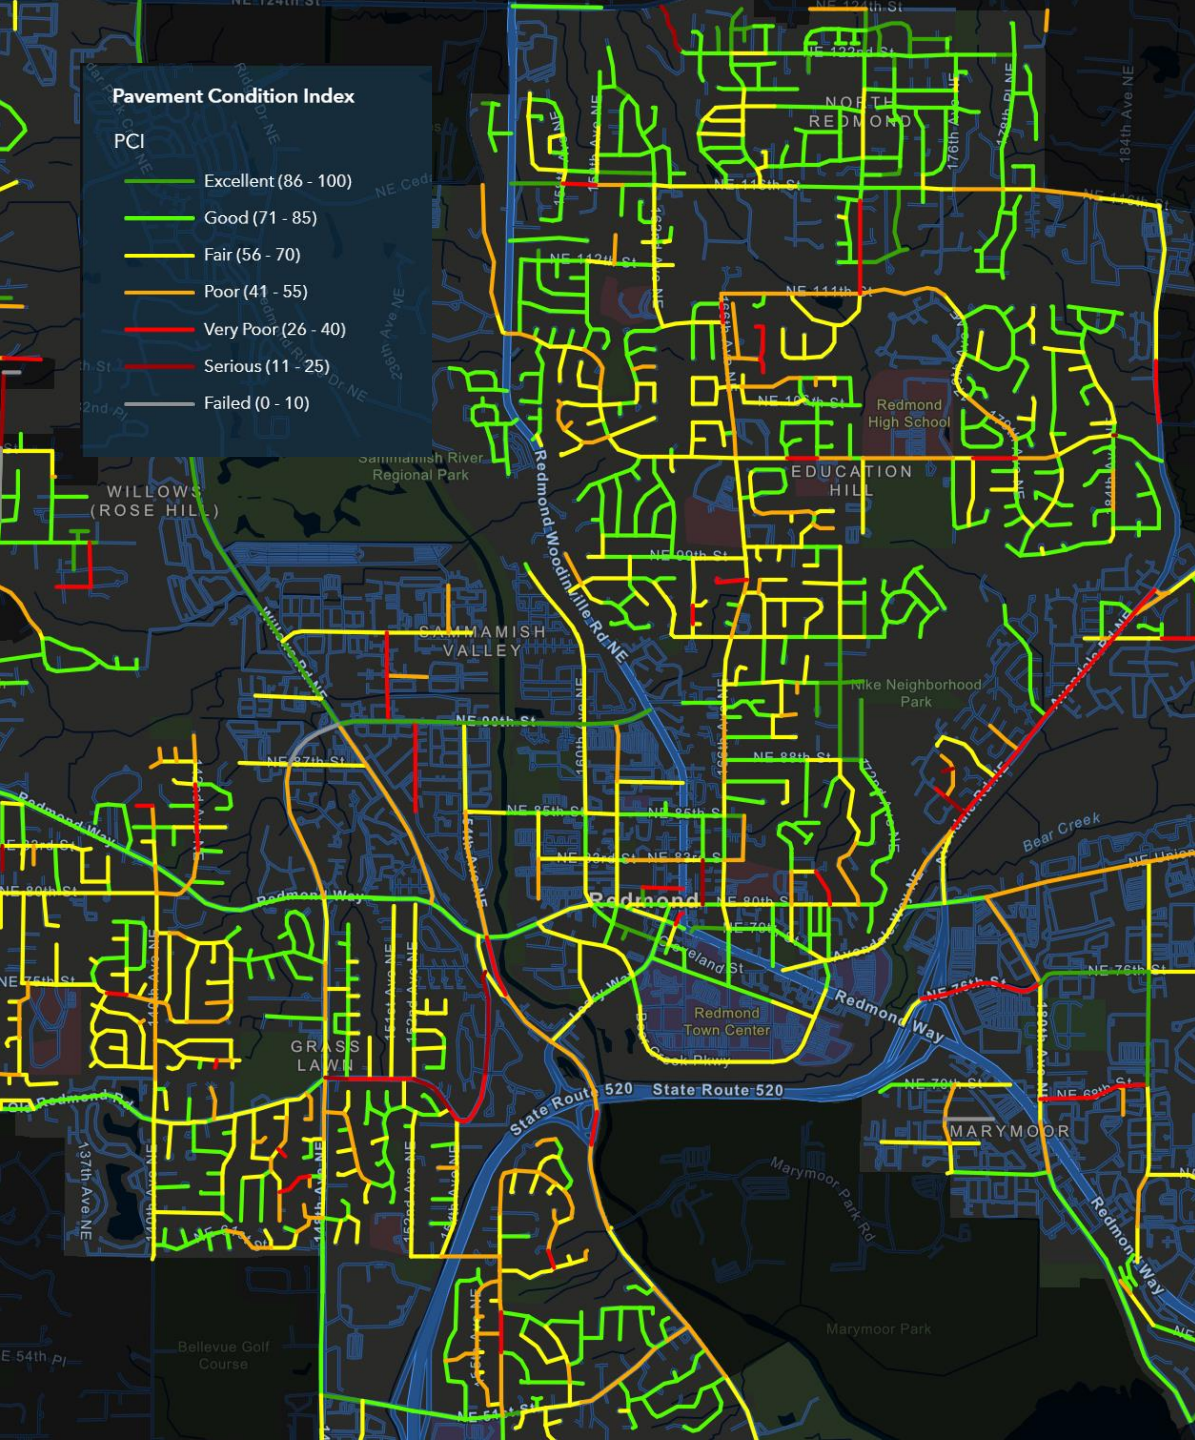
Missing connections
