**Arborist Report
for
WOODSIDE Property
Parcel 0725069033
Redmond, WA**

November 7, 2018

WOODSIDE Property - Arborist Report

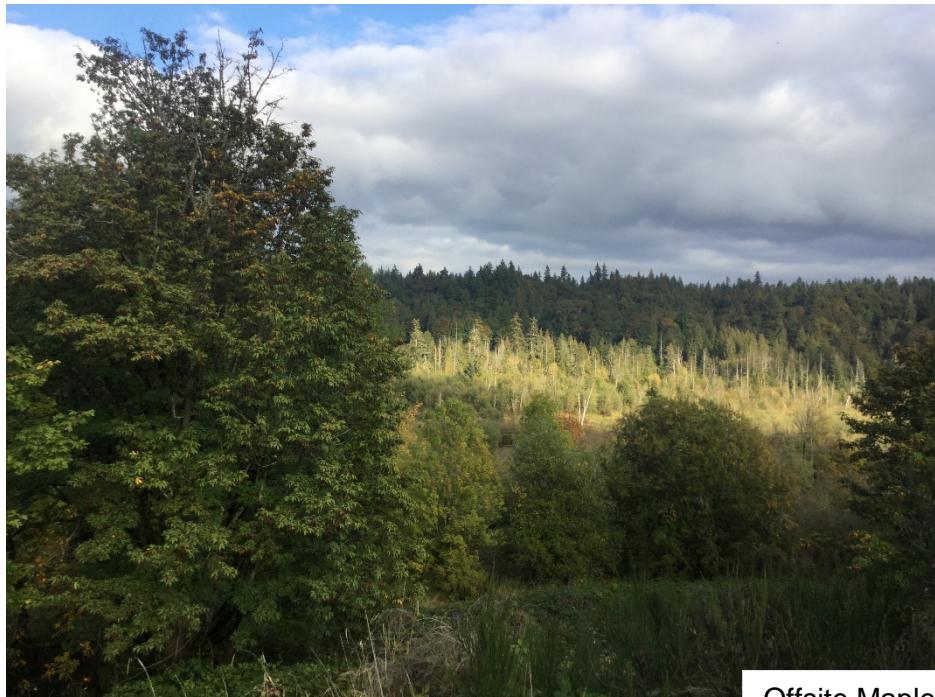
Big Leaf Maple
#9613. Note
small leaves
and dying
crown
indicating
stress.

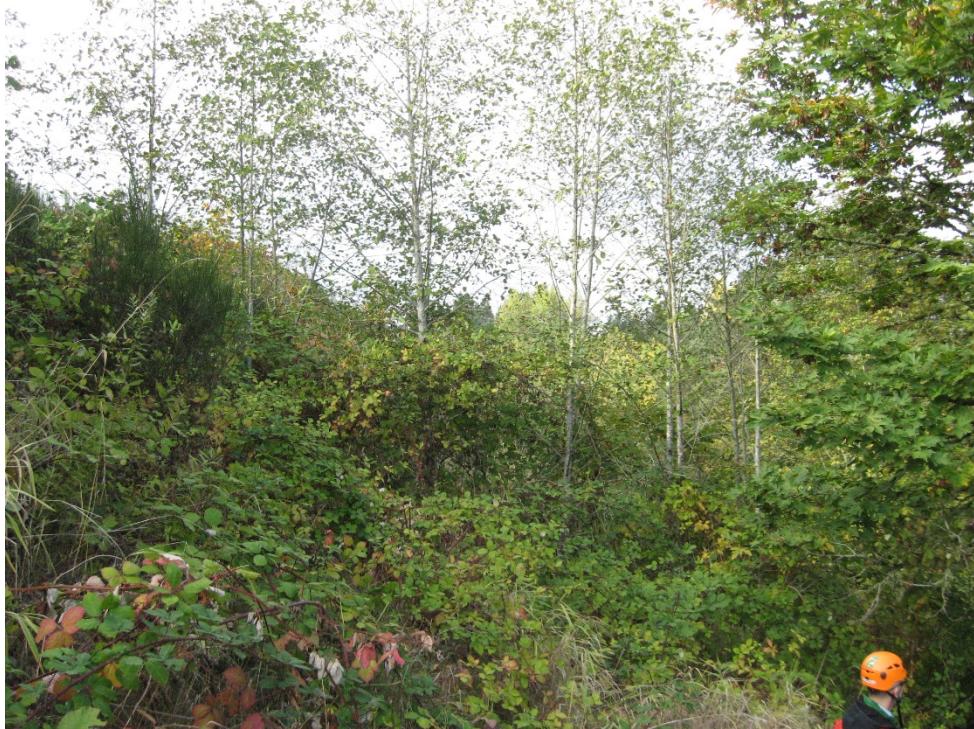
Stand of non-significant alders on east slope
