City of Redmond

Facility Condition Assessment

Facility Details Report

Prepared by MENG Analysis - March 6, 2024

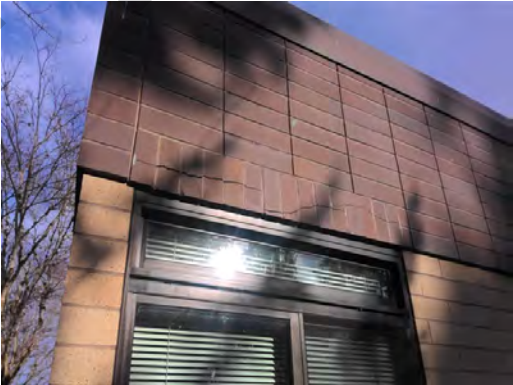
Deficient Material: **Masonry Lintel**
Lintels at exterior window openings and offset walls. Thin brick has cracked.

Remedial Action:
In the short term, caulk cracks to thwart moisture intrusion into window frame and interiors and continue monitoring. Longer term, remove thin brick over lintels and install alternative cladding material (like prefinished metal cladding with drip).

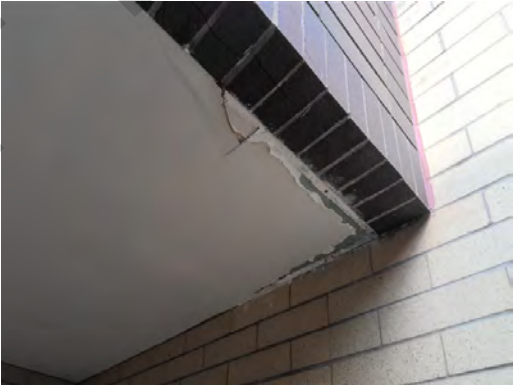
Deficient Material: Soffits
Plaster soffit at east door at administration area (adjacent to hose tower). Underside finish shows signs of water damage.

Remedial Action:
Repair parapet cap and install counter flashing with robust drip flashing to divert rain water and condensate away from face of wall. Remove affected materials, replace with new plaster, paint to match existing.

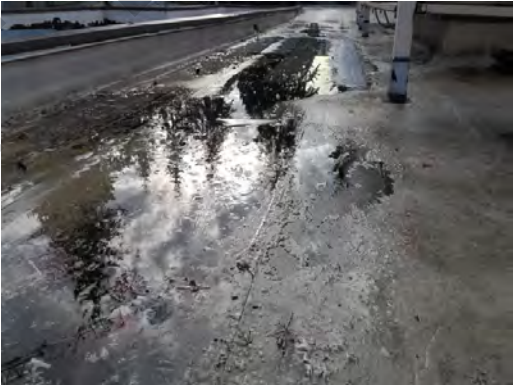
Deficient Material: Membrane Roofing

Remove existing roofing to deck and any damaged decking materials, remove flashings and parapet coping systems. Install fall restraint system. (See B1020 Roof Construction to increase rigid Insulation value beyond code.) Replace roofing, flashings, counter flashings, and parapet caps with new. Install walk pads to all maintainable equipment, scuppers, and drains.

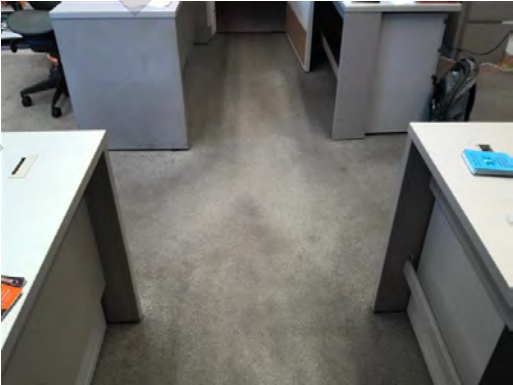
Deficient Material: Carpet
Broadloom carpeting is worn, dated, and soiled in most areas.

Remedial Action:
Replace carpet with new carpet tile.

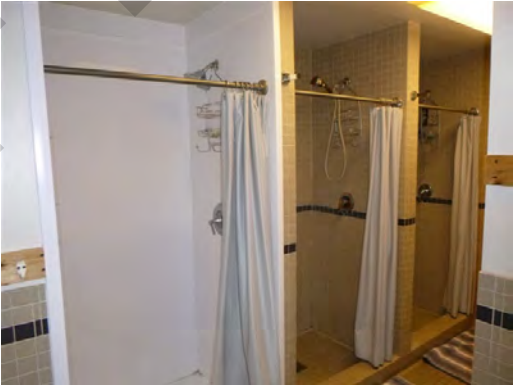
Deficient Material: Showers
Aging showers with one recently renewed with one-piece surround.

Remedial Action:
Renew all other showers prior to failure.

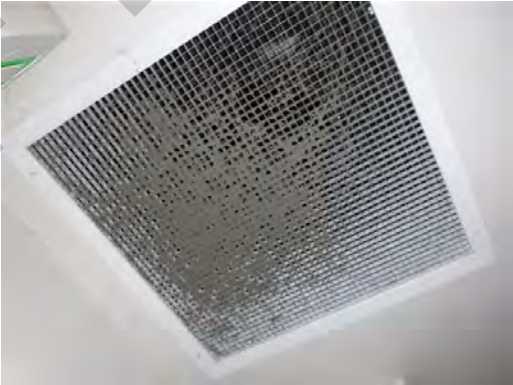
Deficient Material: Ductwork
Dirty HVAC ductwork, especially return air grilles and duct. Dirty, damaged, or missing outside air intake screens at rooftop unit, and dirty rooftop unit mixed-air plenums.

Remedial Action:
Clean ductwork. Clean and repair or replace dirty, damaged, or missing rooftop unit outside air intake screen. Clean rooftop unit mixed-air plenums including cleaning grilles, registers, diffusers, and exhaust fan housings.

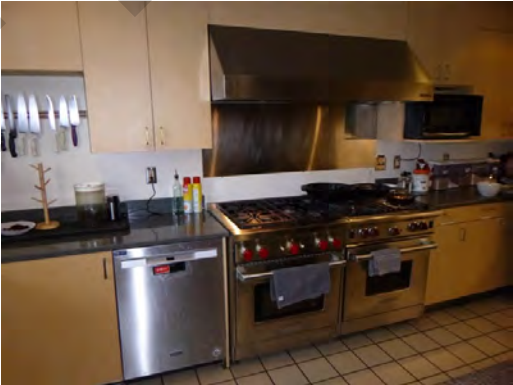
Deficient Material: Kitchen Hood
Type 2 heat and moisture only hood at station house kitchen serving two gas-fired ranges.
