January 7, 2022

ATTACHMENT F

SUBJECT: EXPOSURE PATHWAY EVALUATION REPORT
Redmond Flex
6900 188th Avenue Northeast
Redmond, Washington 98052
Project Number: 0970-017

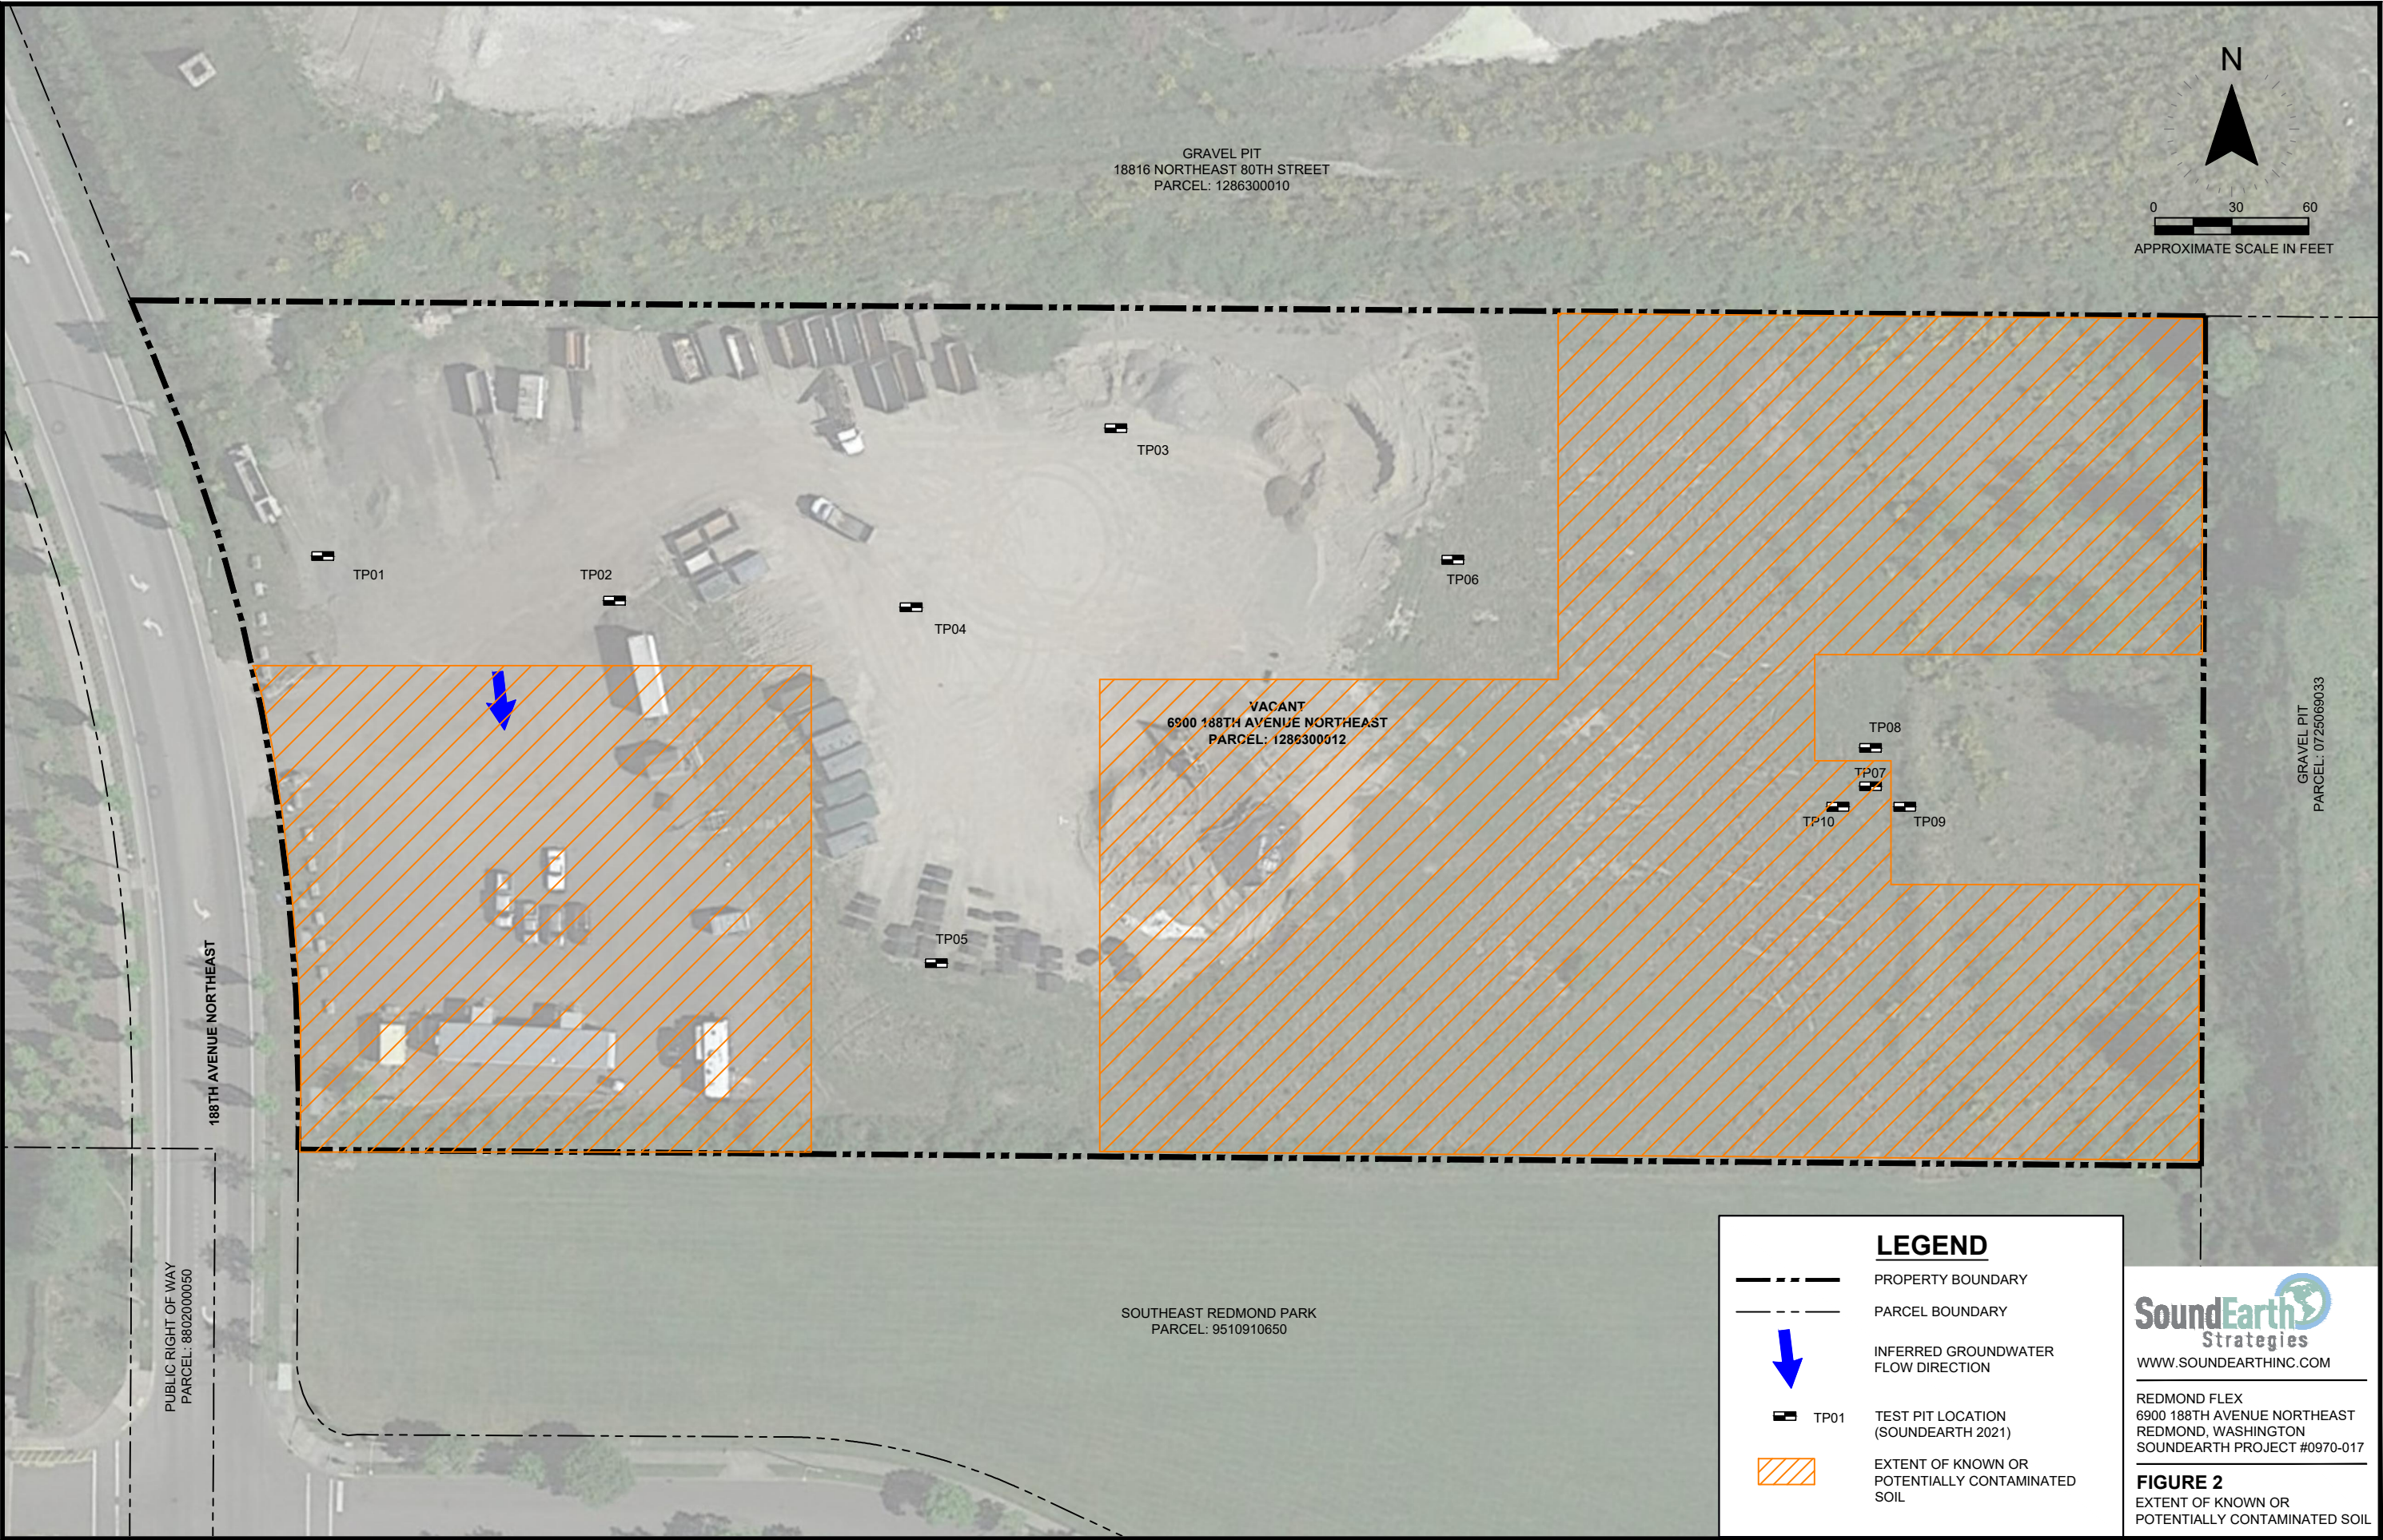
SoundEarth conducted a limited subsurface soil investigation to evaluate the nature of the fill material at the Property in May and June 2021. This investigation included the advancement of 10 test pits to depths of 3 to 5 feet bgs in the locations shown on Figure 2. Test pit locations were selected based on areas that are likely to be graded during planned redevelopment activities.

The results of the limited subsurface soil investigation indicate that petroleum hydrocarbons and metals are not present at concentrations exceeding applicable MTCA cleanup levels in the explored areas of the Property. Elevated cPAH concentrations associated with the fill material beneath the Property were

observed in one localized area on the eastern portion of the Property at a depth of 1 foot bgs, indicating that cPAH impacts in soil are limited in lateral and vertical extent.

Based on the planned land use for the Property, the proposed remedy to mitigate the exposure risks associated with cPAH-contaminated soil at the Property includes the management and disposal of contaminated soil that may be removed during excavation and grading associated with the planned redevelopment. Given that the planned redevelopment involves the construction of a slab-on-grade building with minimal excavation and grading for utilities and other subsurface features, it is not feasible to remove the full extent of known and potentially contaminated soil, as shown on Figure 2, in conjunction with the planned redevelopment activities. Based on the current redevelopment plans, it is estimated that approximately 50 percent of the known or potentially contaminated soil may be excavated during redevelopment activities. Any excavated soil with cPAH concentrations exceeding the MTCA Method A cleanup level will be handled as Class 3 contaminated material and will be transported to a Subtitle D landfill for proper disposal.

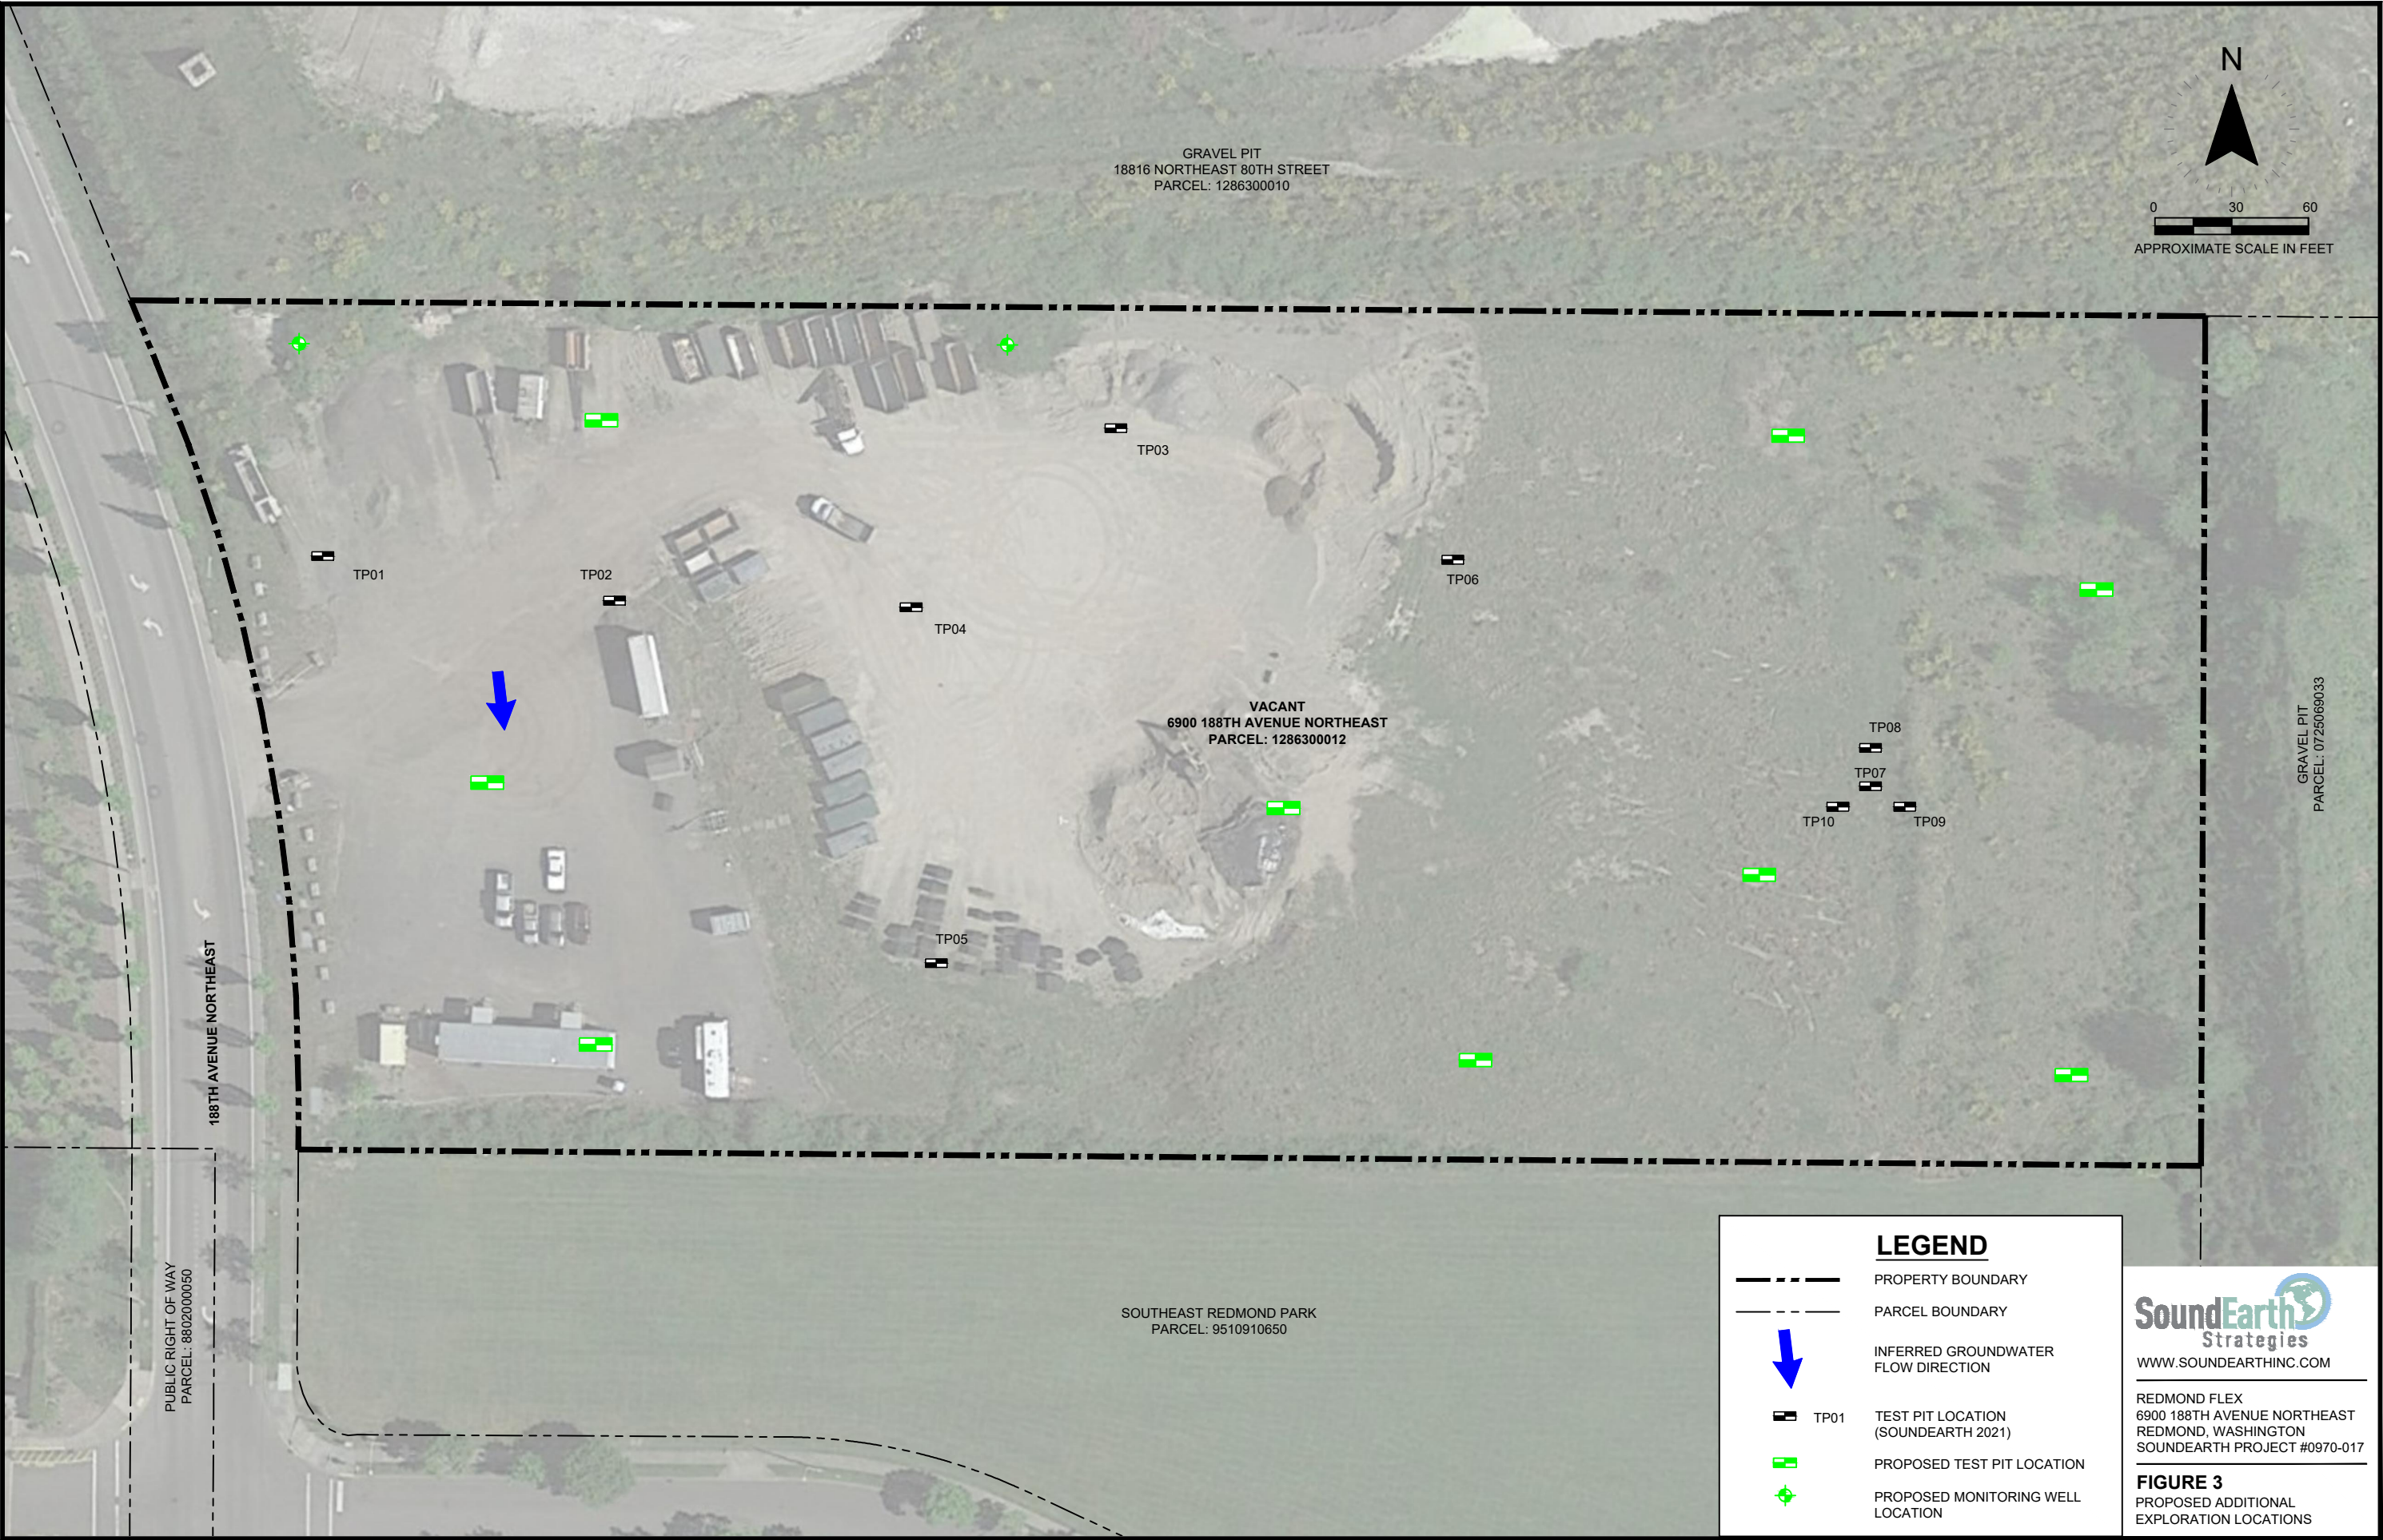
Test pit locations during SoundEarth's 2021 limited subsurface soil investigation were selected based on the areas that are likely to be graded or excavated during planned redevelopment activities. Soil conditions beneath the northeastern, southeastern, southwestern, and central portions of the Property were not evaluated during this investigation. The results of the test pit soil sampling indicated that cPAHs were not present at concentrations exceeding the MTCA Method A cleanup level in shallow soil collected from the majority of the test pits, with the exception of two test pits advanced in a localized area in the eastern portion of the Property. Based on these findings, cPAH impacts in shallow soil beneath the Property appear to be limited in lateral and vertical extent. However, given the heterogeneous nature of fill material that is present throughout the Property, the potential presence of cPAHs in soil at concentrations exceeding applicable cleanup levels beneath the northeastern, southeastern, southwestern, and central portions of the Property remains a data gap.

Previous subsurface investigations conducted by SLR Consulting (SLR) at the west-adjacent FedEx Ground Distribution Center property have identified concentrations of dissolved arsenic exceeding the MTCA Method A cleanup level in groundwater beneath the southeastern portion of the property. Concentrations ranged from 5.6 to 86 micrograms per liter ($\mu\text{g/L}$). These elevated arsenic concentrations have been attributed by SLR to the upgradient Cadman Inc property, which maintains large infiltration ponds for the discharge of storm and process water to groundwater. The majority of the detected arsenic concentrations fall within the range of natural background arsenic concentrations for the Puget Sound lowlands (0.8 to 76 $\mu\text{g/L}$), as determined by Ecology in its July 2021 draft study on Natural Background Groundwater Arsenic Concentrations in Washington State. Based on SLR's investigations, groundwater flow beneath the west-adjacent property is generally to the southeast. However, the findings of regional groundwater studies conducted by the City of Redmond have shown that groundwater flow direction in the vicinity of the Property is generally toward the west-southwest. Given the uncertainty regarding groundwater flow direction and the known presence of elevated arsenic concentrations in groundwater on the west-adjacent property, the potential presence of arsenic in groundwater beneath the Property is considered a remaining data gap.

To address the remaining data gaps and further evaluate the extent of cPAH-contaminated soil, SoundEarth proposes to conduct a supplemental subsurface investigation of soil and groundwater at the Property. The proposed scope of work includes the advancement of nine additional test pits in previously unexplored locations, as shown on Figure 3, to a depth of approximately 5 feet bgs. Up to two soil samples per test pit would be submitted for laboratory analysis of cPAHs.

Additionally, to evaluate the potential for arsenic in groundwater that may have migrated beneath the Property, two monitoring wells would be installed to a depth of approximately 50 feet bgs, depending on observed groundwater conditions, on the northern portion of the Property (Figure 3). The monitoring wells would be advanced using a hollow-stem auger drill rig. The monitoring wells would be developed following installation, and groundwater samples would be collected from each monitoring well using standard low-flow methodology and submitted for laboratory analysis of dissolved arsenic.
