**FACILITY
CONDITION
ASSESSMENT**

To
City of Redmond

For
Old Fire House Teen
Center
16510 NE 79th St.
Redmond, WA 98052

Dated
July 9, 2025

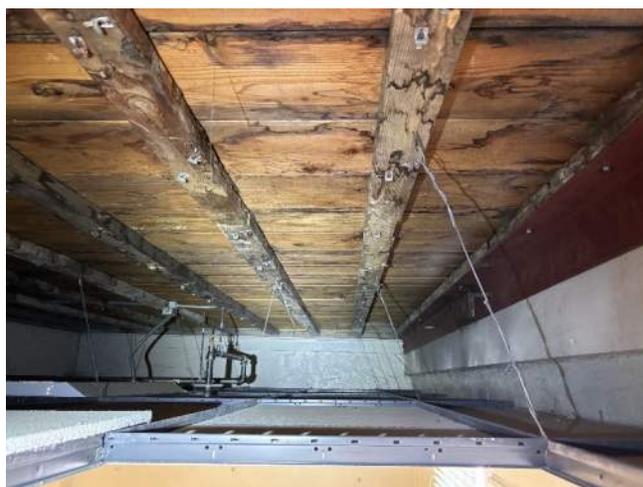
Image VI.14 Water-damaged roof decking in couch room

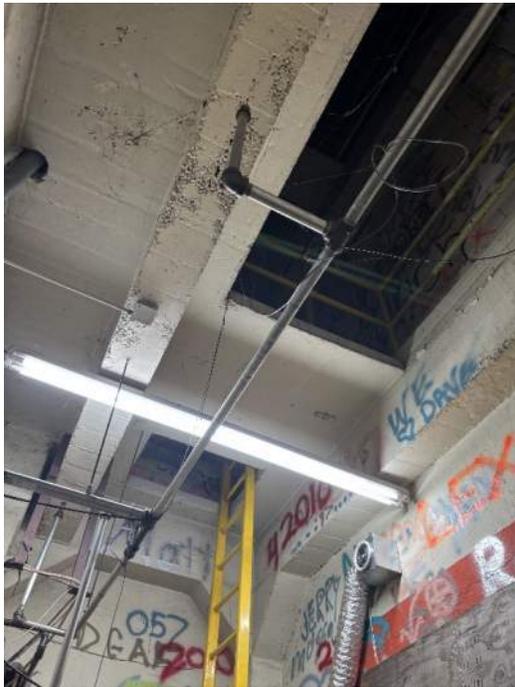
Additionally, the Hose Tower is the greatest structural concern and poses a risk of breaking apart in a seismic event if it is not removed or strengthened. It could be a potential life safety issue and damage the rest of the building. The tower's cast in place concrete frame requires strengthening and the CMU façade is beyond repair and needs to be rebuilt with reinforced CMU or replaced with a light façade panel.

Image VI.15 Hose Tower from first floor

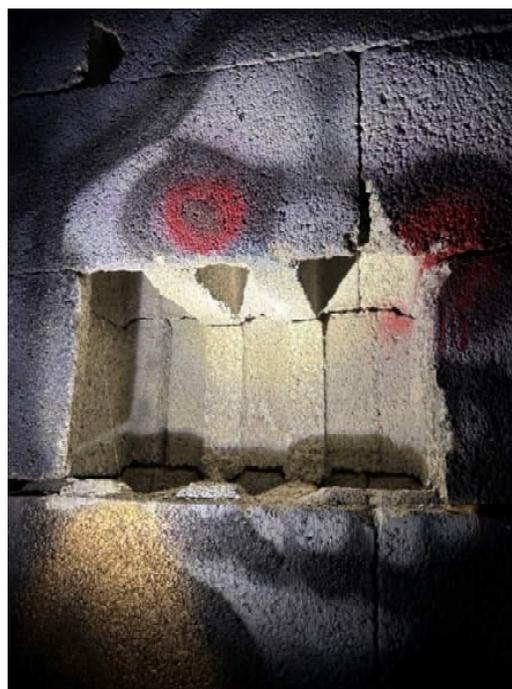
Image VI.22 Broken CMU block in Hose Tower wall

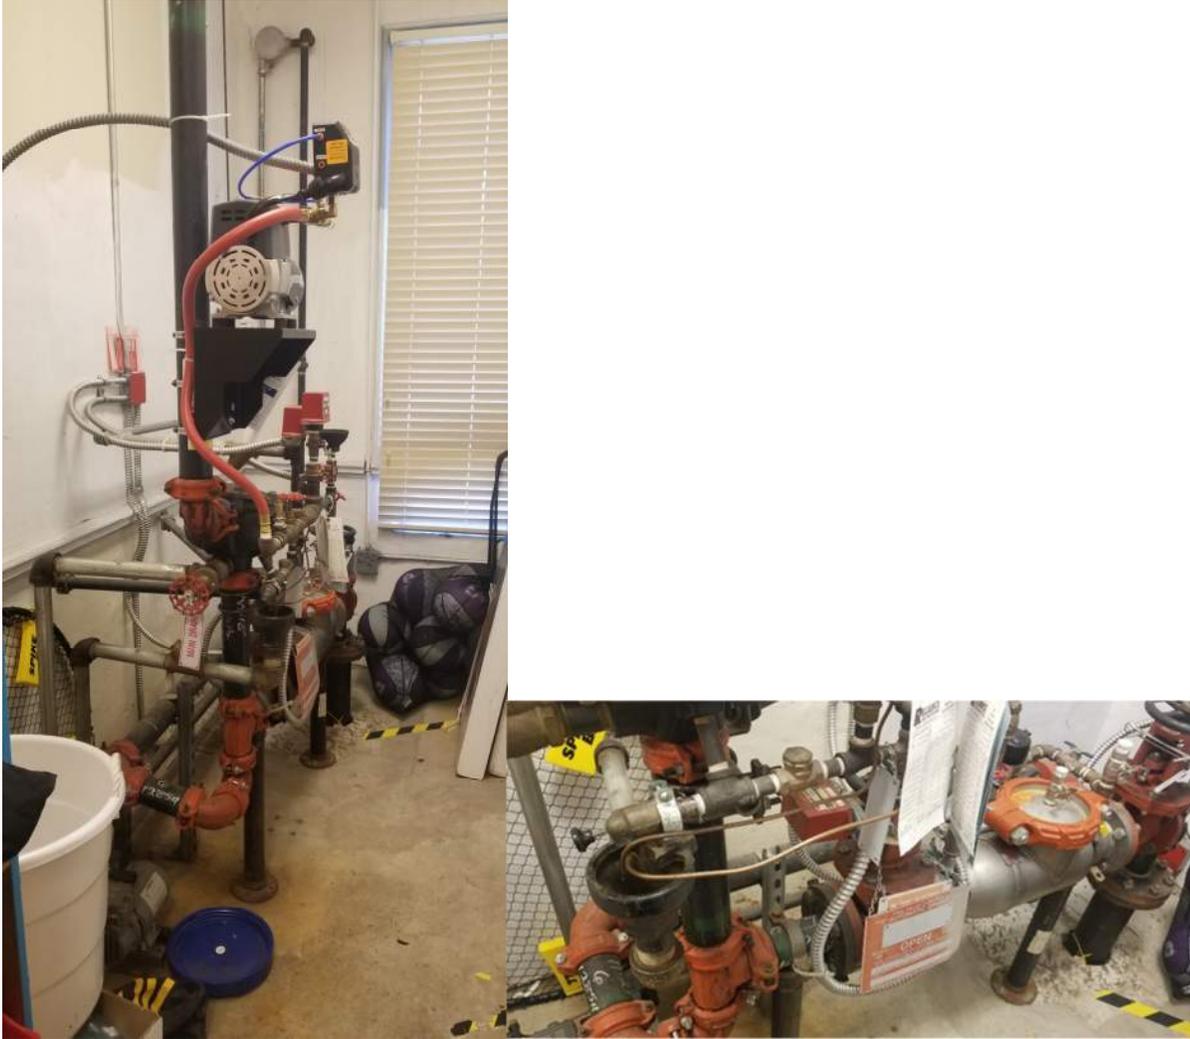
Figure M1A and M1B – Fire xFIRiser with backflow

The system itself is functioning and has been tested in the past year. A fire hydrant is within 50' of the fire department connection (FDC) and post indicator valve (PIV). The riser is located on the West side of the building in a riser room that shares as a storage space with gym type equipment. There is a single dry riser, however, the system itself along with the backflow do not meet current water safety standards or NFPA-13 standards. The sprinkler heads themselves are not quick response heads. The system is functional and holding pressure.

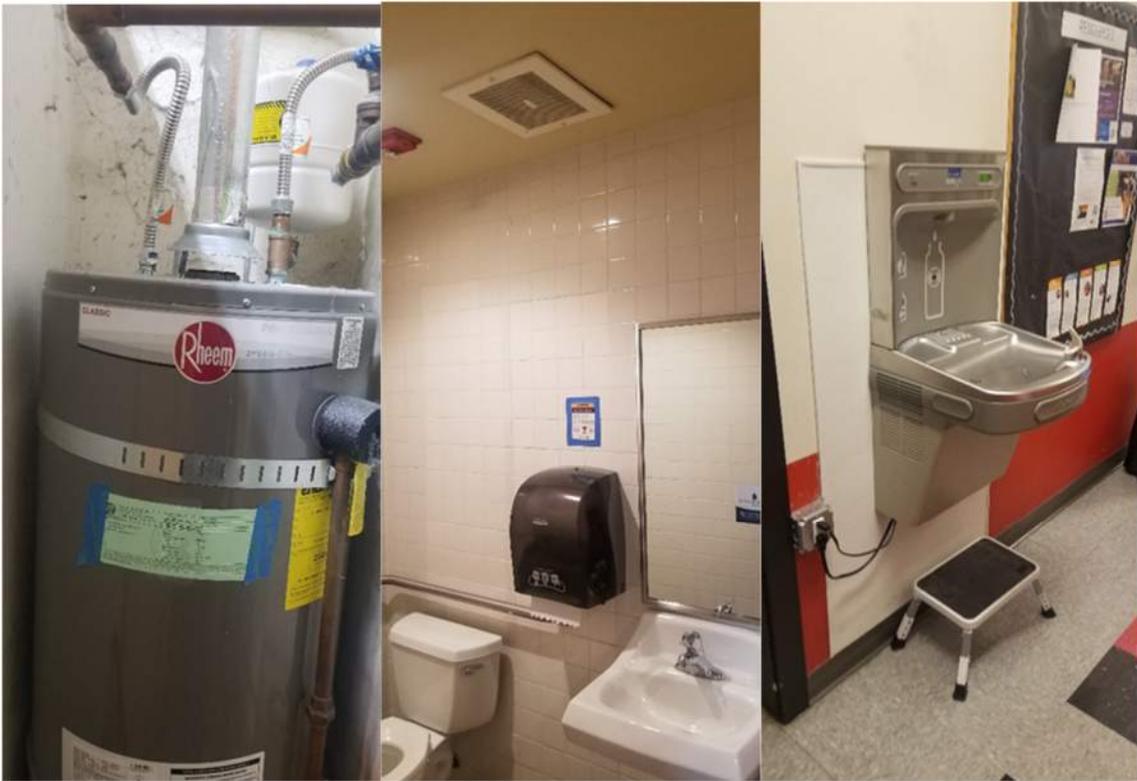
Figure M2 – Water Heater

The piping distribution system could not be observed other than where exposed at the water heater and below grade at an access panel. Based on the age of the building, it is likely that the sanitary sewer lines are not cast iron, but should be confirmed in conjunction with videoing of the lines to understand the condition. The piping is a combination of galvanized and copper. The water heater was replaced in 2014/15 based on the manufacture date. The hot water system is currently using natural gas with a flue through the roof. A circulation pump was not observed allowing for a hot water recirculation system to get hot water to lavatory fixtures within the health code required 10 seconds. These systems were observed to be functioning, but well beyond their useful life.

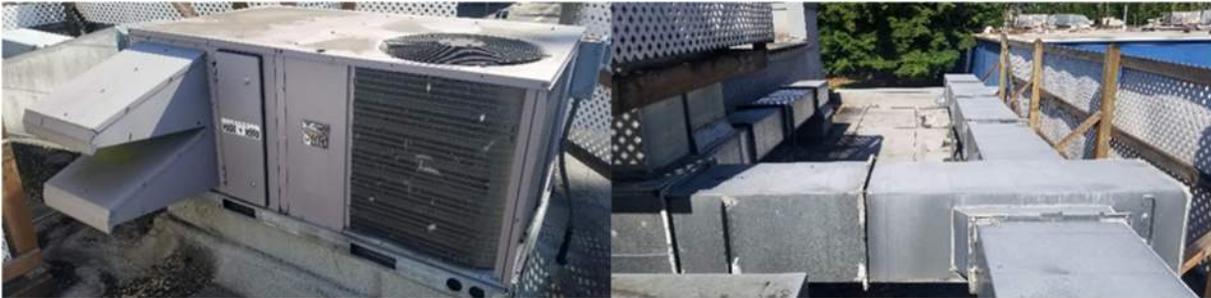
Figure M5 – Packaged HVAC unit

The equipment has been replaced along throughout the life of the building with the most recently observed new equipment being the packaged rooftop unit from 2010. The exhaust fans, wall heaters and gas fired units are all older than 20 years. The ducting on the roof did not appear to be insulated and does not meet current energy code requirements for efficiency or refrigerant type. Some of the thermostats did not appear to be functioning as the readout was not visible.

Mechanical systems are old equipment models and do not meet current energy code. The rooftop unit should be replaced. Exhaust fans should be installed at restrooms and kitchen. Control system should be replaced with a modern one. Gas furnaces should be replaced with more modern, efficient systems.

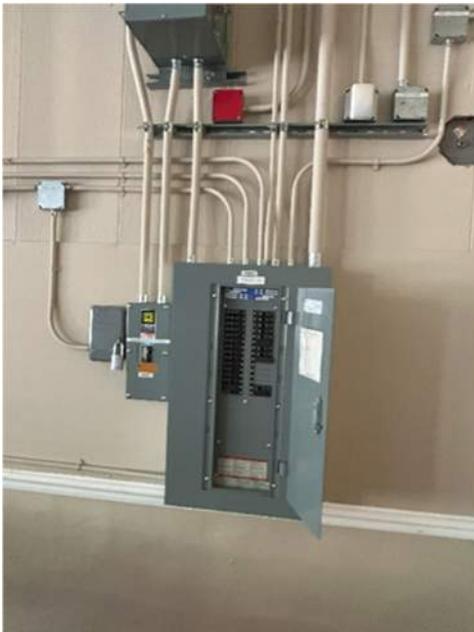
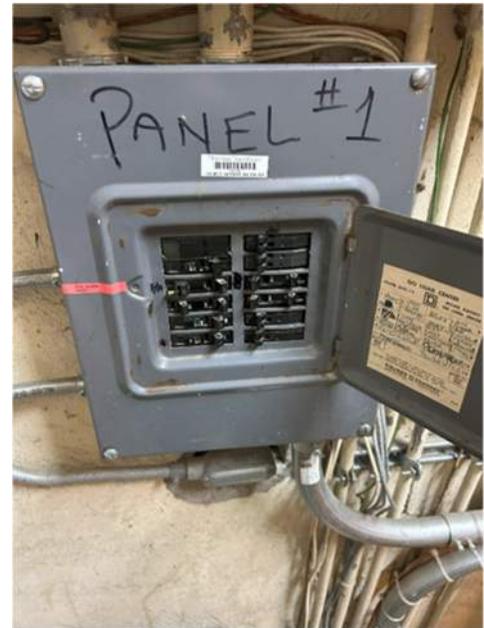
Figure E1 – Electrical Panels

- 5) Panel 2. 100A, 120/240V, 1phase, 3wire, 24 circuit residential load center style with plug-in circuit breakers. Half of the breakers are using high density dual breakers. Square-D, 1970s vintage. Panel is beyond useful life. Location is in the auditorium area.

The electrical panels do not include arc flash labels as recommended by NFPA70E for equipment maintenance. Not clear if a fault study has been performed in past. Panels 1 and 2 do not have any spare circuits available. Several spare circuits are present in Panels MDP, A and B. Regular electrical panel maintenance is not evident at this facility. The electrical service capacity appears adequate for the building.

The old electrical panels should be replaced with new. All new receptacles should be installed. All lighting controls should be replaced with a modern, energy compliant system. All light fixtures should be replaced with LED versions. The Fire Alarm system should be replaced. Old and unused wiring in the electrical room should be replaced or removed.

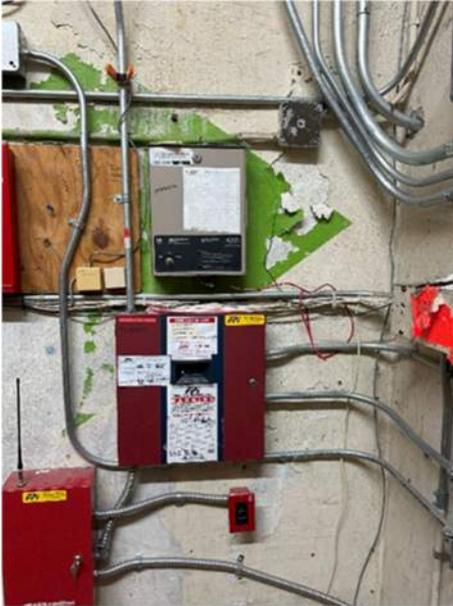
Figure E3 – Fire Alarm Panel

show no deficiencies. The system is outdated although it appears to be functioning adequately. Fire alarm distribution devices appear to meet code requirements.
