Arborist Report

Site: East side of 156th Ave NE, Redmond, WA 98052 (between NE 45th Street to NE 51st Street)

Re: Tree Inventory and Assessment

Date: May 13, 2026

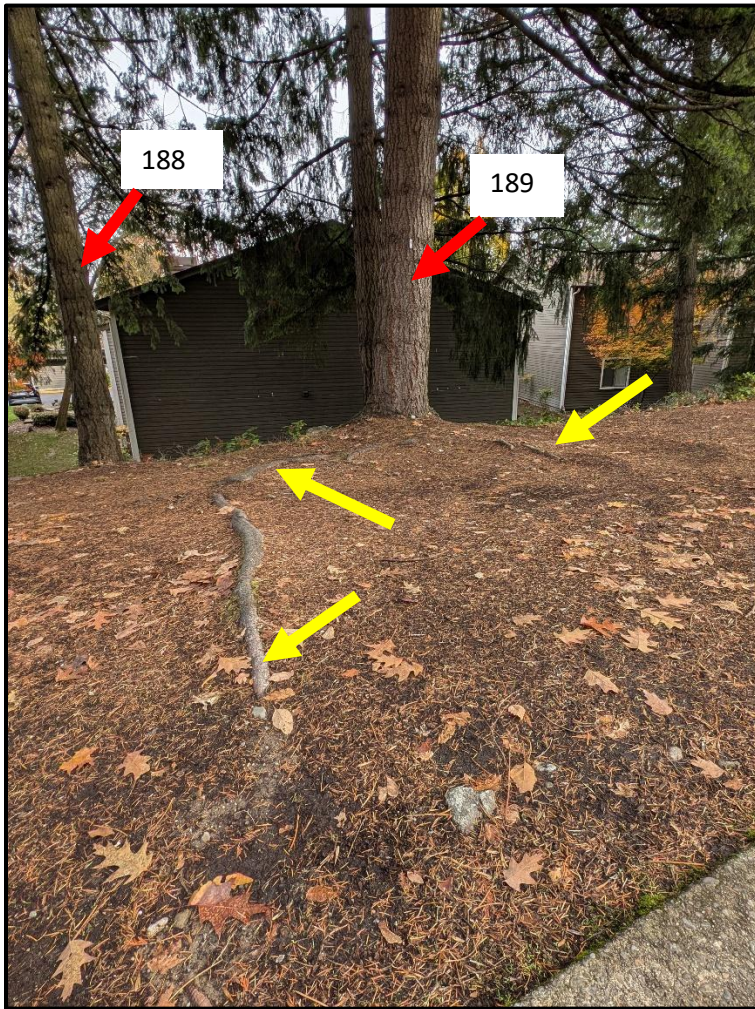
Many of the trees had surface roots throughout their planting areas likely due to being planted in compacted soils (**Photo 1**). Tree protection measures should be taken to protect surface roots for retained trees during construction.

Photo 1. Looking southeast at trees 188 and 189. Yellow arrows indicate common site conditions where surface roots are located near existing sidewalks.

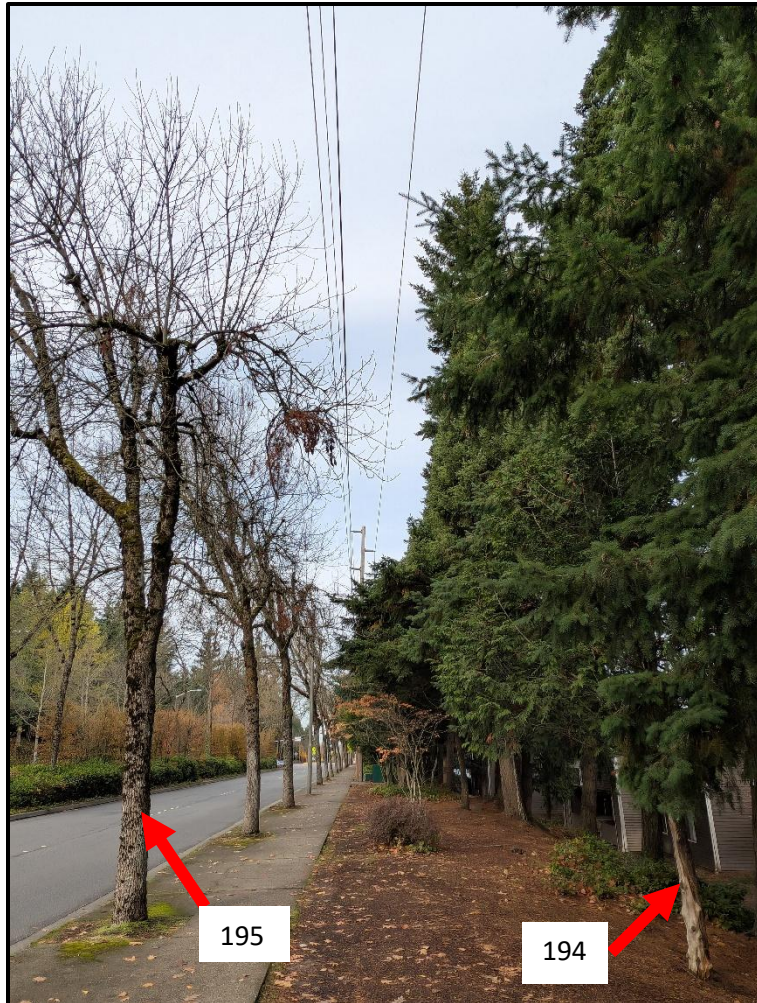
The majority of the trees planted on the western side of the sidewalk were green ash (*Fraxinus pennsylvanica*) that have been heavily pruned for utility clearance (**Photo 2**). There were some newly planted cherries (*Prunus* spp).

Photo 2. Looking north in project site area showing typical site conditions where trees have been pruned for utility line clearance.

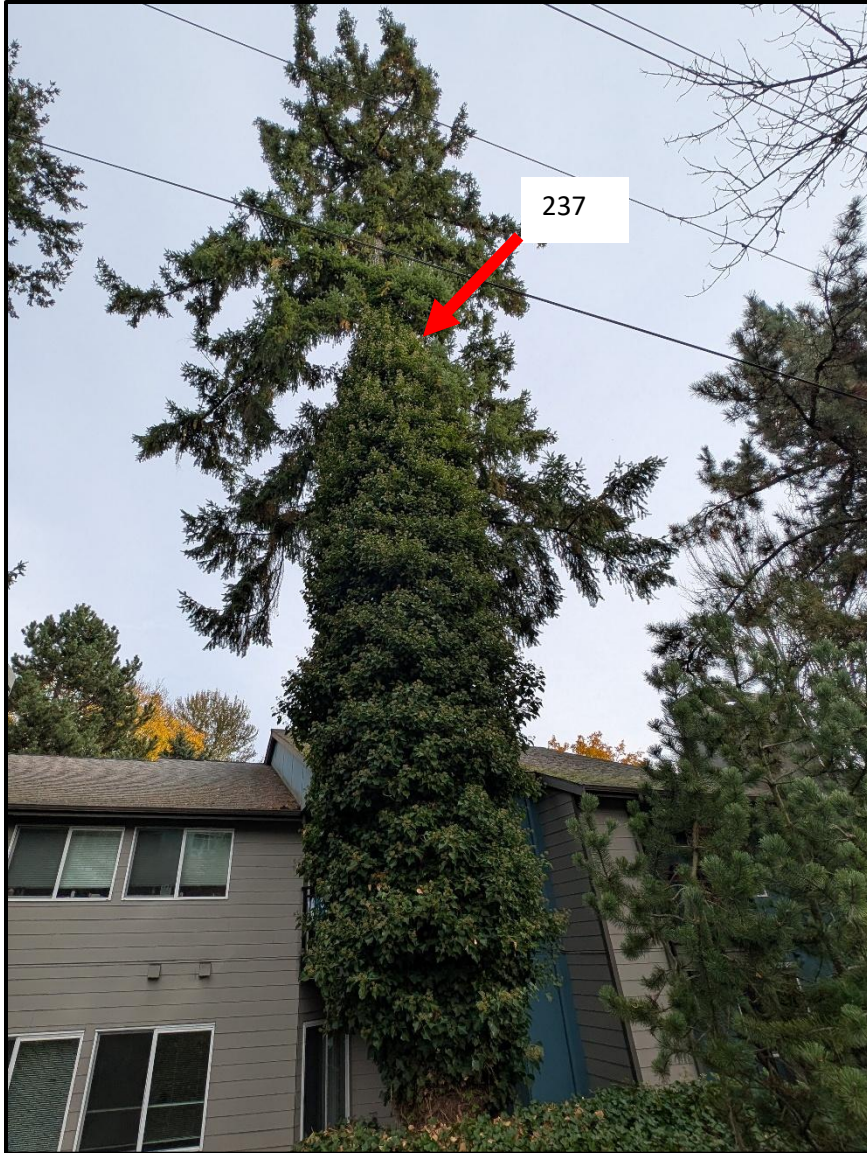
Several of the trees had ivy (*Hedera* spp.) growing up the trunks and into the canopy (**Photo 3**). Ivy should be cut away from base of tree and at 4-feet above the base to allow the vines to desiccate. We recommend ivy is managed several feet from the base to ensure it does not climb the trunks of trees.

Photo 3. Tree 237 showing substantial ivy growth up trunk.

- Follow the Tree Protection Specifications in Appendix F throughout site work.
- Cut and remove ivy from the base and at 4 feet above the base of trees and maintain ivy away from the base of retained trees.
- All replacement plantings must be consistent with RZC 21.72.080.
 - Utilize alternative tree genus than ash or maple to promote species diversity in the ROW.
