# Embankment Failure

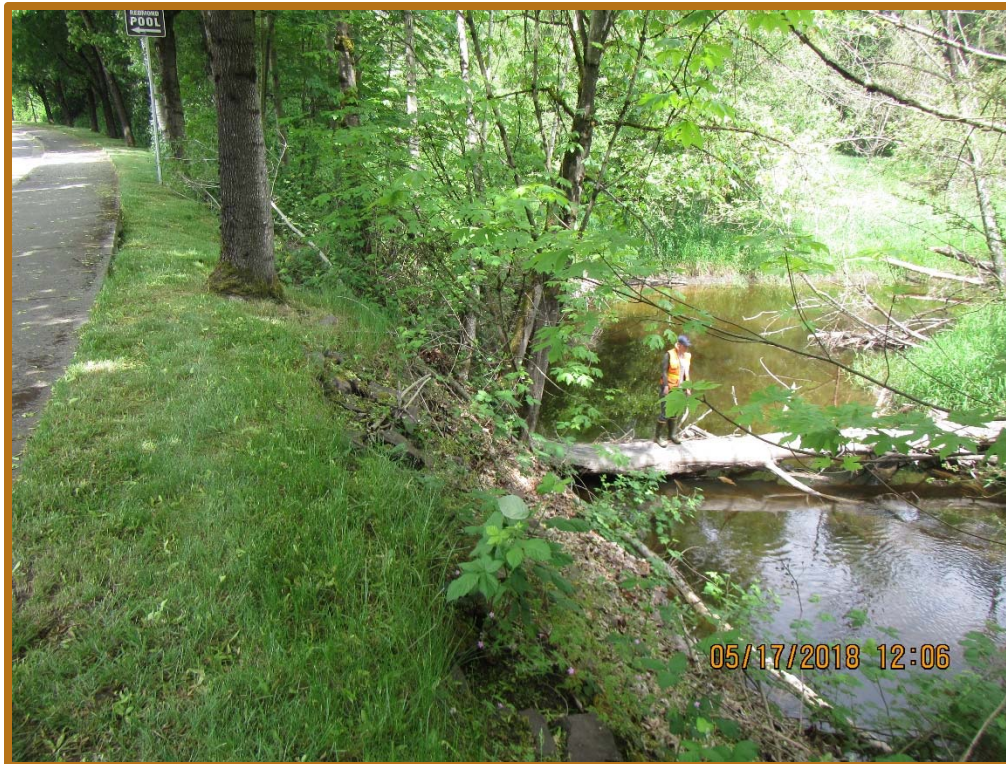
Bear Creek is migrating into the roadway embankment for Avondale Road.

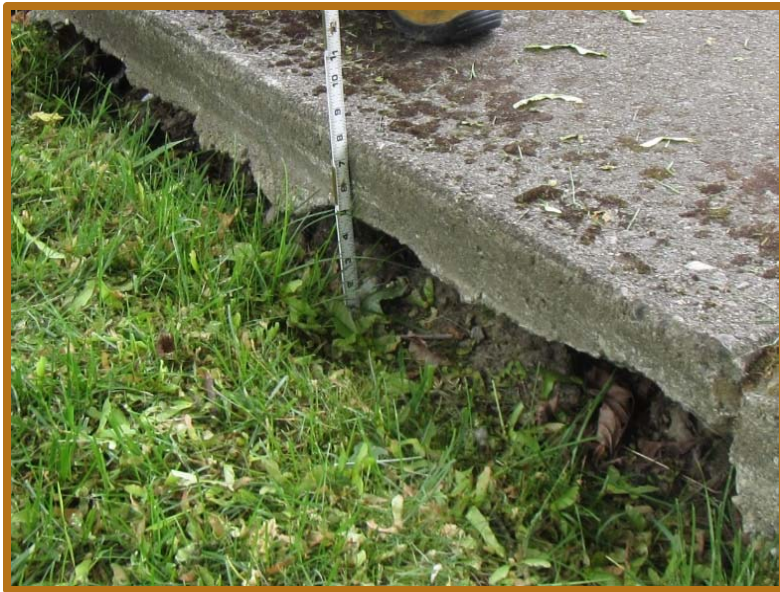
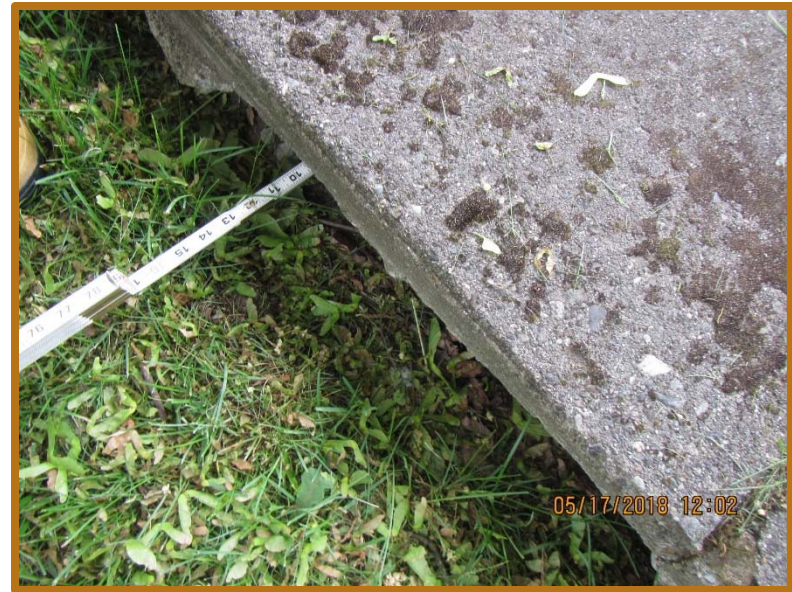
# Embankment Settling Under Sidewalk

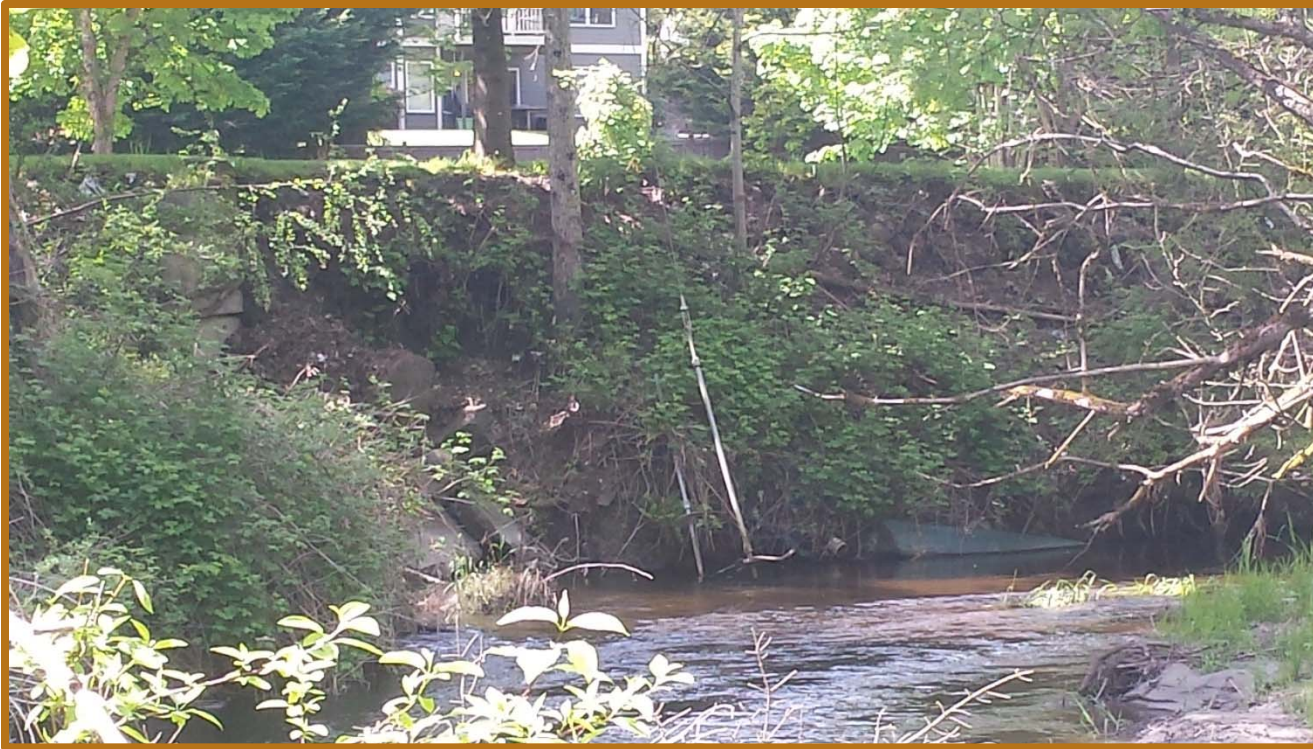
# *Embankment Failure*

The embankment, with two stormwater outfalls and a utility pole, is being eroded by Bear Creek.

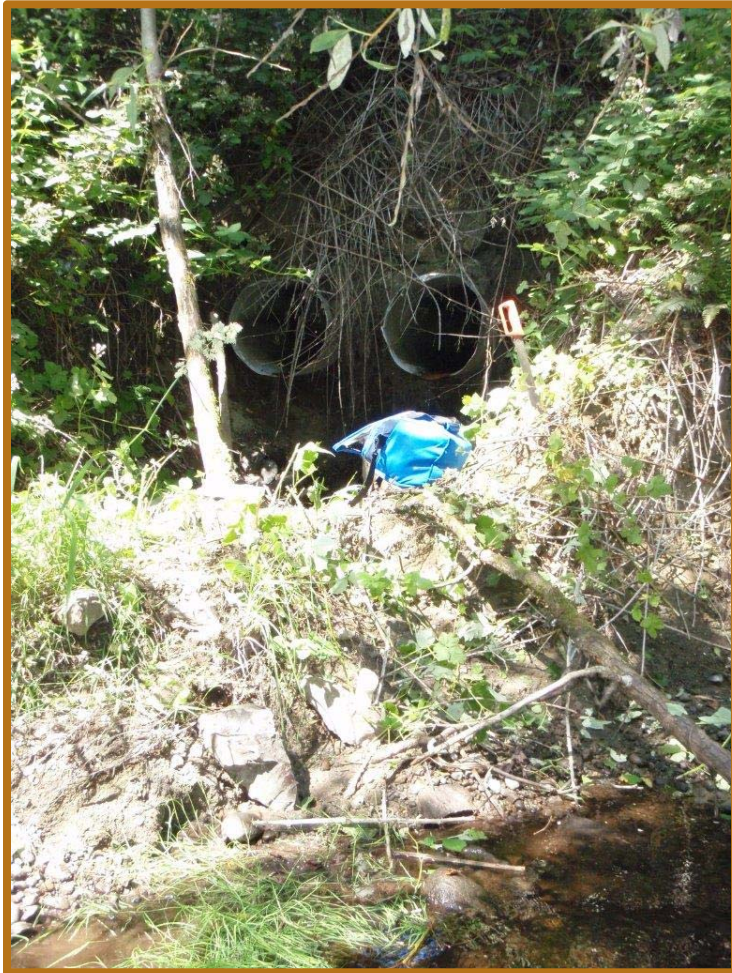
2010

# Stormwater Outfall Damage
