**Lennar Multifamily Communities  
Marymoor Project  
Redmond, WA  
Arborist Report**

**July 20<sup>th</sup>, 2018**

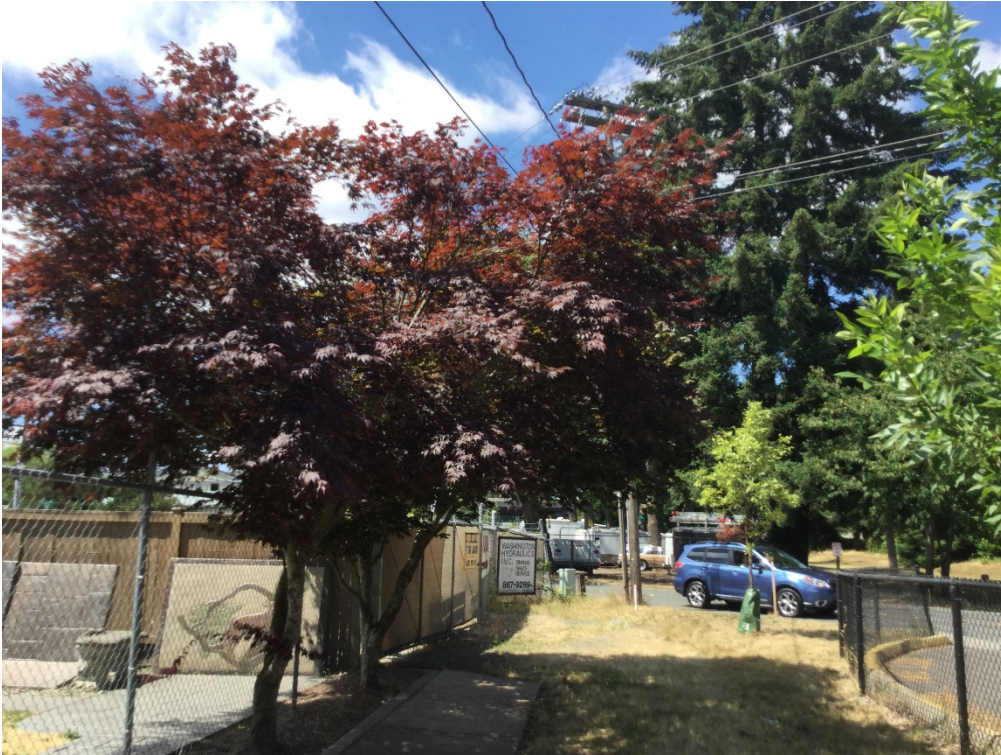
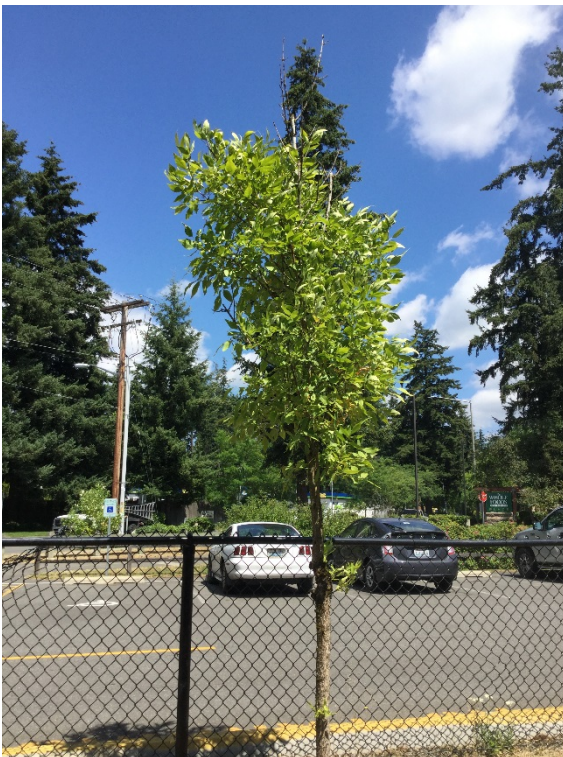
The only other notable trees on this property are Japanese maples, #7 and #8. They are in overall good condition and have an average DBH of 5" which are not considered to be significant trees by RZC 21.72, but could potentially be protected or salvaged.

Trees #7, 8 – Non-significant Japanese Maples

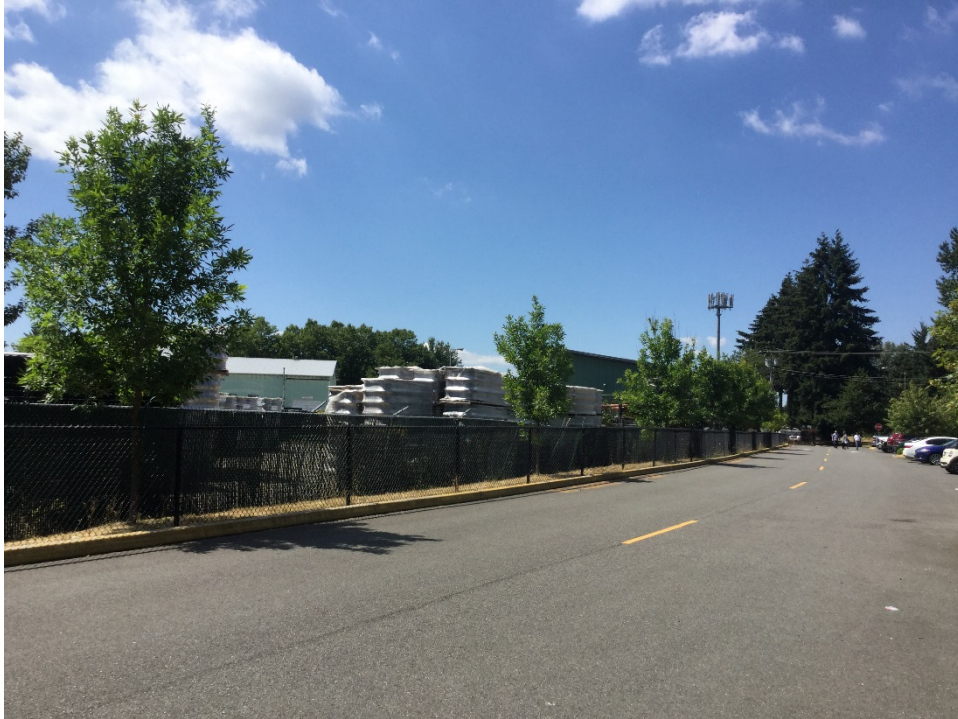
R.O.W. Trees

#103-#114 are Ash trees planted close to the west property line. The subject trees are young or non-significant with 2-3" caliper trunks. They are in good or fair condition mostly

due to compaction and drought. 'Gator bags' were installed on some, but empty. These trees could remain viable with regular watering through the summer months and if construction activity is limited to the existing fence line.

Tree #104 – Non-significant Ash with a dead top as a result of poor planting soils and drought stress

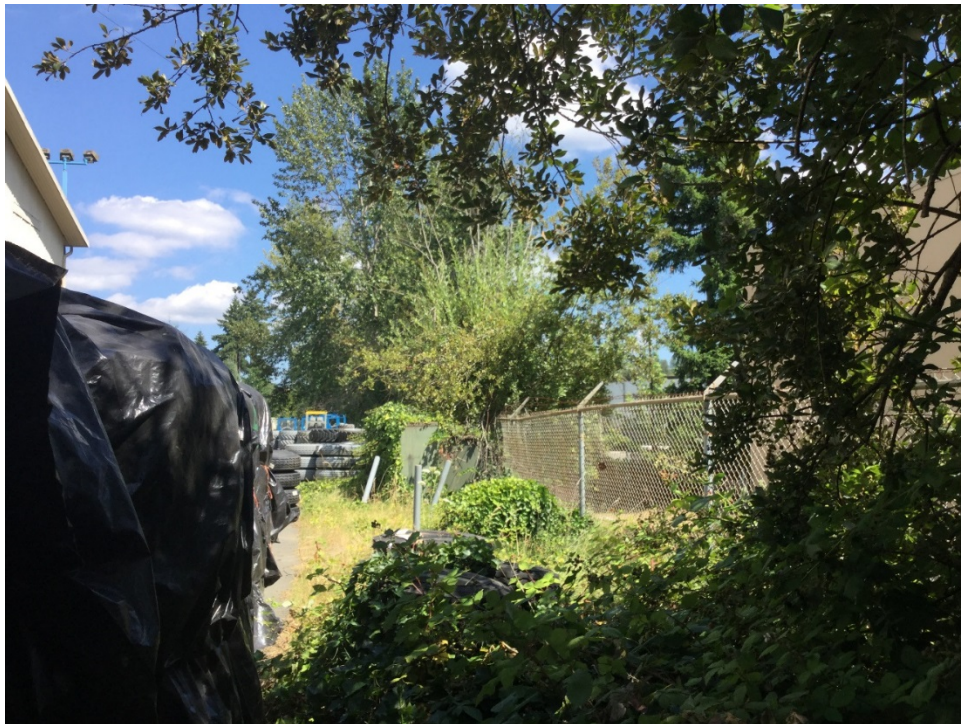
Trees #119-127 are a mix of poor - fair condition Cottonwoods, Scouler's Willow, and an Oregon Ash. These are growing a few feet south of the property line, with canopies extending 8 - 20' over the property line.

#121-122 – Scouler's willow over south fence.

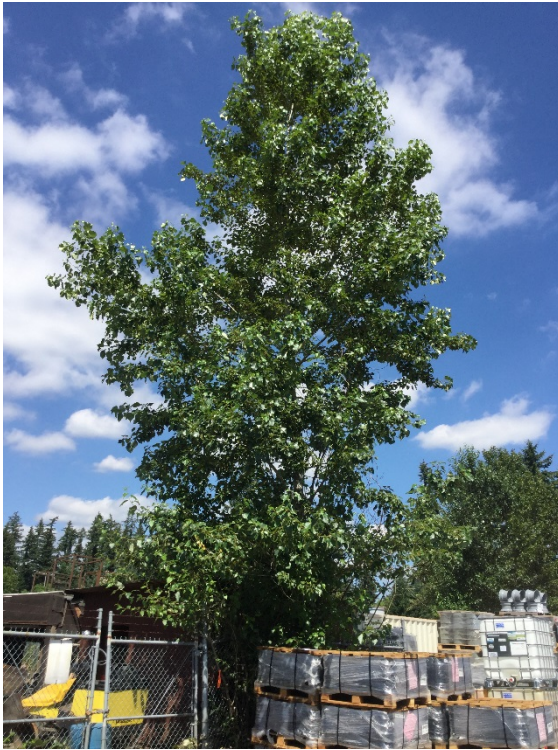
Trees #1>#6 are black cottonwood, which have blown in as seed and taken root in gravel or cracks in asphalt. Some are in difficult to access areas between shipping containers, so DBH is approximate. Their overall condition is rated as fair, but are not considered to be viable in the long term due to present compaction and future site development.

#1 – Black Cottonwood

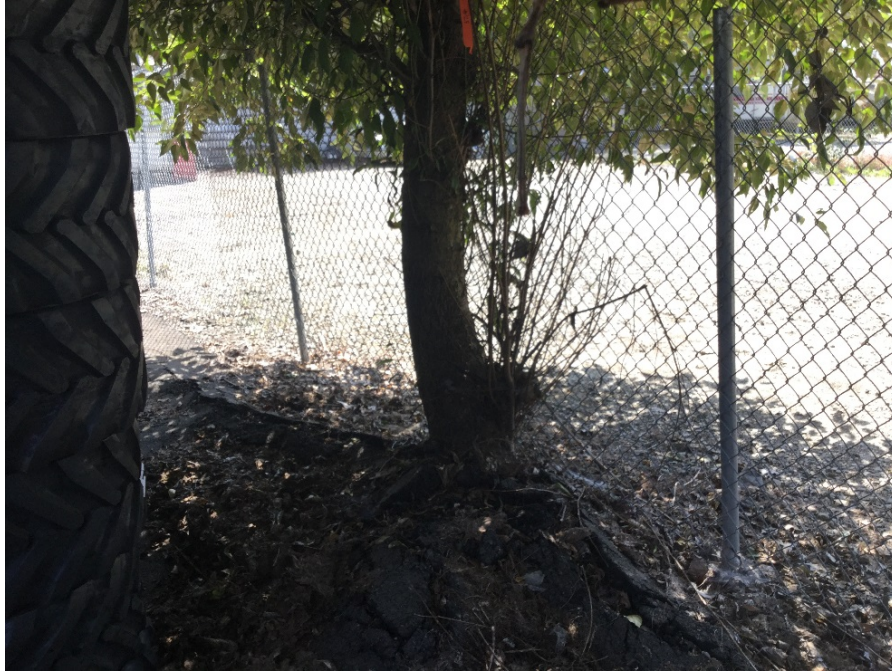
Cottonwood breaking through asphalt.
