February 7, 2019

Site: Willows Northwest I, LLC Parcel number: 272605-9026 15.4 acre

To assess all significant and landmark trees on site and to prepare a Tree Preservation Plan to be included with the proposed plat improvements.

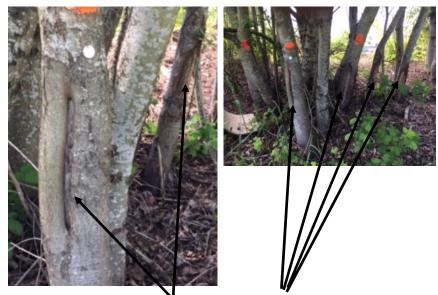
#5 is a multi-stemmed beech with significant decay in most the trunks

Beech as a species nationwide is in serious decline from both insect and disease. The tree species has a low ability to compartmentalize disease and once the tree is injured, decay follows quickly.

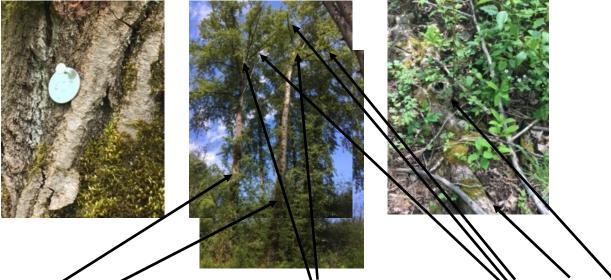
Trees # 416 and #417 are cottonwoods with previous top loss, dead wood throughout the canopy, exposed and decaying roots, Tree #416 has a lean to the NE

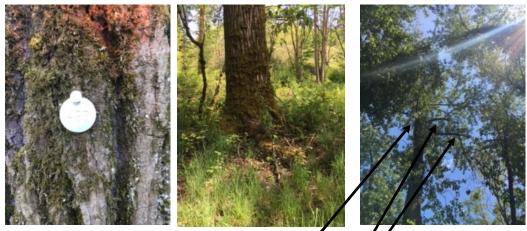
Tree #423 Cottonwood, significant failure of 1/2 of the tree, dead wood, exposed roots

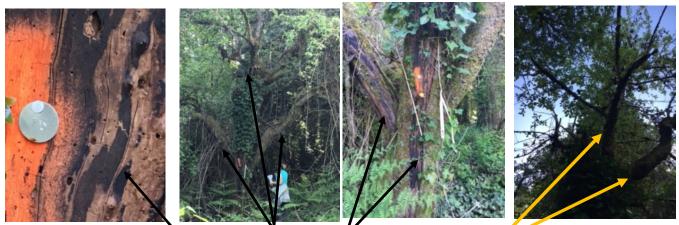
Tree #75 is an overly-mature apple with little live wood

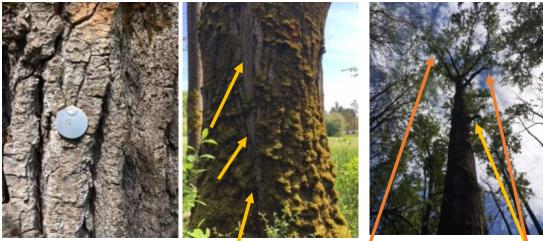
Tree #51 Cottonwood, vertical crack with decay, previous top loss, low live crown ratio and dead wood
