## **Redmond Senior Center**

## **Building Investigation**

August 29, 2019

Prepared by: Zane Kanyer PE, SE

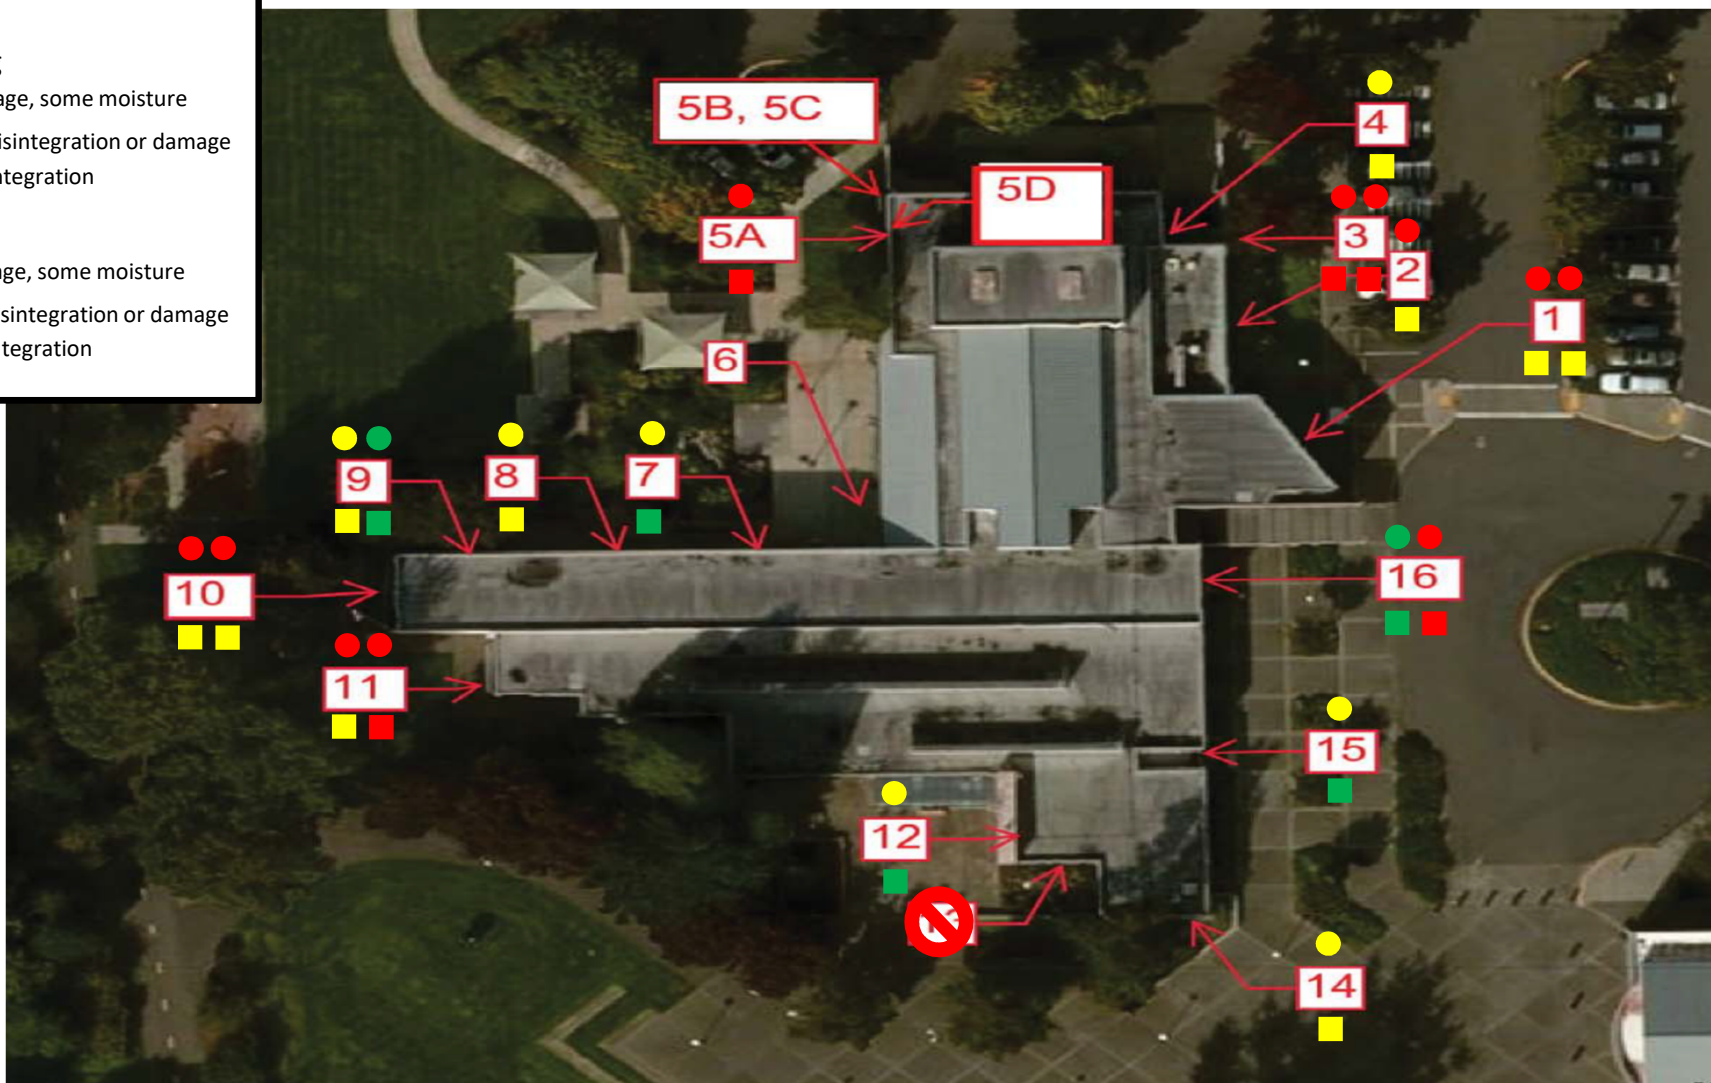
### Site Map & Summary of Findings

Site No.	Plywood Sheathing Rating*	Plywood comments	Framing Stud Rating*	Framing comments	General Comments
1a	0	Disintegrated	1	Some rot	
1b	0	Disintegrated	1	Some rot	Added an extra hole at this site
2	0	Disintegrated	1	Some rot	
3a	0	Disintegrated	0	Extreme rotting of studs	
3b	0	Disintegrated	0	Extreme rotting of studs	
4	1	Half of plywood disintegrated	1	Some rot	
5	LOCATION 5 IS FOR REPAIR OF PANEL FAILURES				
6	0	Disintegrated	0	Extreme rotting of studs	
7	1	Rotten	3	Studs OK	
8	1	Rotten	2	Some rot	
9a	3	Clear and dry	3	Clear and dry	lower location beneath window
9b	1	Half of plywood disintegrated	2	Some rot	
10a	0	Disintegrated	2	Studs wet	Upper hole added at this site
10b	0	Disintegrated	2	Studs and plate wet	
11a	0	Disintegrated	2	Studs wet	location near door
11b	0	Disintegrated	0	Extreme rotting of studs	location move to tiled column
12	2	Some Rot	3	Studs OK	only 1 of 3 locations opened up
13	LOCATION 13 NOT DONE

14	1	Rotten	1	Some rot	lower location not done
15	1	Rotten	3	Studs OK	
16	3	Clear and dry	3	Studs OK	
17	0	Disintegrated	0	Extreme rotting of studs	this location added between 15 and 16

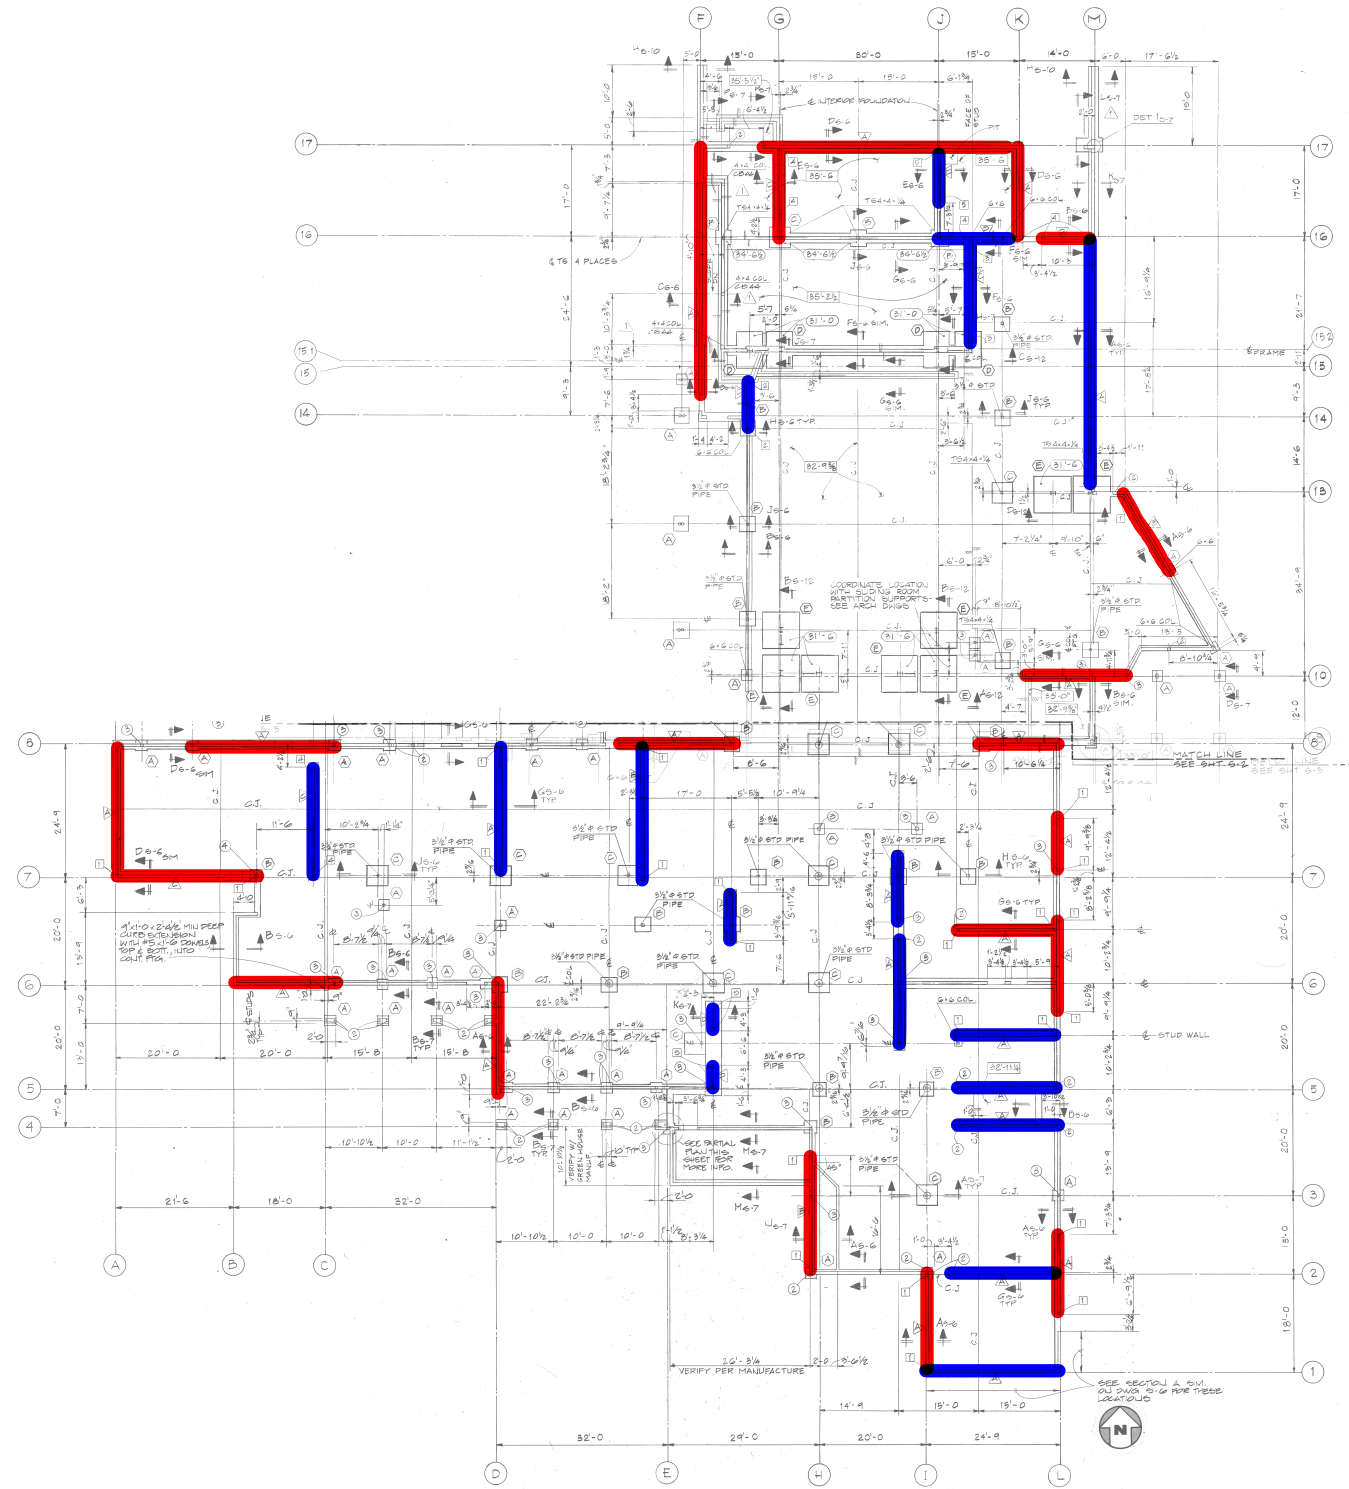
Areas of overstress

In the case of the Redmond Senior Center, item 1 outlined above would be most applicable. As such, section 404 of the IEBC requires the building be laterally evaluated with full code level wind loads and 75 percent code level seismic loads. We evaluated the existing lateral load carrying system using the above values and assuming all exterior walls were damaged. This analysis determined that significant deficiencies in the lateral system are present (See Appendix B).

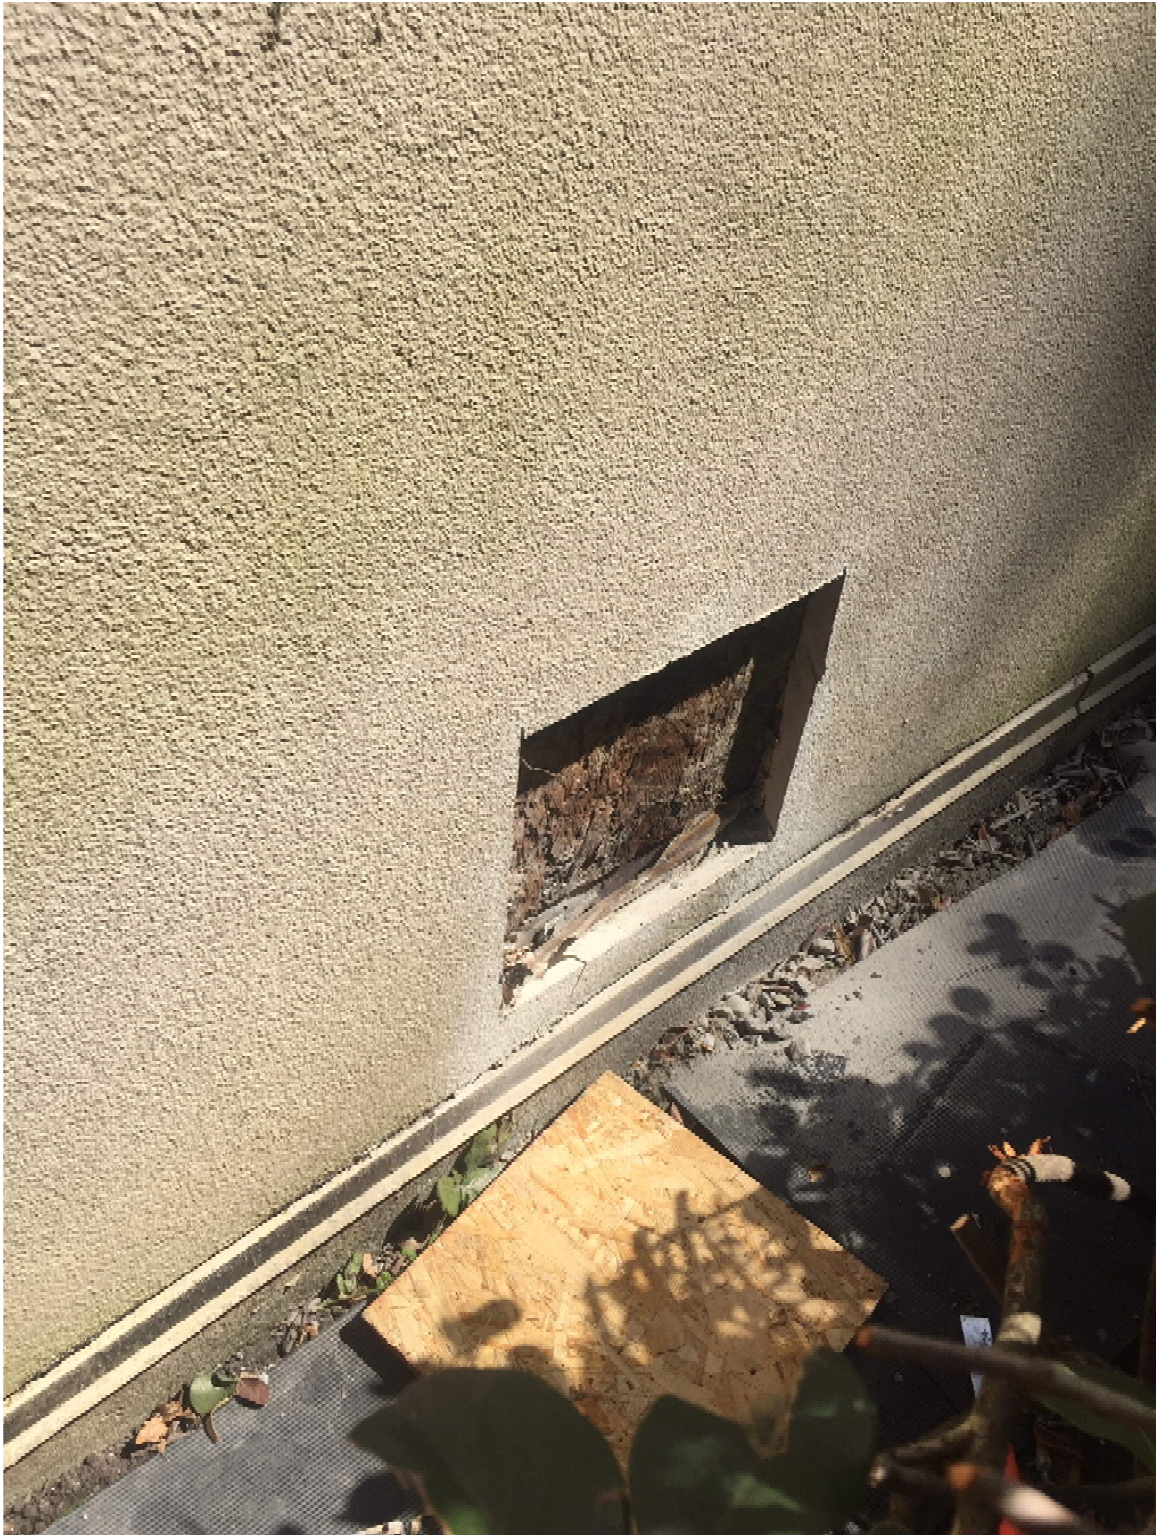
**Figure 1 - Typical opening showing signs of significant deterioration of OSB sheathing.**

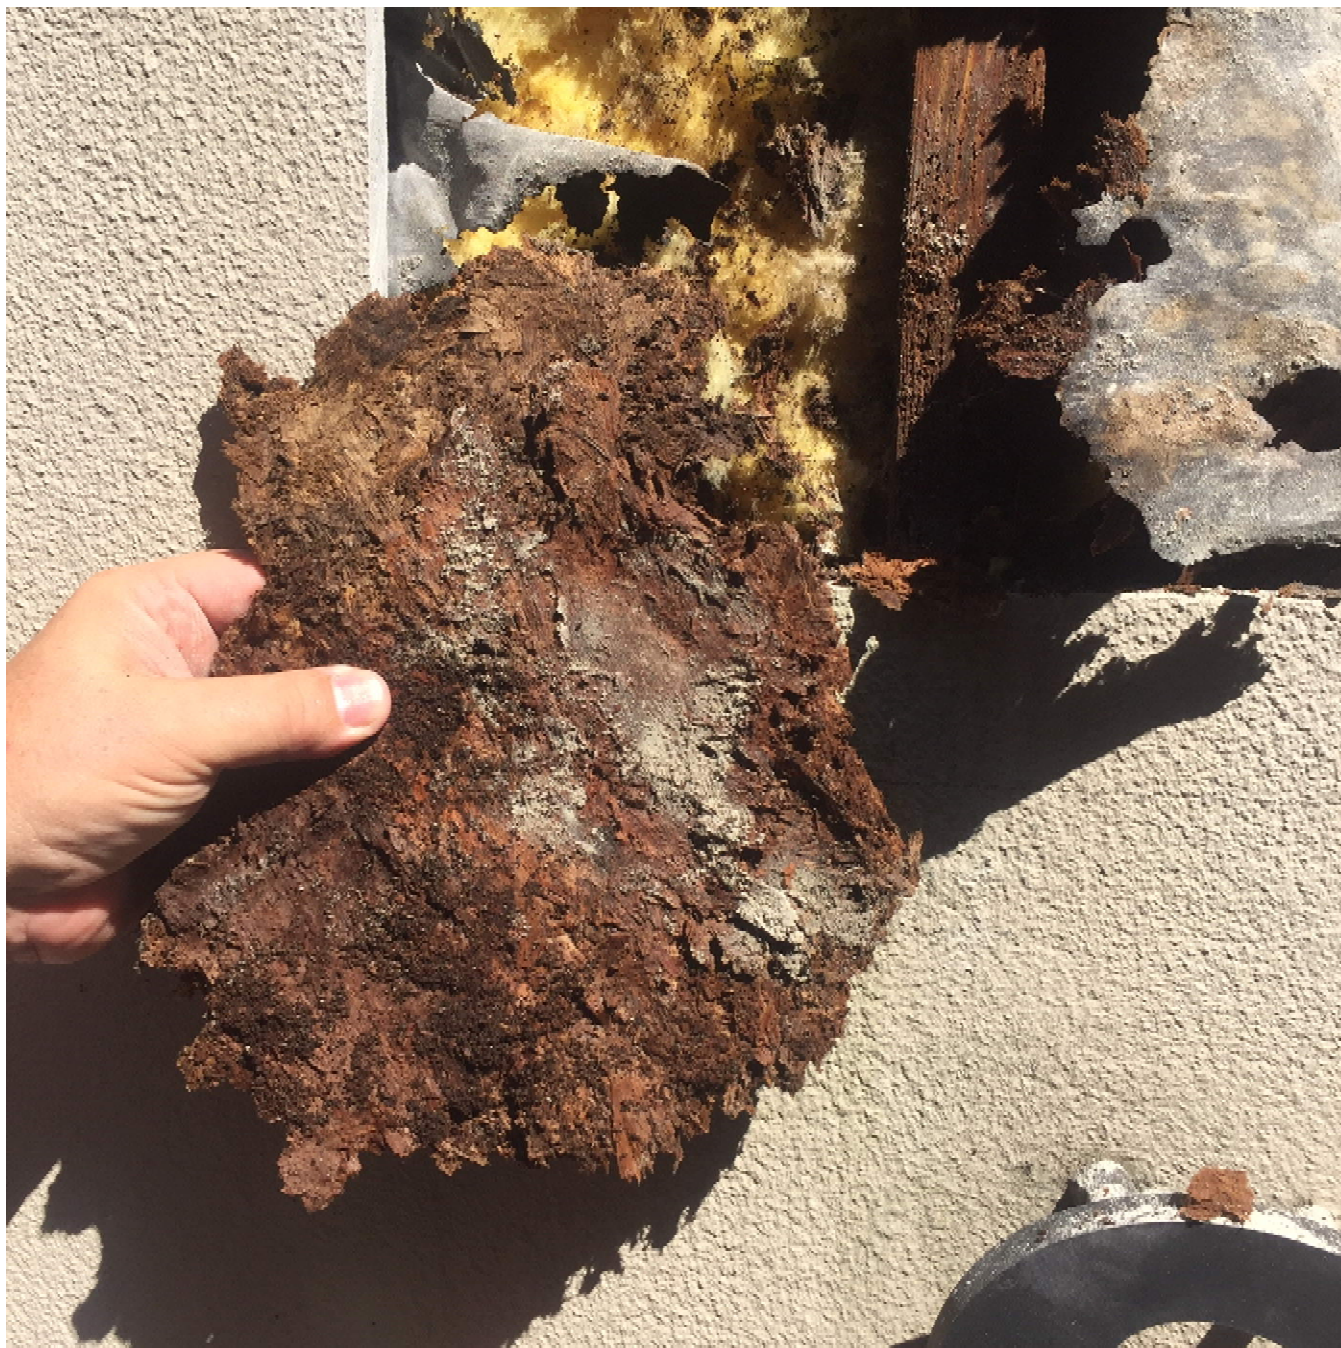
**Figure 2 - Significant OSB sheathing deterioration.**

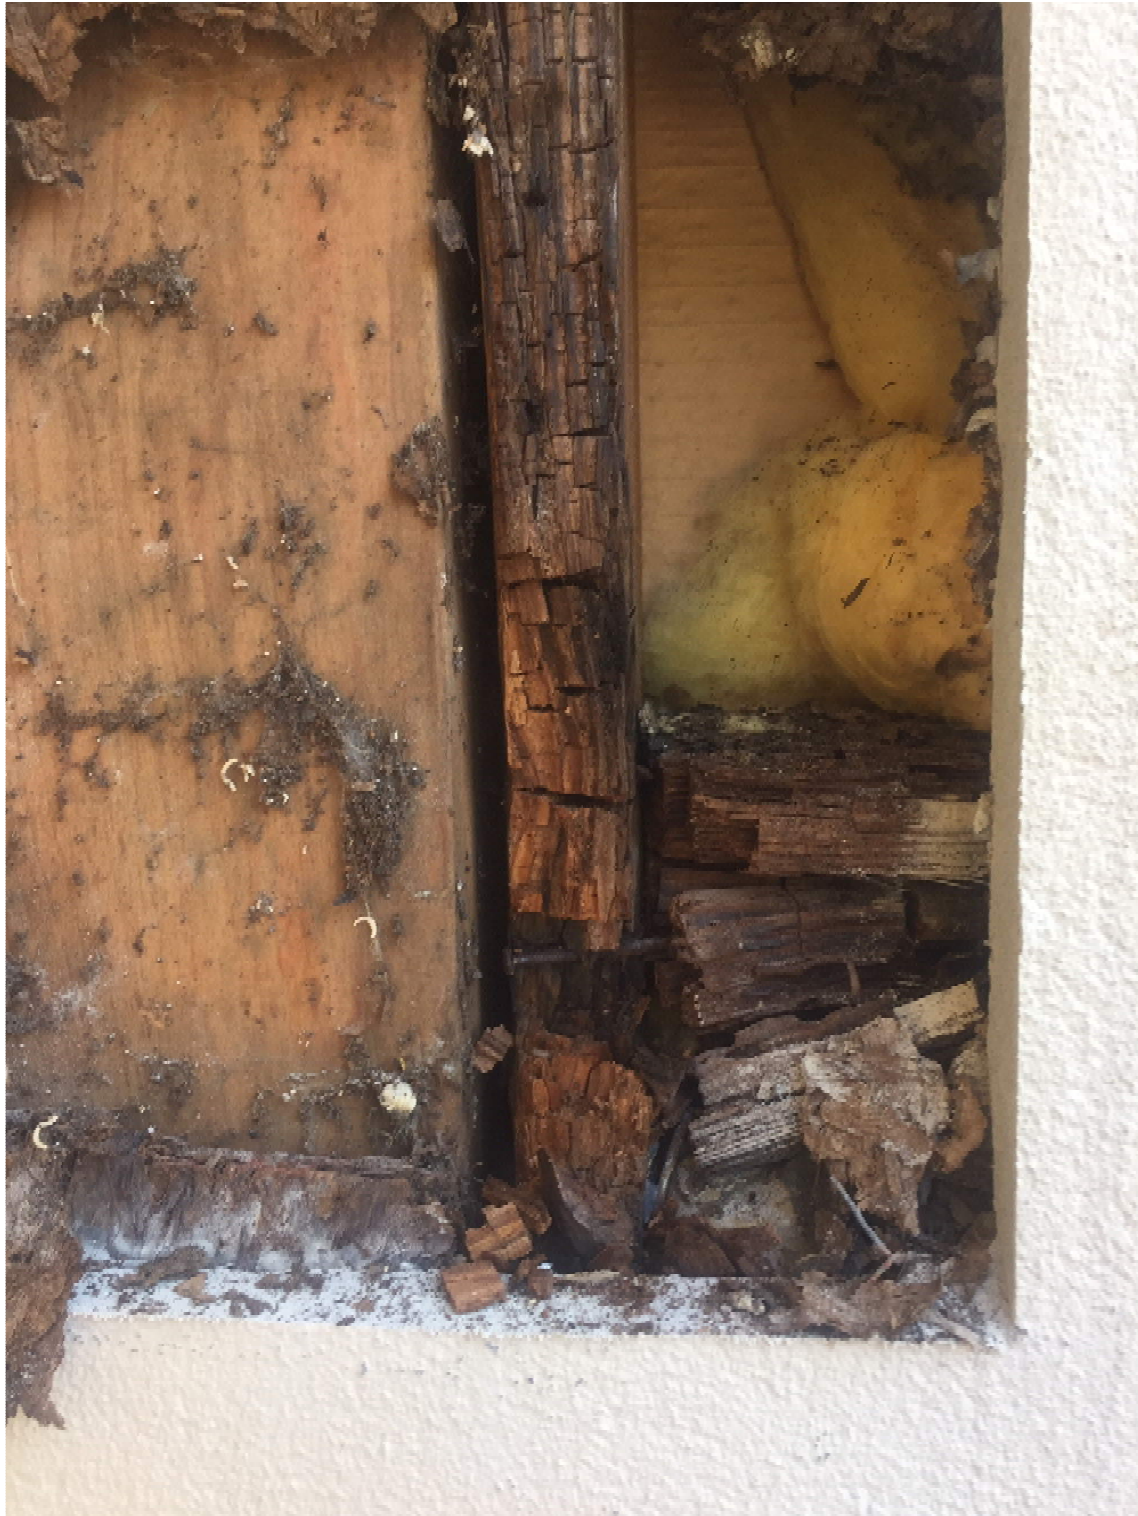
**Figure 3 - Sample of significant deterioration in wood stud wall framing.**
