Tree Health Risk Assessment and Mitigation Project

.....
Parks and Recreation Department

March 12, 2024

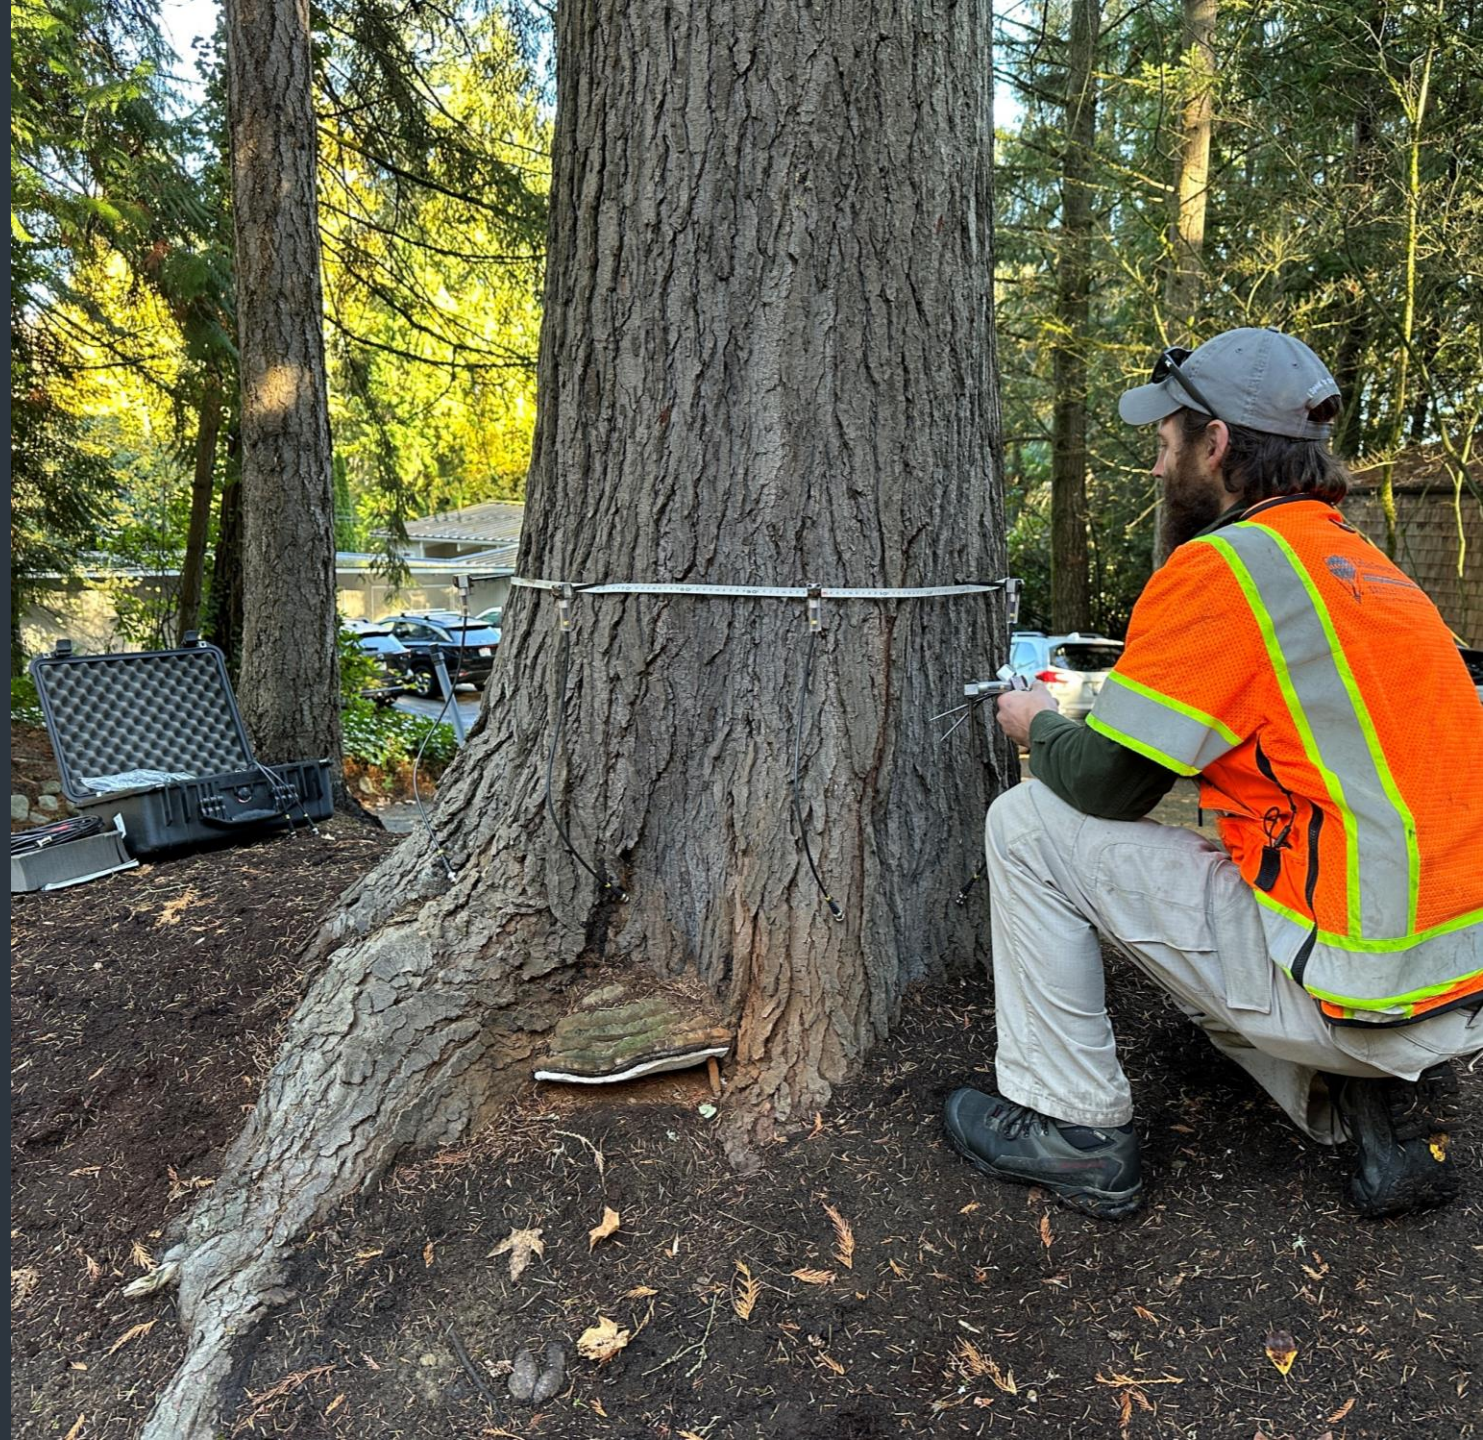
Top Defects

- Dead (77 trees)
- Decay (37)
- Codominant stems (25)
- Cavities (20)
- Over extended large branches (12)
