Redmond Senior Center Final Building Investigation Report

City of Redmond Senior Center Building

8703 160th Ave NE, Redmond WA 98052 November 25, 2019

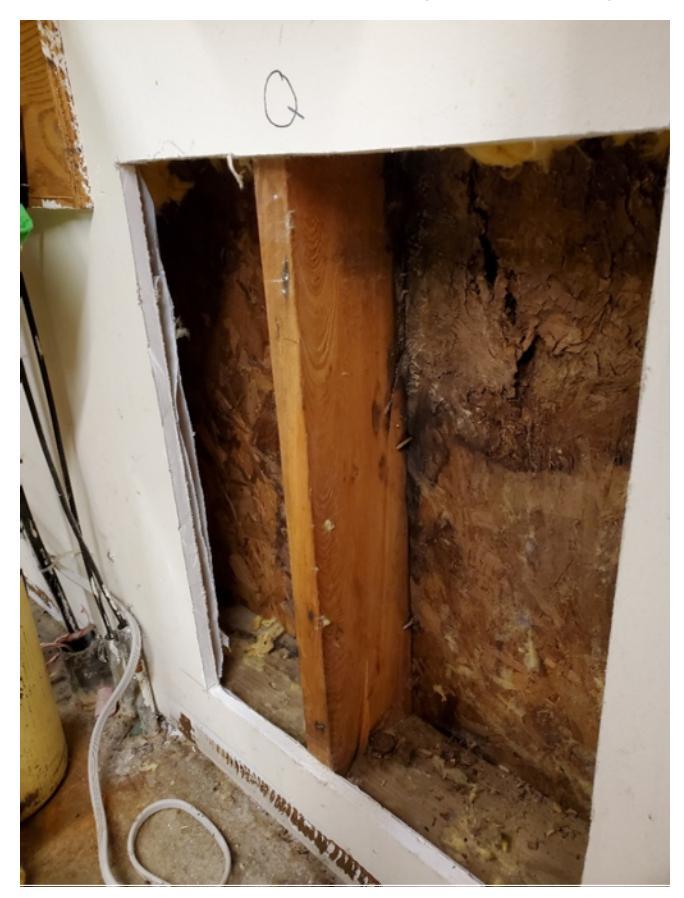
Figure 1. Damage at south wall

A raised planting bed abuts the wall surrounding the Storage Room (Room 100). The cladding appears to be inadequately waterproof and allows water intrusion into the stud wall (see photos in Appendix A). Observed conditions show significant damage to the sheathing, studs and base plate (see Figure 1).

This damage significantly impairs the structure's gravity and lateral load bearing abilities at this location. Because the extent of the damage is relatively limited, it is assumed that the adjacent structure is providing gravity support. The lateral capacity of the shear walls are completely compromised by the sheathing damage.

It is anticipated that the entire exterior stud wall, including sheathing, studs, and base plate will need to be removed and reconfigured to provide a more weather resistant wall assembly. Possible solutions would be to 1) raise the 12-inch-tall foundation stemwall so that the top of the stemwall is 6 inches above the adjacent soil, 2) to lower the top of the raised planting bed such that 6 inches of the foundation stemwall would be exposed, 3) to provide a more moisture proof cladding intended for subgrade use, or 4) demolish the planter bed. Additional work, including removing and replacing interior sheathing, wall-mounted electrical, and mechanical equipment and flooring will be required.

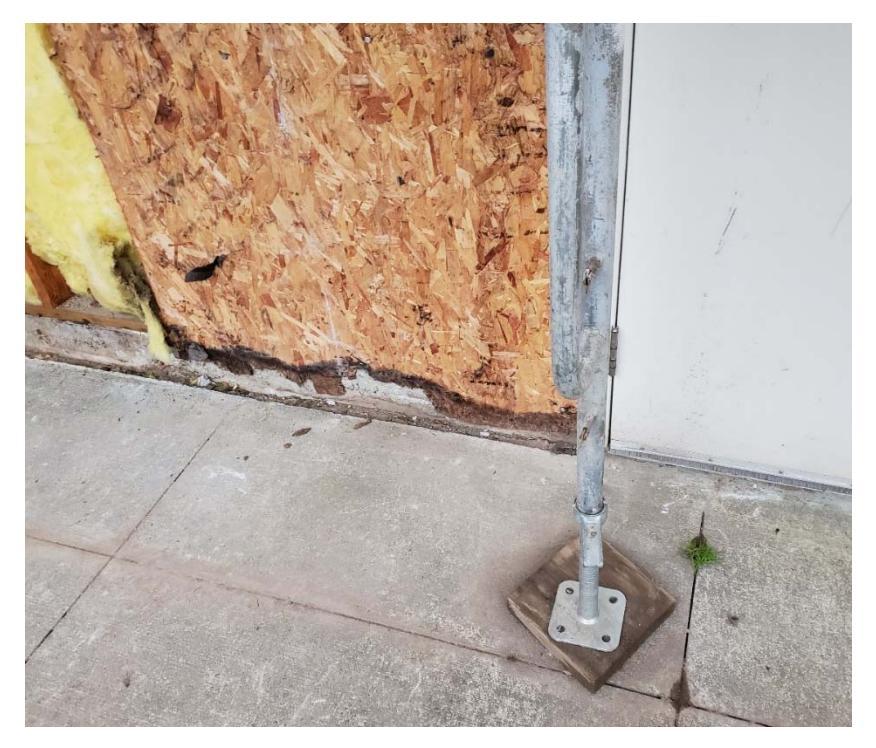
Figure 2. Damage at base of shear wall sheathing

Our investigation found that the bottom 2 to 3 inches of all the observed exterior shear wall sheathing was damaged by moisture/dry rot. This damage completely compromises the lateral load carrying ability of all exterior shear walls. **Based on this observation it is HDR's opinion that the building is NOT SAFE for general occupancy.** As noted in Section 2, compromising the exterior shear walls affects the lateral load carrying capacity of the entire building. In addition, no portion of the building is unaffected by the damage. This makes it impossible to use a portion of the building while making repairs to rest of the building.

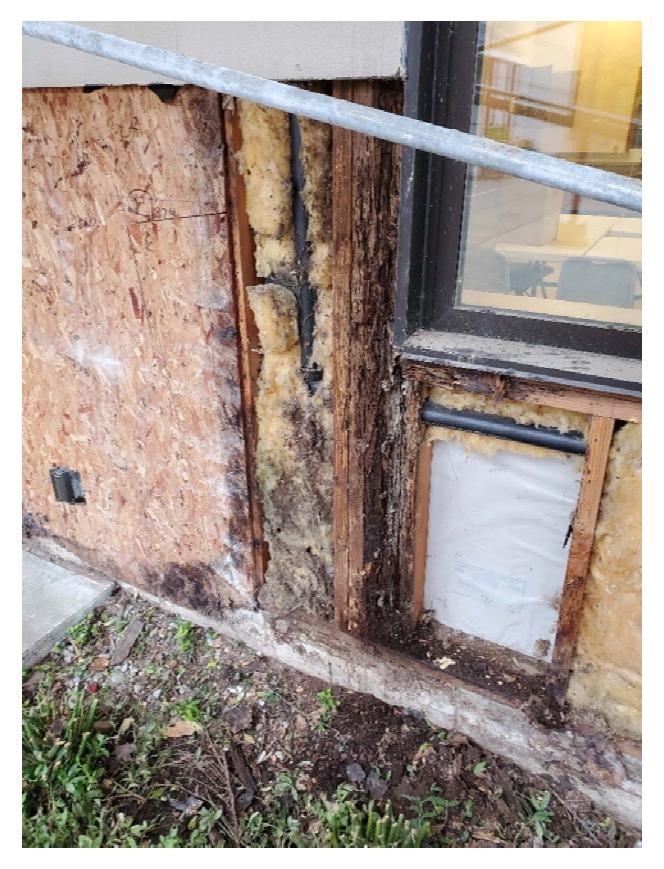
Figure 3. Damage to framing, base plates, and windowsill

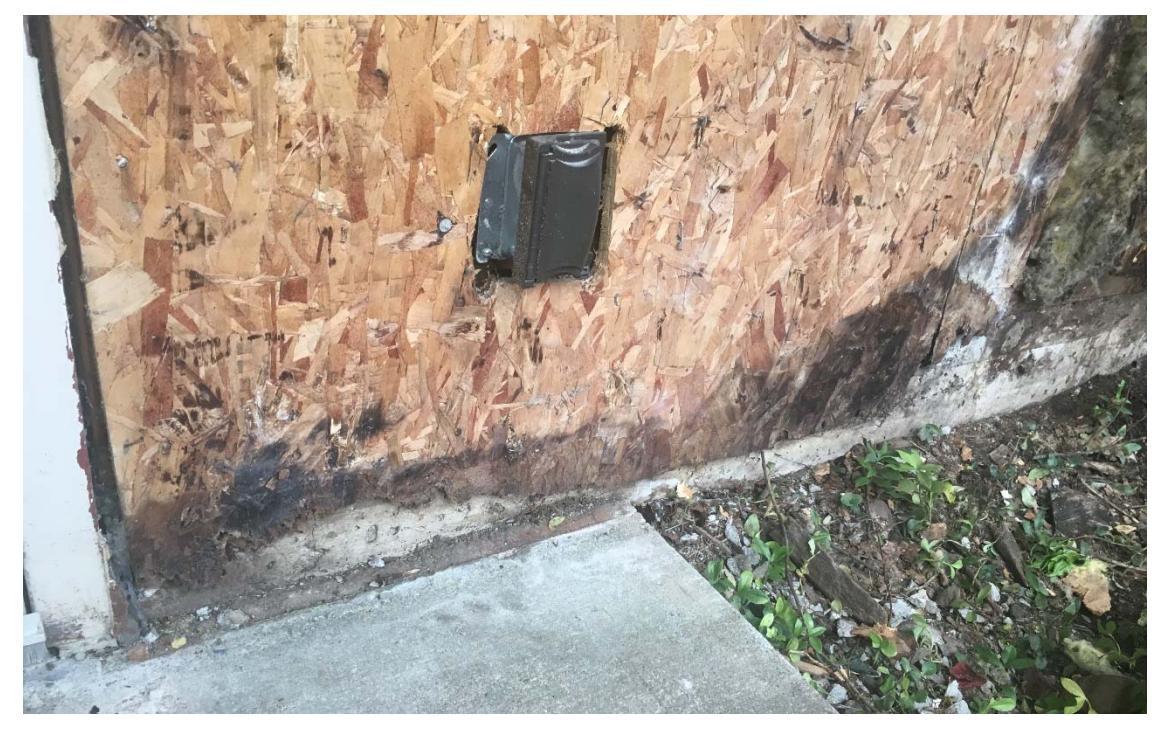
In reviewing numerous areas at the exterior of the RSC, the stucco finish on the walls terminates in soil or at hardscape conditions like sidewalk. Per the Northwest Wall and Ceiling Bureau (NWCB) the recommended practice is "Termination of the stucco assembly at the base of the building to be located no lower than 4 inches from the finished grade and 2 inches from the hard surface". The Uniform Building Code (UBC) at the time of the RSC's construction and the current International Building Code (IBC) have similar language. The building code and recommended practice were not followed, allowing water to wick up behind the stucco plaster and soak into the OSB, damaging the vertical framing studs, sill plate, and sheathing, and causing shear panel failure and cladding failure. See Section 3.2, Building Structure Condition, of this report.

Figure 6. Moisture/dry rot at stucco cladding termination at sidewalk and soil.

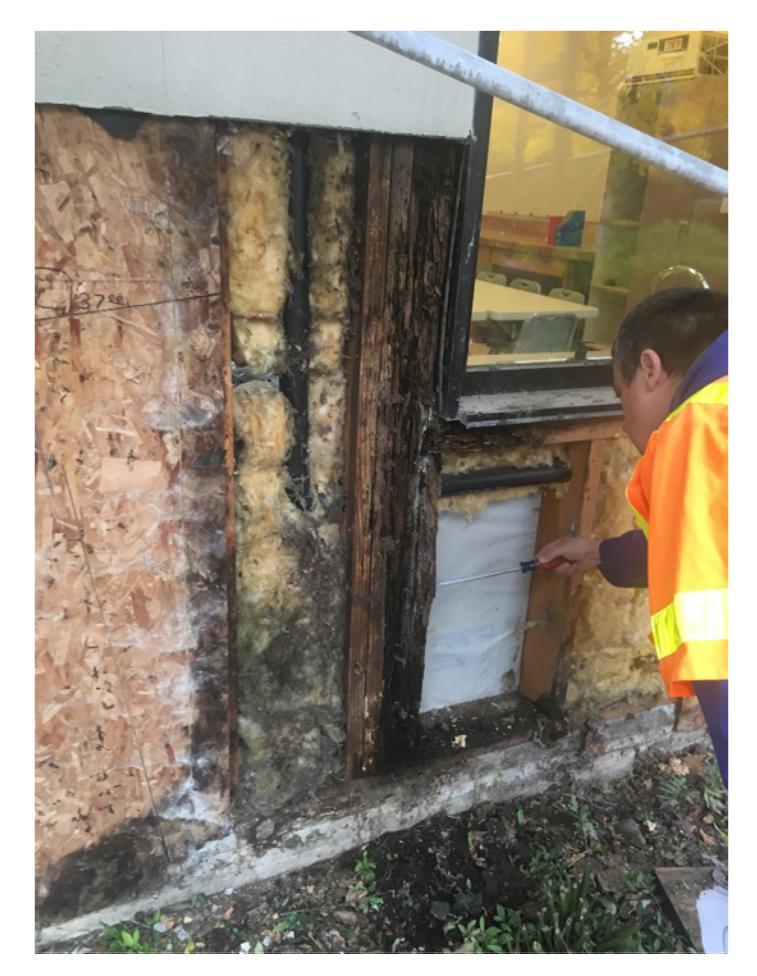
The NWCB recommends that storefront style windows be installed with a sill pan flashing. The sill pan should be constructed with an upturned back edge or back dam and end dams (fully soldered) to prevent moisture from entering the wall cavity. The RSC has sill flashing and at the sill corners protection is offered by sealant only. As the sealant ages, cracks, shrinks and degrades there is no protection at the crucial jamb-sill intersection, allowing water intrusion as is the case at the RSC. Refer to photos included showing wood moisture/dry rot at the window sill area.

Figure 8. Moisture/dry rot damage at window sill plate without a sill pan flashing

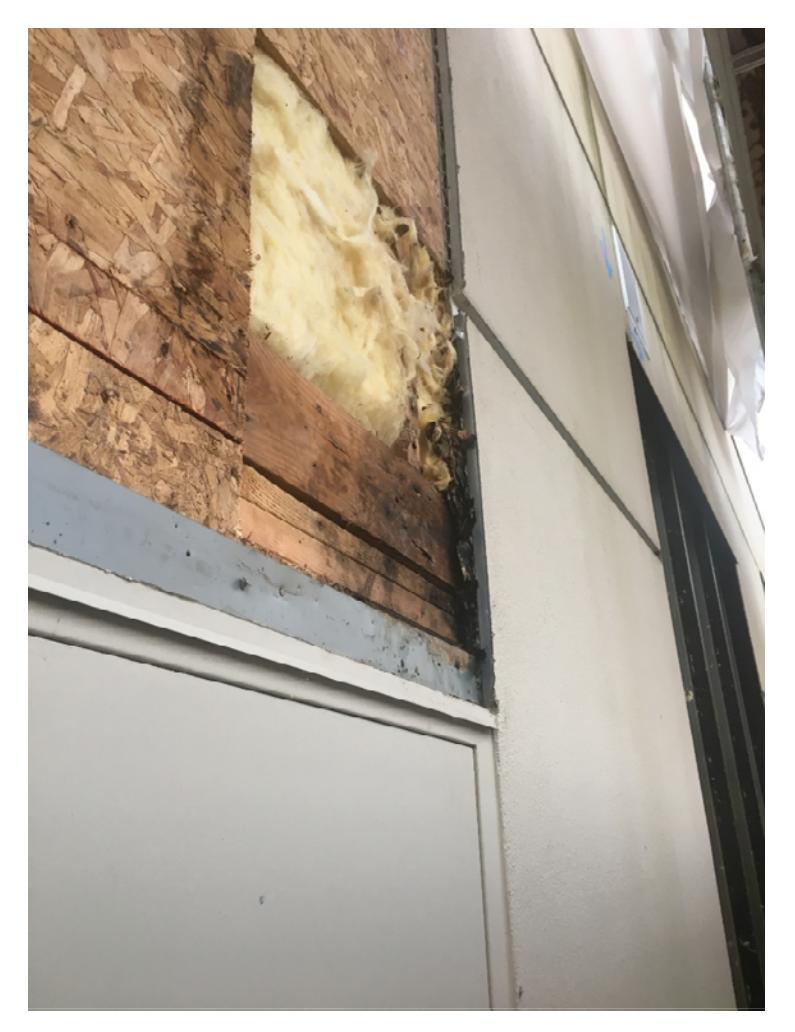
At RSC there are horizontal aluminum reveals or trim accessory joints. The stucco assembly needs these joints for thermal expansion and contraction. Joints are recommended to limit the maximum size of an unbroken expanse of stucco to a maximum of 180 square feet. As installed at RSC, the trim accessory joint or plaster channel screed also requires careful installation. Per the NWCB, it is recommended that trim accessory joints be weather-sealed by embedment in caulking at intersections when placed end to end, abutting one another at terminations. At RSC some sealant is evident at some of the butt joints. Reveal connector clips should set in sealant at butt joints. HDR did not observe molding at the butt joints at RSC. Factory fabricated inside corner and outside corner molding should be mitered, welded and sealed when used with stucco per the NWCB. At RSC the inside or outside corners were not factory mitered or welded, allowing water to penetrate at the corners of the building. A handful of the outside corner reveals showed signs of aging sealant and this protection is dubious. The detailing was a contributing factor in the moisture/dry rot damage that is present at RSC.

Figure 9. Moisture/dry rot damage behind trim joint above door head flashing

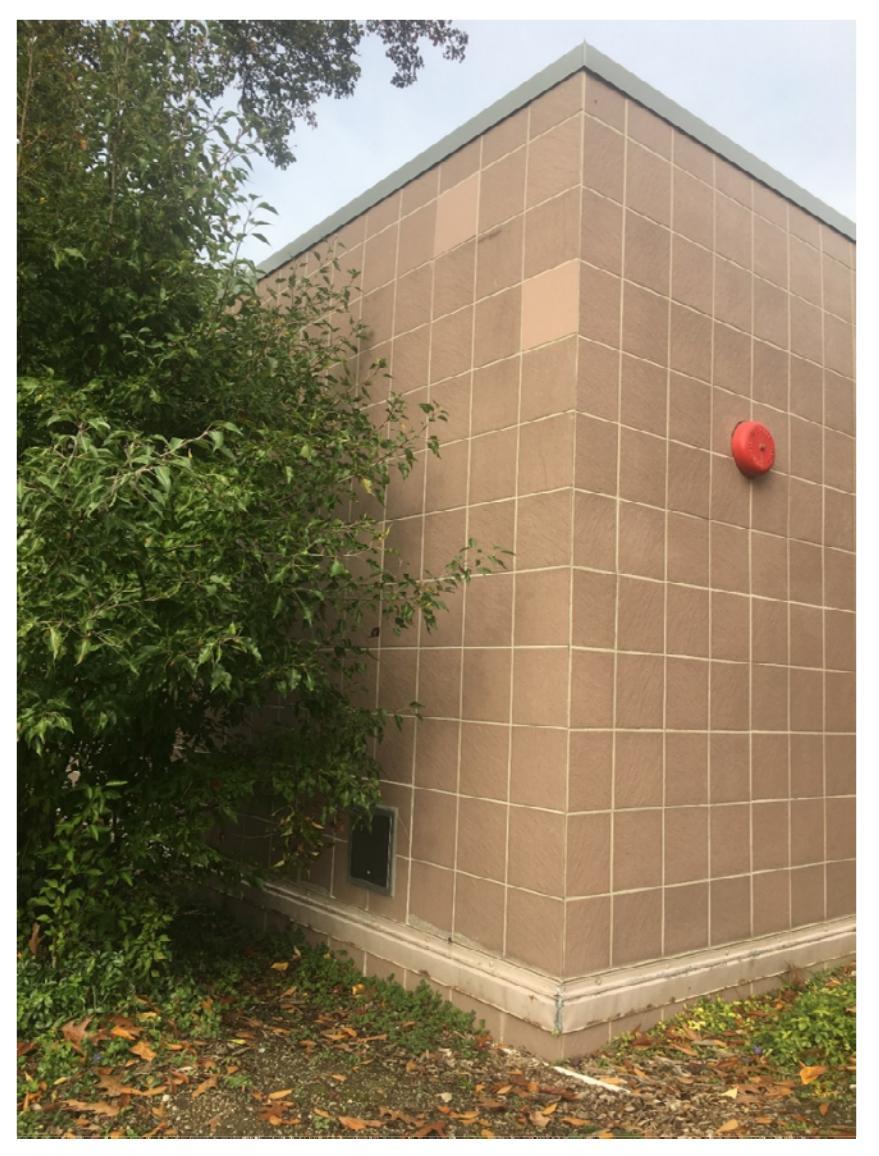
In reviewing the tile exterior wall assembly at RSC, there are many areas where the tile cladding terminates at or in the soil or the sidewalk. Like the stucco wall assembly noted previously, both the UBC (the code in place when the building was built) and the IBC (current code) both have similar language regarding terminations. The UBC refers to metal lath assemblies (the tile substrate at the RSC) and the IBC refers to exterior adhered masonry veneers – porcelain tile. Whether per the codes or recommended building practice, the terminations of the exterior tile wall assembly at the base of the building are to be located no lower than 4 inches from the finished grade and 2 inches from the hard surface, and this was not followed at RSC from the original construction. Evidence of moisture wicking up behind the tile cladding was evident with tiles coming loose from the mortar bed. In discussion with the City, there has been an ongoing program to replace cracked tiles and re-grouting areas of tile for envelope integrity. This likely helped slow the deterioration but would not have stopped it completely.

Figure 10. Tile cladding termination at soil in planter

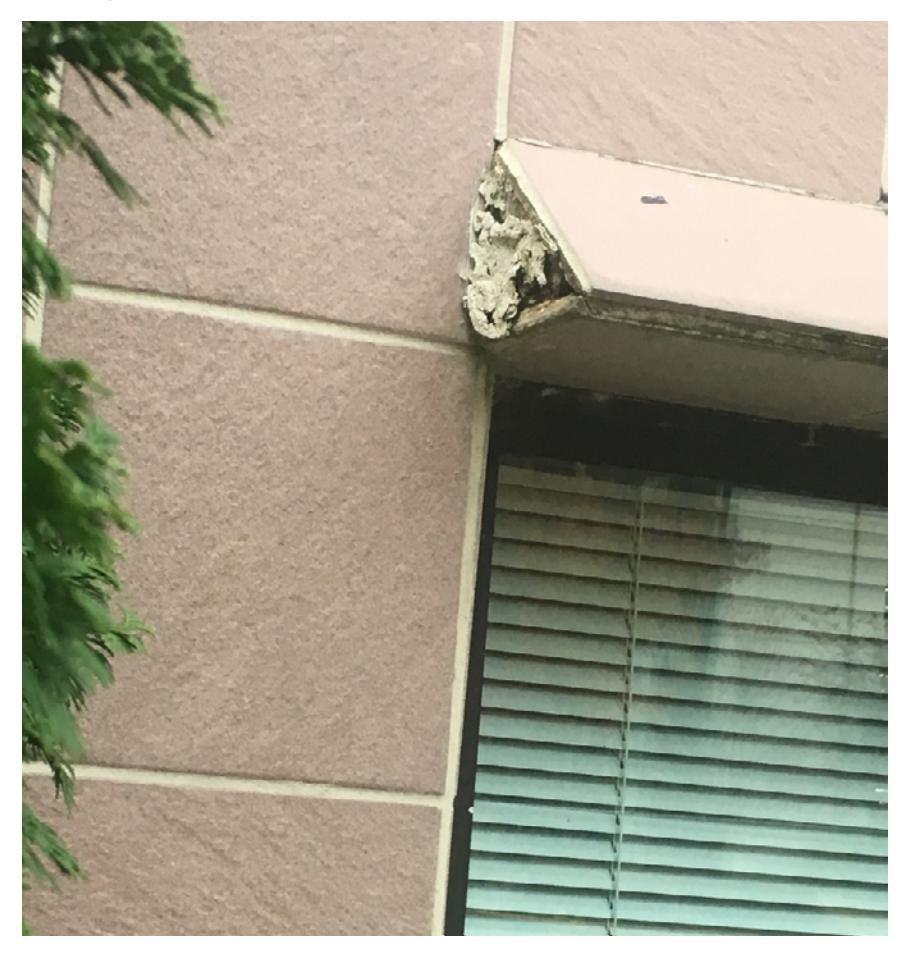
The RSC windows' as-built condition at the tile exterior cladding do not have metal head flashings. Some evidence of sealant is present, which can fail as it ages. There are also tile "eyebrow" architectural features over the windows, offering some protection but these features appear to have damaged tile and could be a source of moisture entering the building.

Figure 11. Tile cladding showing damage at window head

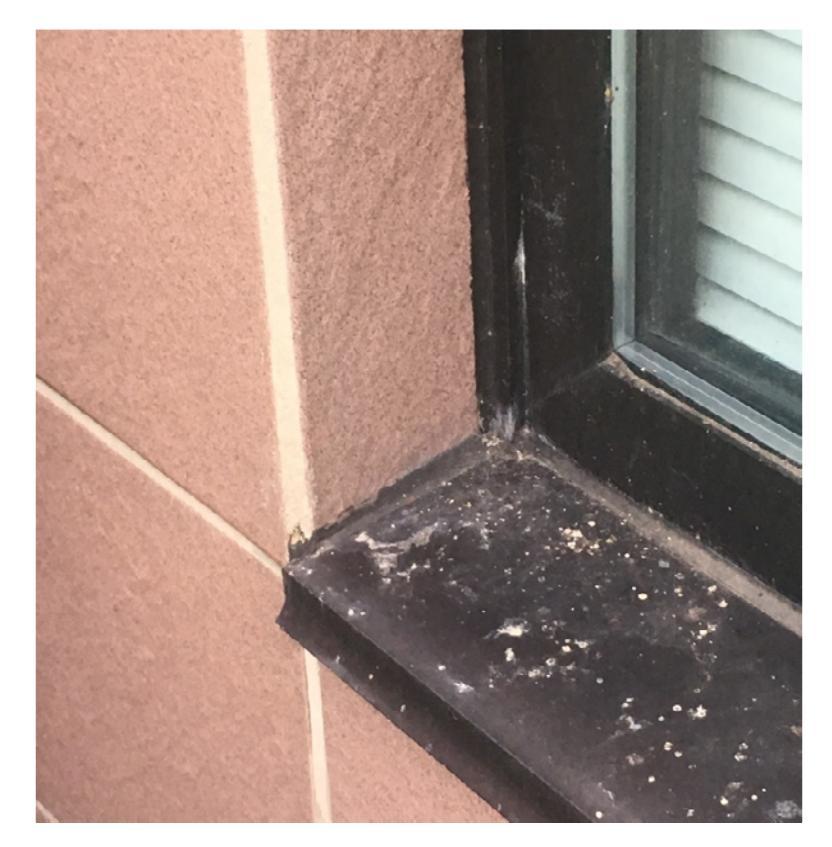
The RSC windows at the exterior tile cladding do not have metal sill pans with end dams as noted in the Wetherholt report. As the sill condition relies on sealant, over time as the sealant dries and weathers, these areas will fail and be a source for water to get behind the tile and work its way into the building. This condition was found as part of our shear wall investigations.

Figure 12. Sill flashing without end dam and sill pan

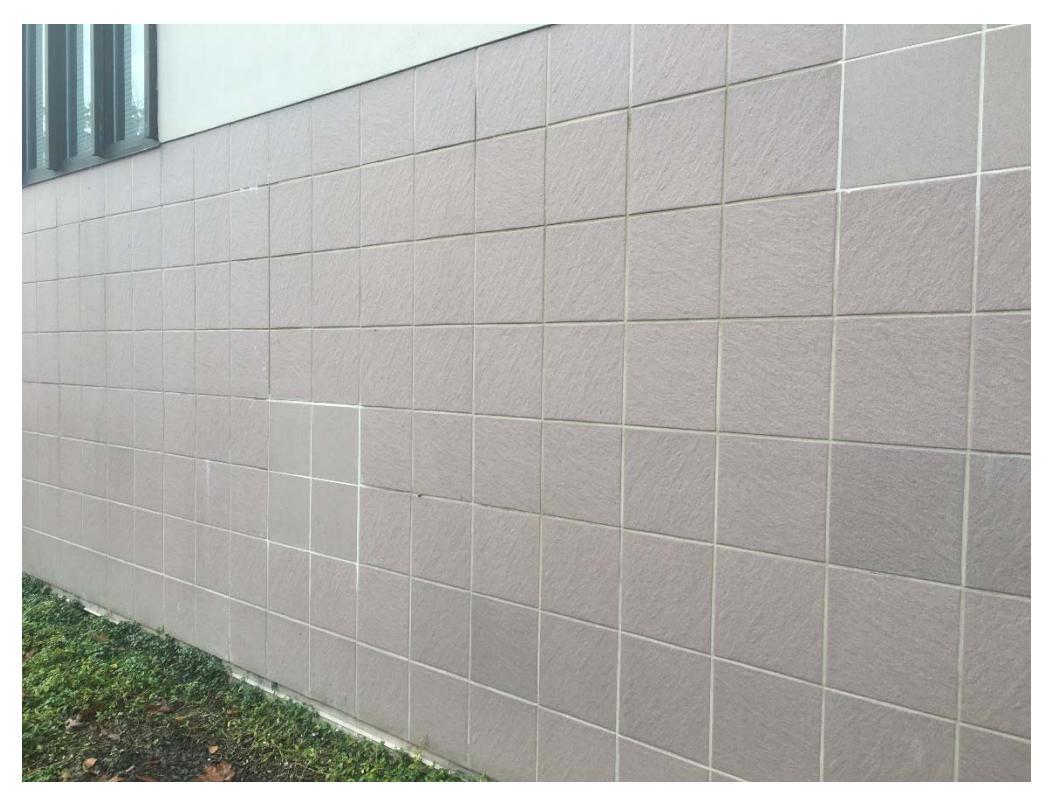
At the RSC there are areas of the building where the exterior wall tile intersects with a parapet, the Portland cement stucco or a building canopy. At the parapet intersections the transition flashing is metal surface mounted angled flashing set in sealant. Over time as the sealant dries and ages, this becomes a source of water entry into the building. At the intersection between the tile and the stucco, there are no transition flashings and this transition can become a source of moisture entering the building as there is no barrier. Also, where the wood main entry canopy intersects with the tile cladding, this intersection, like the parapet, is a metal surface-mounted angled flashing set in sealant. All these detailing conditions allow moisture to enter the building and get behind the tile exterior wall cladding and cause damage.

Figure 13. Lack of transition flashing at tile and stucco cladding intersection

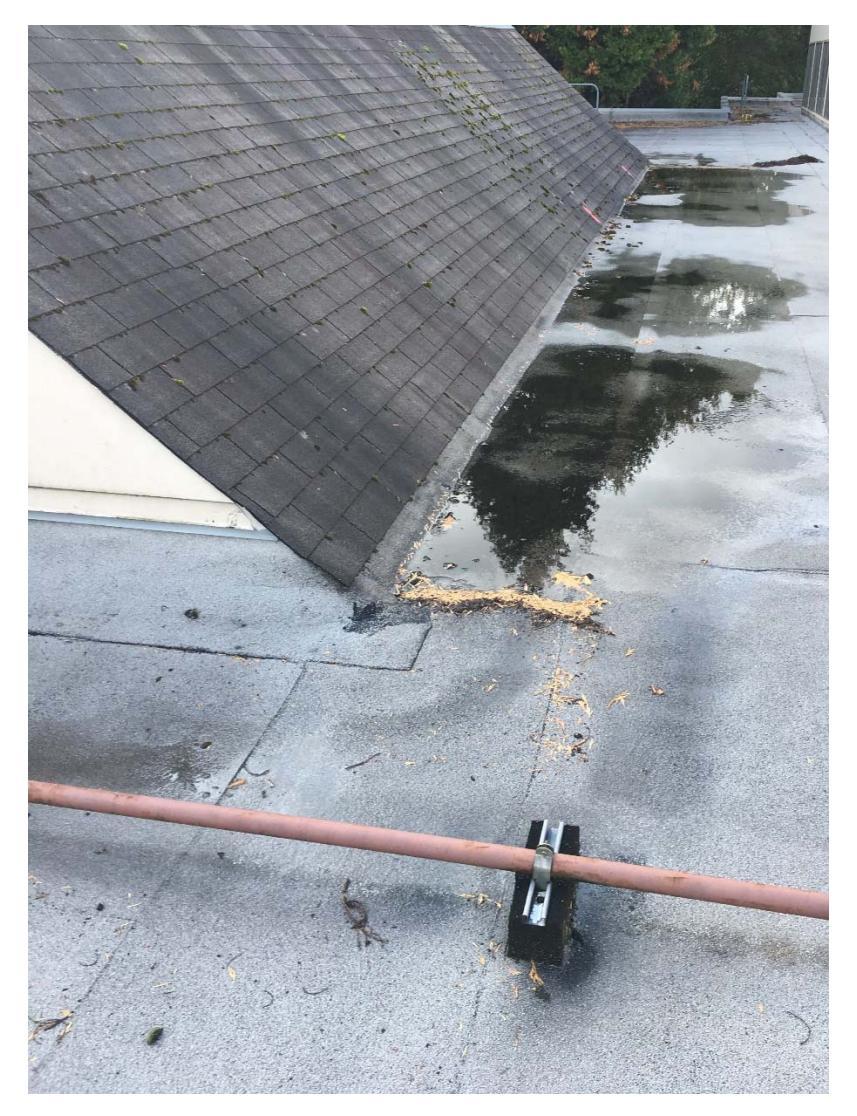
In reviewing the condition of the single-ply asphalt roofing, it had a number of blisters but was in a generally fair condition. No evidence of roof deck insulation was present. While the roof membrane appears in fair condition, the roofing assembly is in poor condition. In any major alteration to the Redmond Senior Center, additional roof insulation should be added and tapered to produce new roof crickets. The asphalt roofing should be replaced and additional drainage constructed, which will prolong future roof membrane life. We understand these roof repairs and roofing replacement are included in the \$15M project already budgeted in the current CIP.

Figure 15. Roof lacking crickets to provide positive slope allowing water to collect and not drain

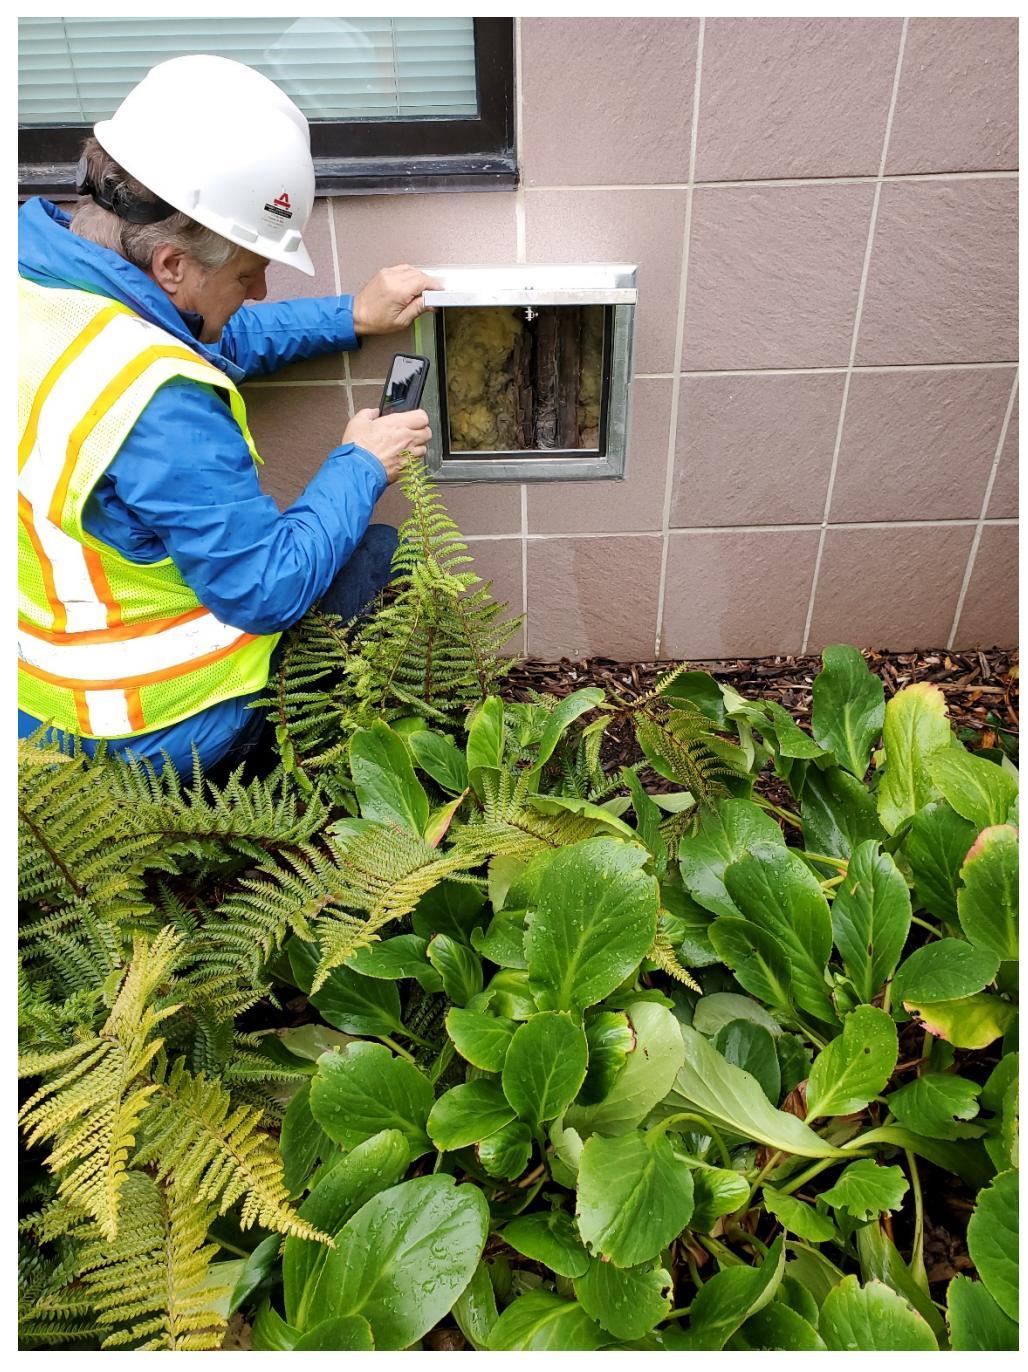
Damage at base of shearwall sheathing

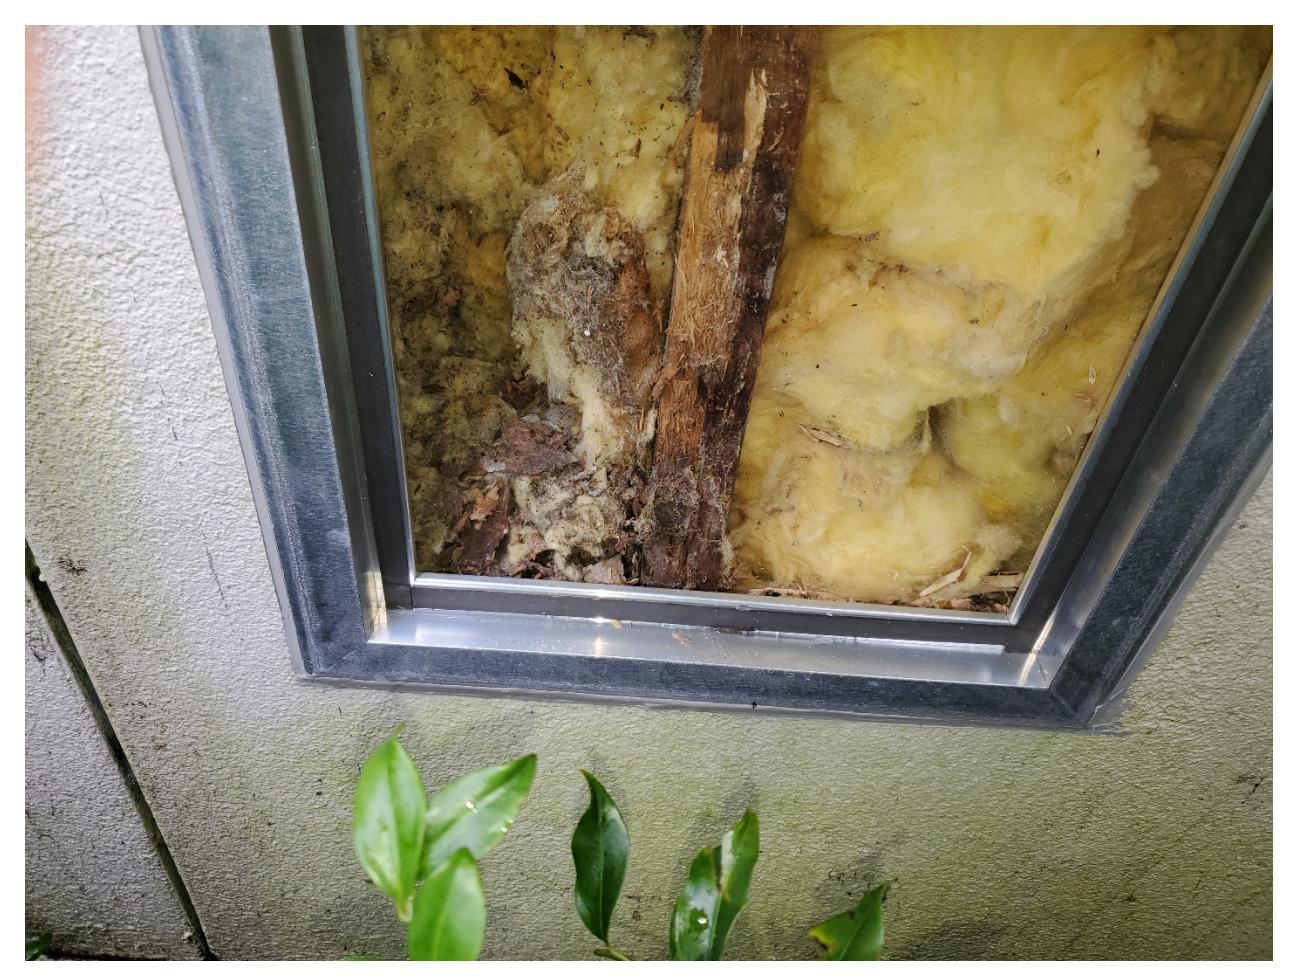
Damage at window jamb

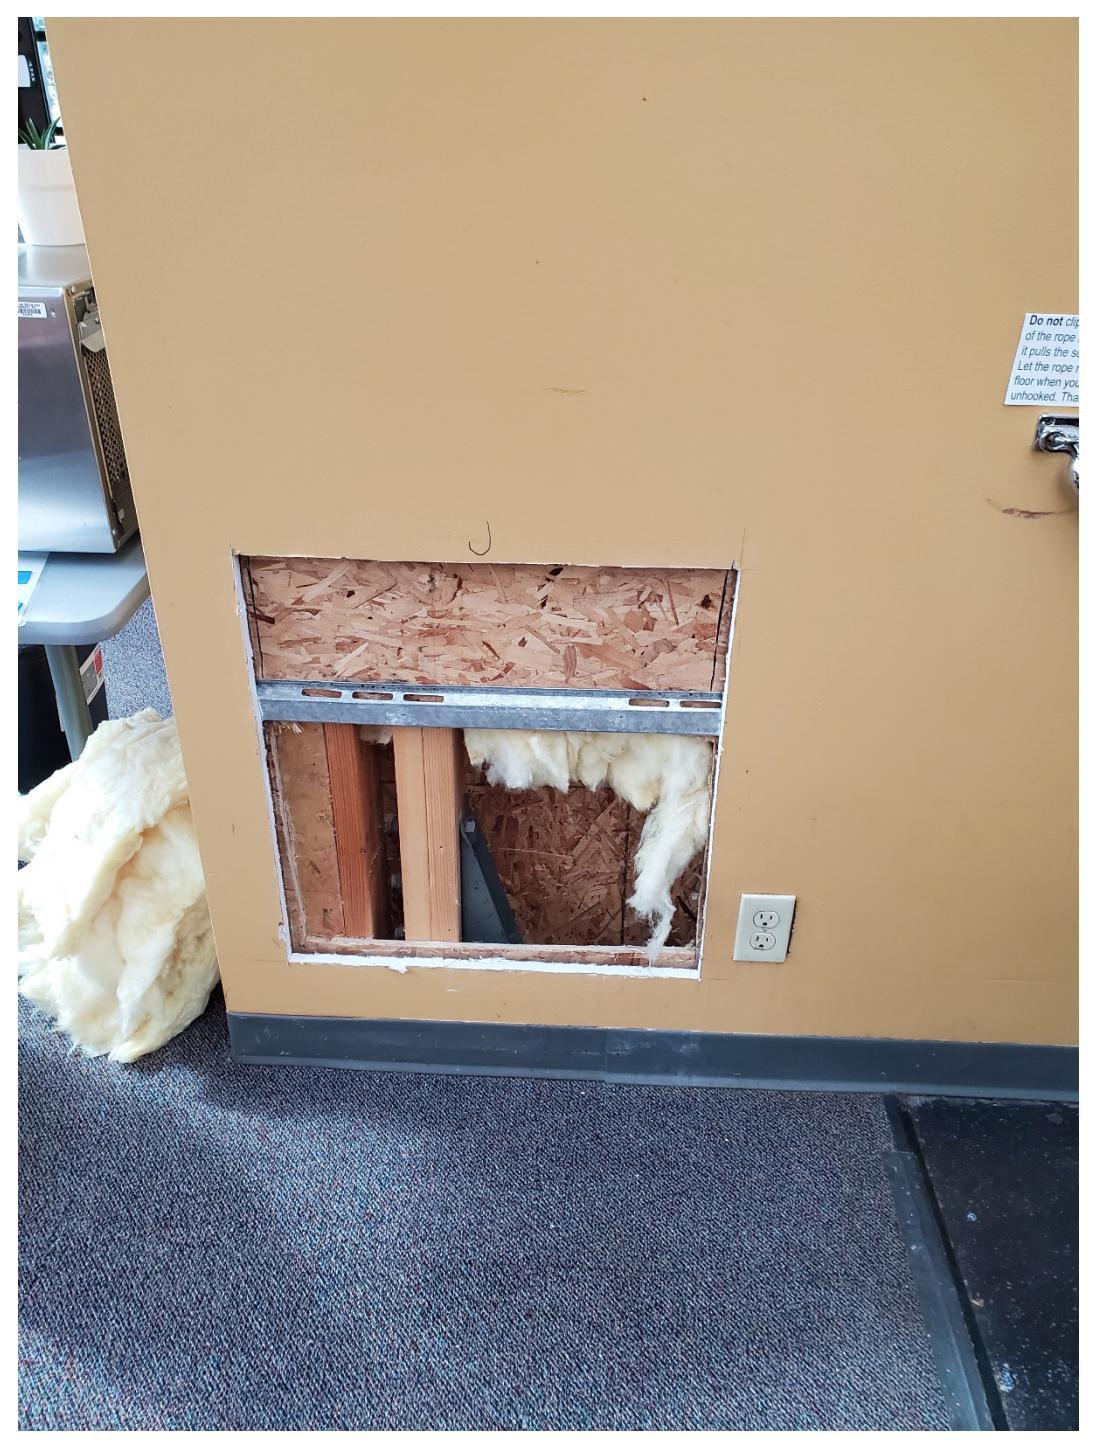
All observed interior areas had no evidence of water intrusion or dry rot. Based on the observable conditions, it appears no remediation of the interior shear walls is required.

Typical observed condition of interior shear wall, including hold down

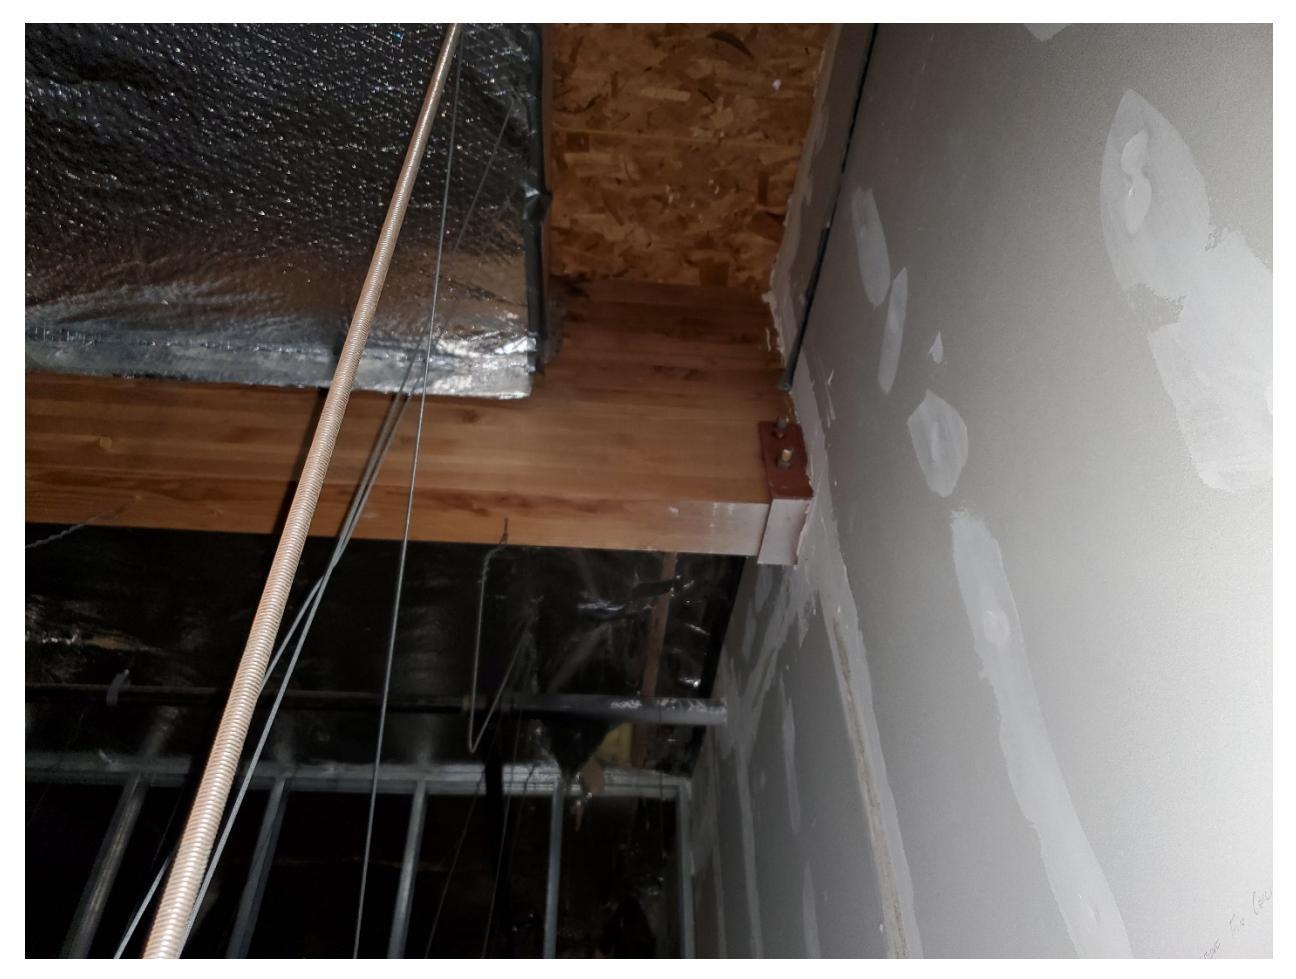
All observed roof framing had no evidence of dry rot damage. In some locations the roof sheathing was wet but had no evidence of dry rot.

Typical observed condition of glulam roof beam

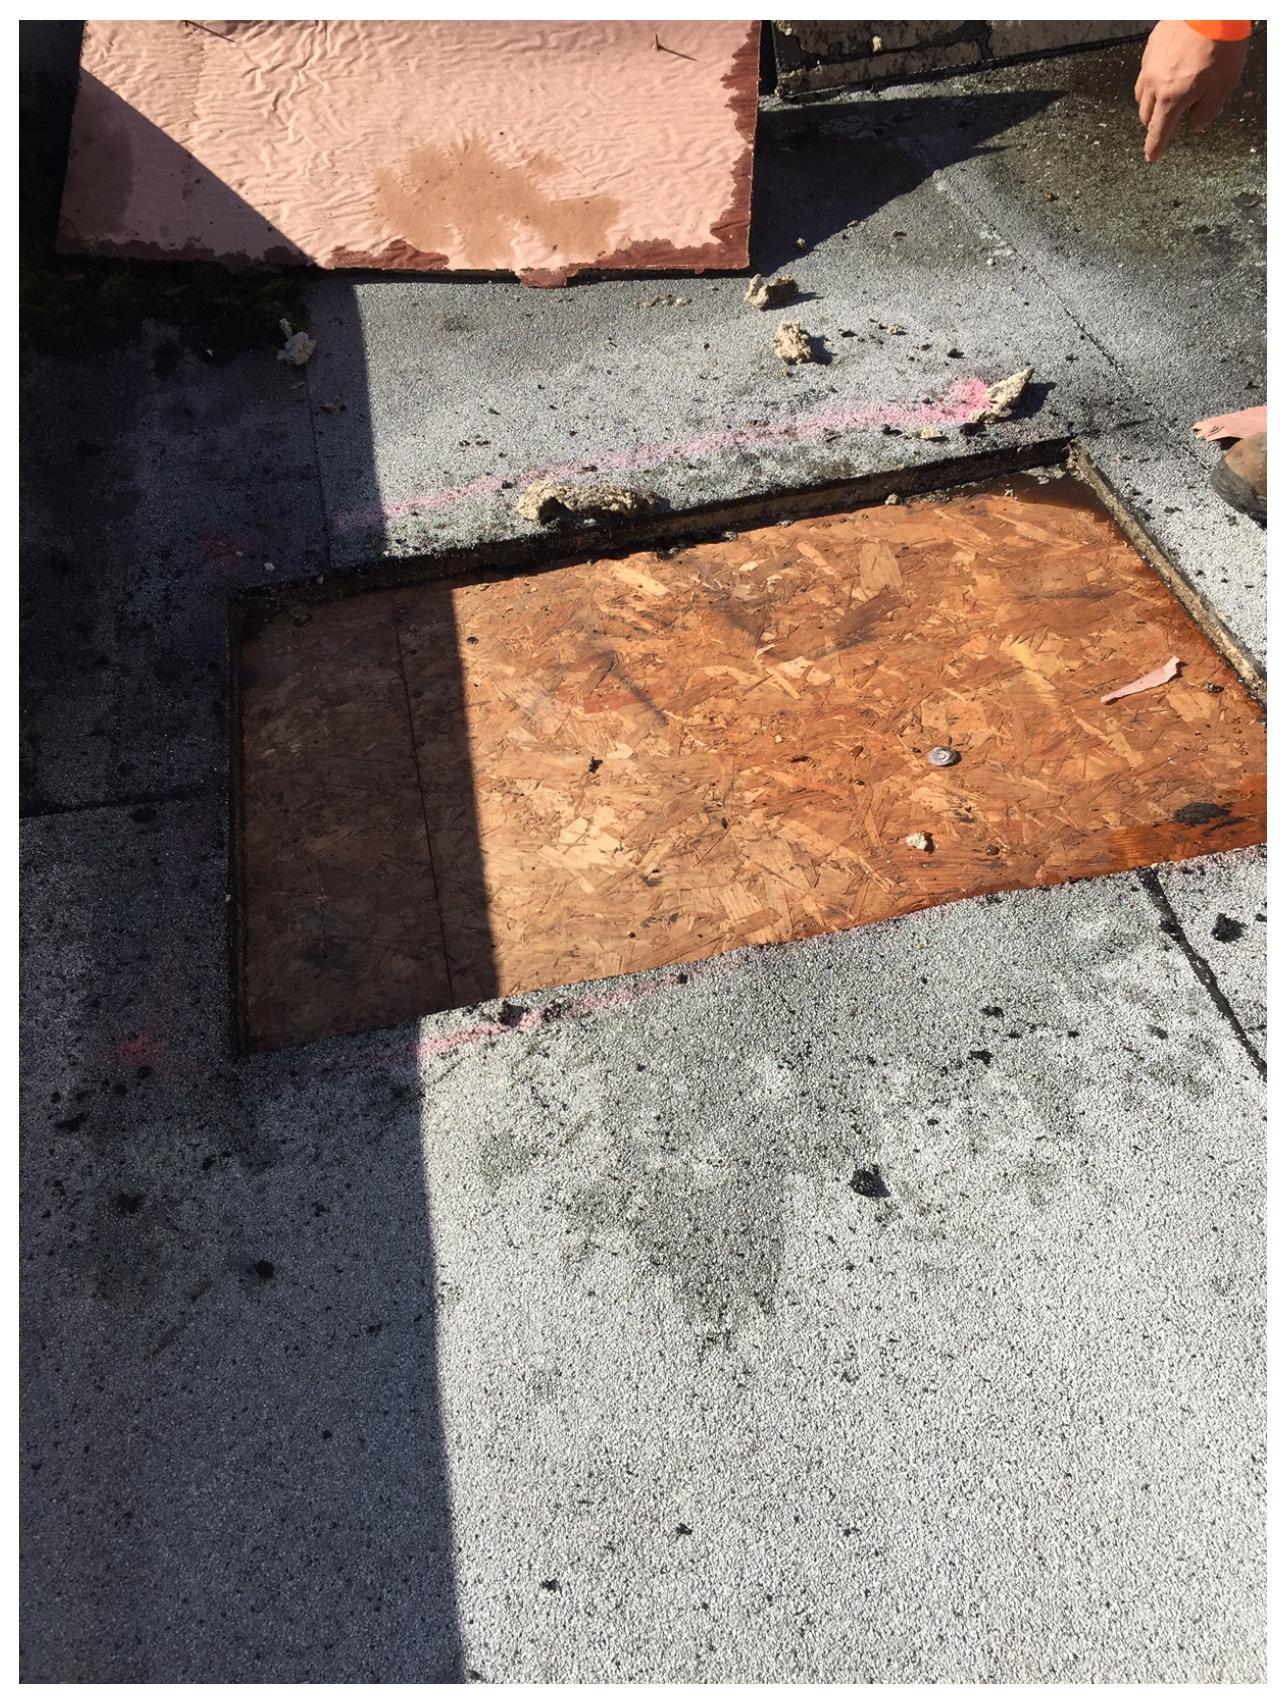
Typical observed condition of roof sheathing

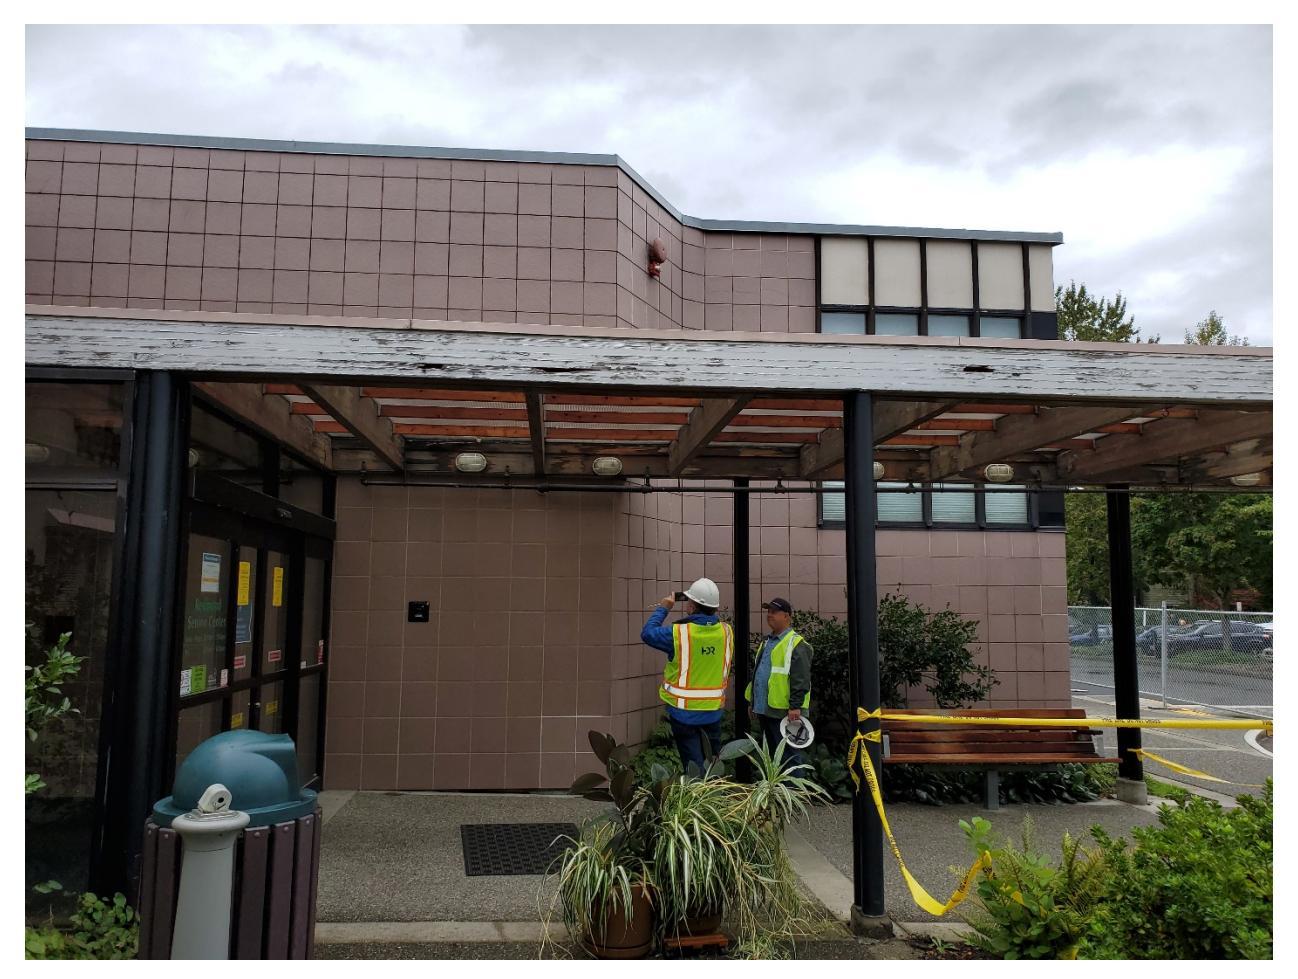
Framing around the front canopy consists of exposed glulam beams. The beams are damaged to varying degrees by dry rot. Although the damage appears to be significant in nature it was outside the scope of this report. Because of the framing layout, a failure may occur without warning.

Damage at front canopy framing

The canopy framing and any damaged wall should be replaced in kind, with weatherproofing as required to prevent future water damage. The canopy framing is scheduled and budgeted to be replaced under a separate task.

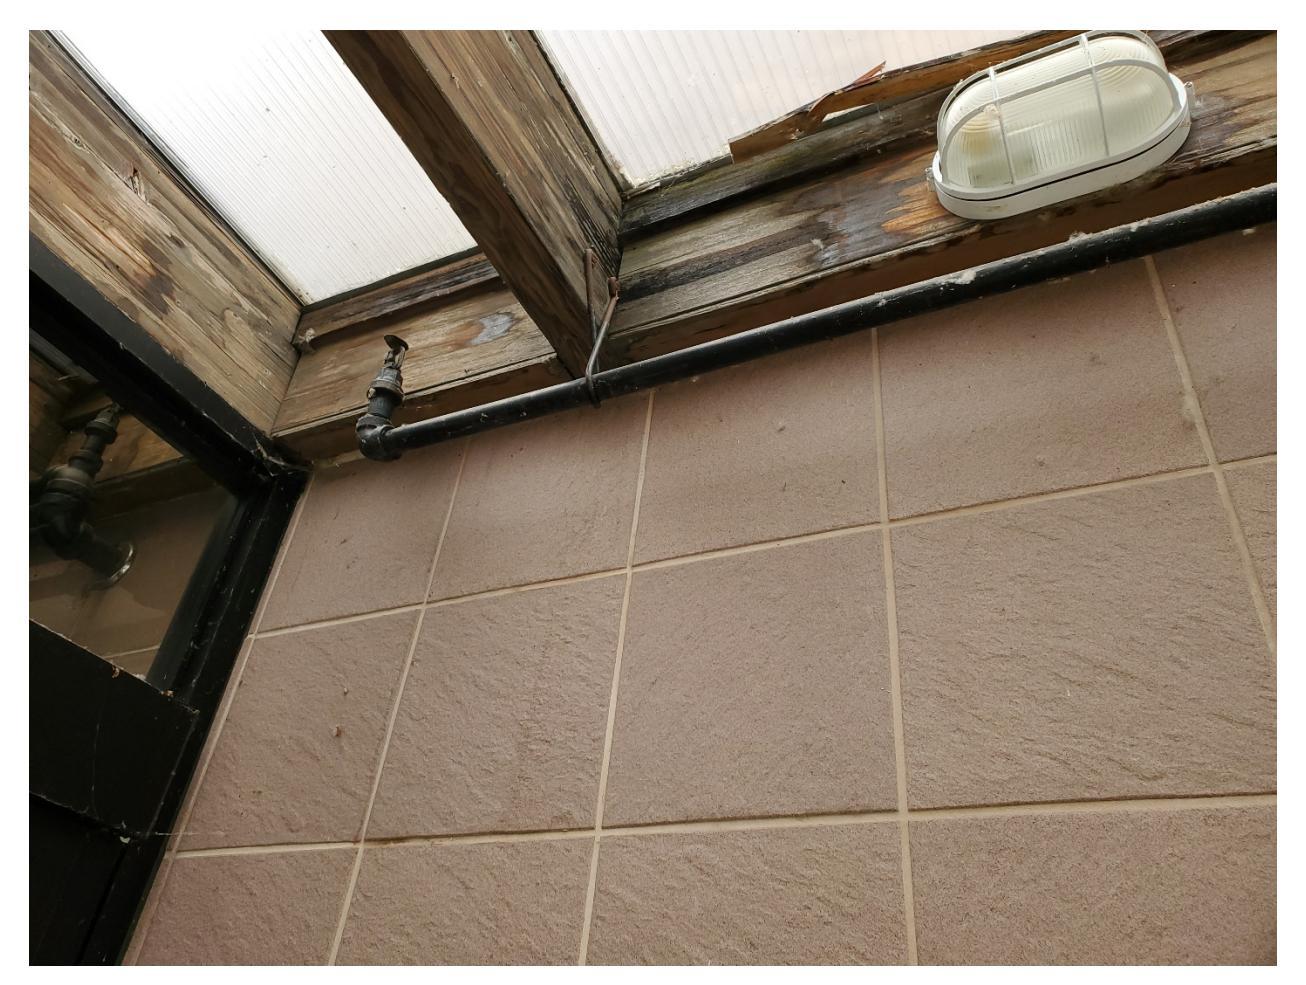
Closeup of front canopy framing damage

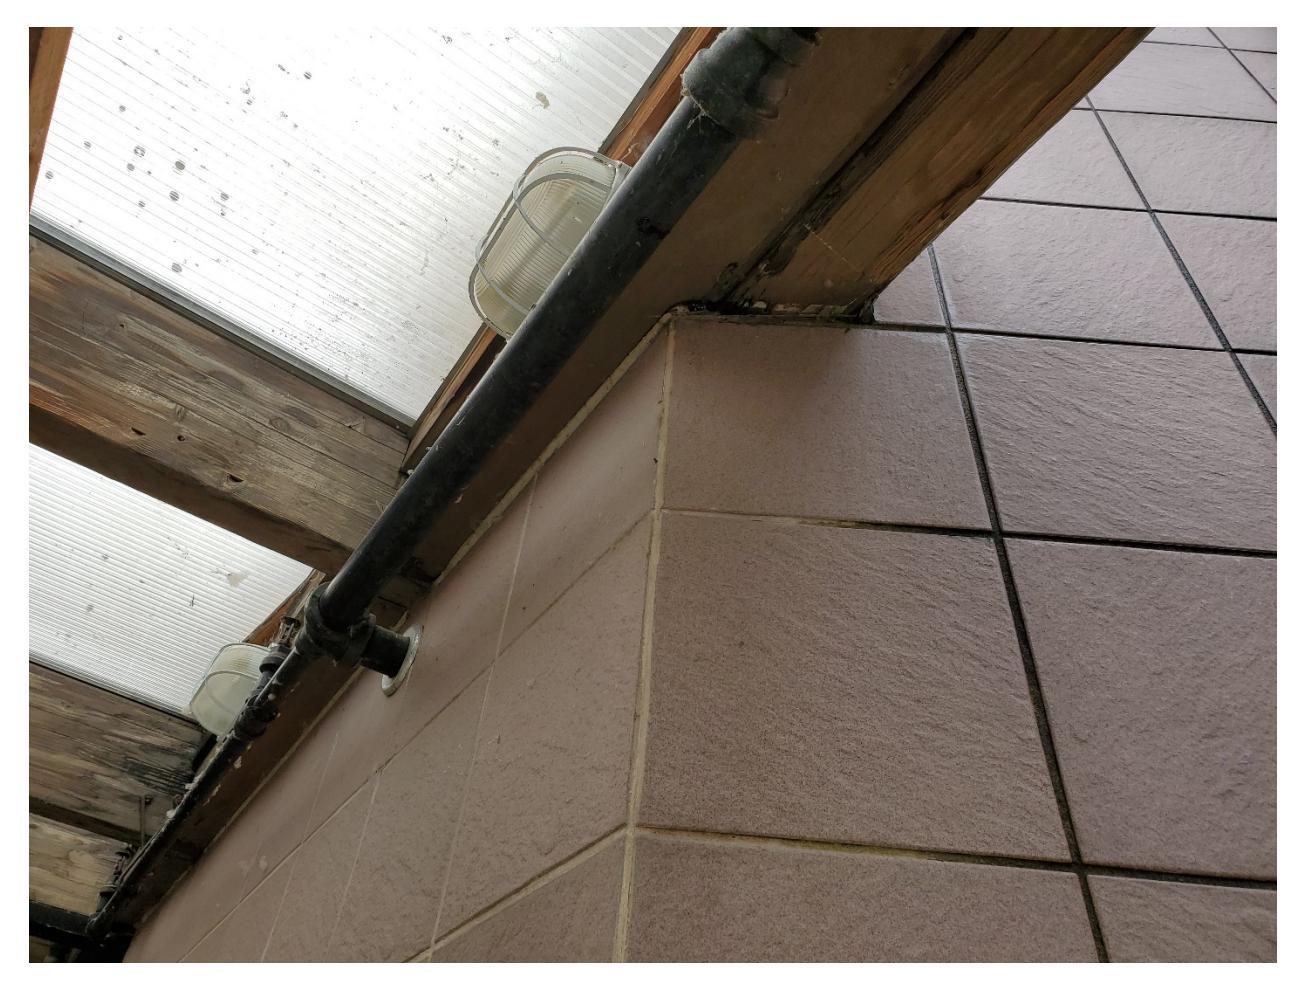
In addition, the canopy framing penetrates the building cladding and is supported by the building walls. Replacing the front canopy requires additional consideration to account for wall weatherproofing and wall condition; walls supporting the canopy framing were not observed and may have dry rot damage due to moisture traveling down the canopy framing. Pictures showing the front canopy are in the appendix.

Intersection between front canopy beam and wall
