Redmond Senior Center Final Building Investigation Report

City of Redmond Senior Center Building

8703 160th Ave NE, Redmond WA 98052 November 25, 2019

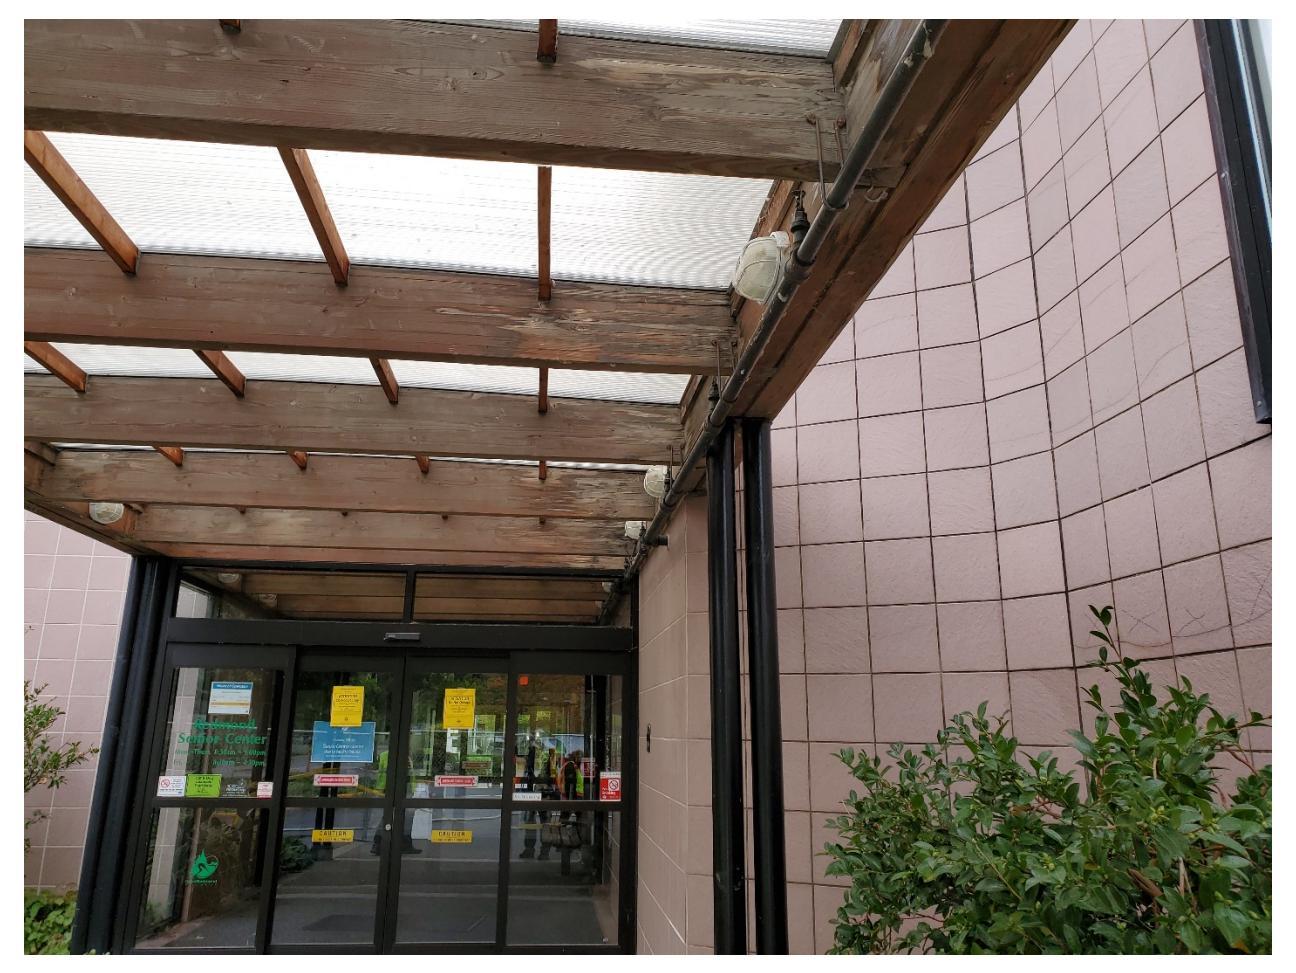
View of canopy cross beams

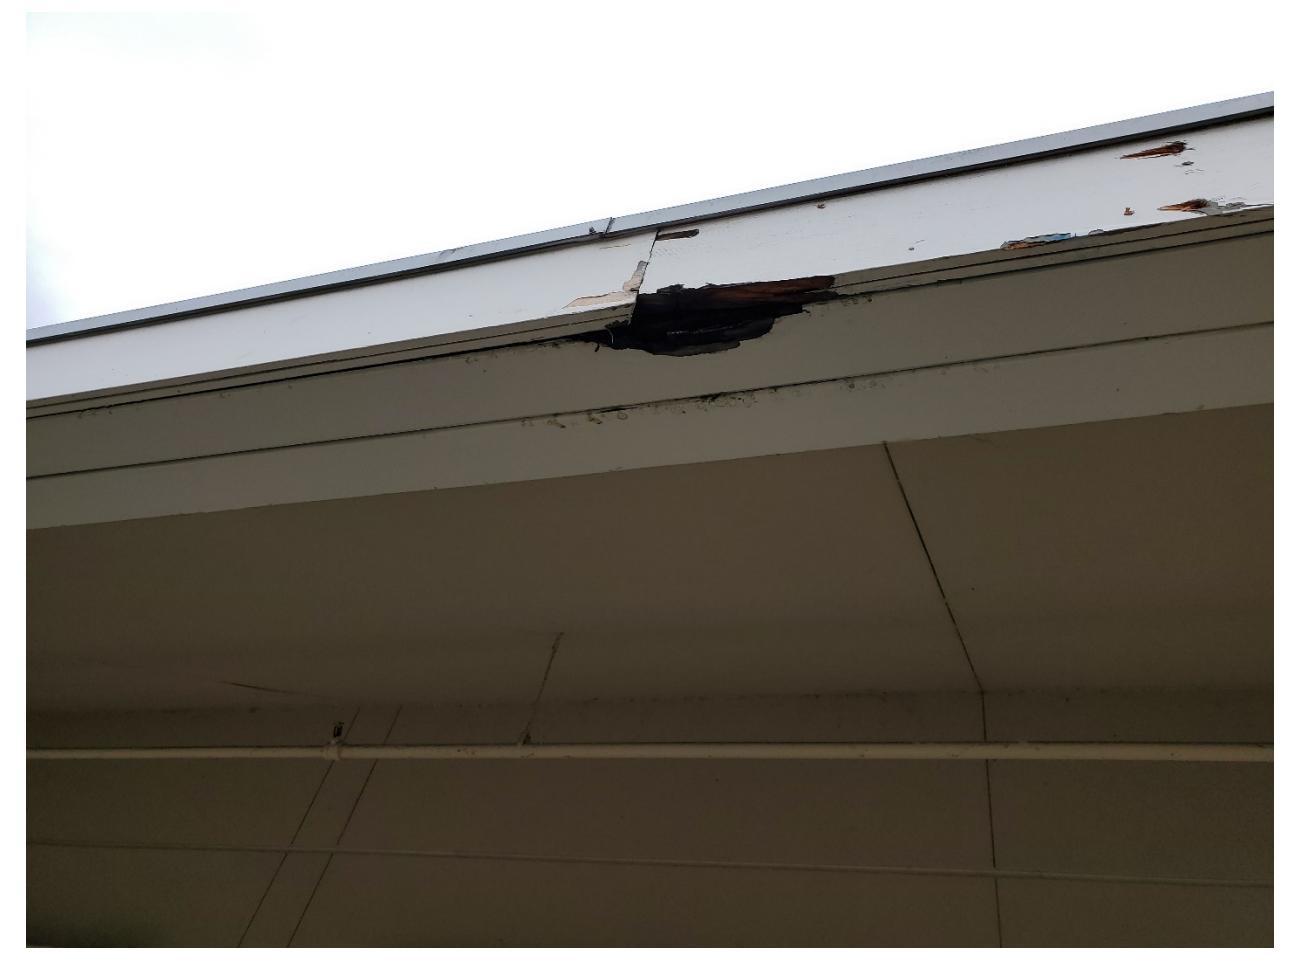
Framing for eaves to the west of the social hall (Room 210) consist of 2- x 12-foot rafters supported by a glulam beam over two 4-inch-diameter steel pipe columns. A framed-in gutter is adjacent to the glulam beam. The gutter framing appears to have localized dry rot damage due to leaking from the gutter.

Damage at eave gutter to west of ballroom

Damaged eave framing should be replaced in kind, with weatherproofing as required to prevent future water damage.

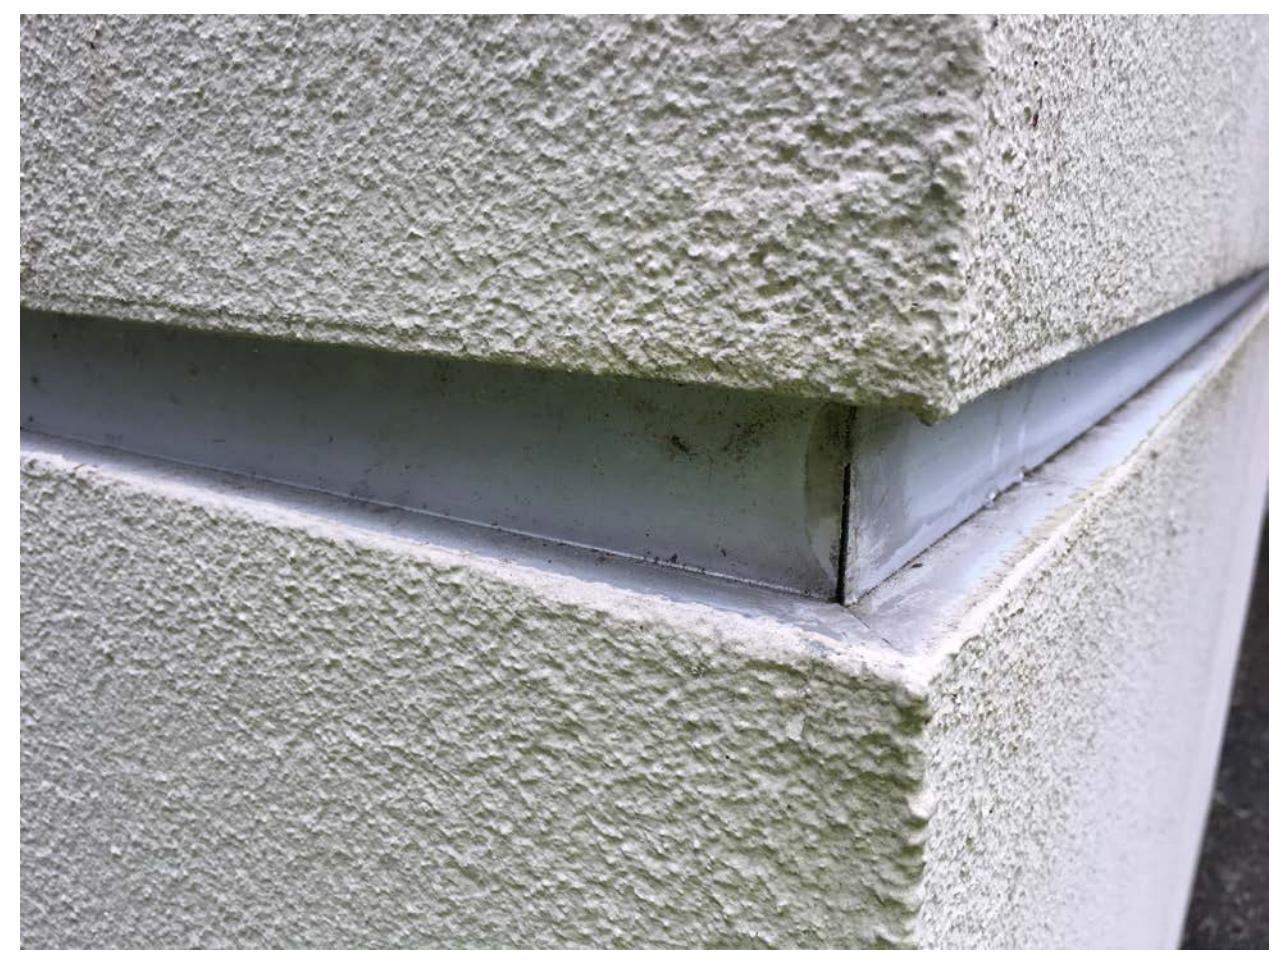
Stucco trim joint without factory molded outside corner. Moisture can enter at open corner joint.

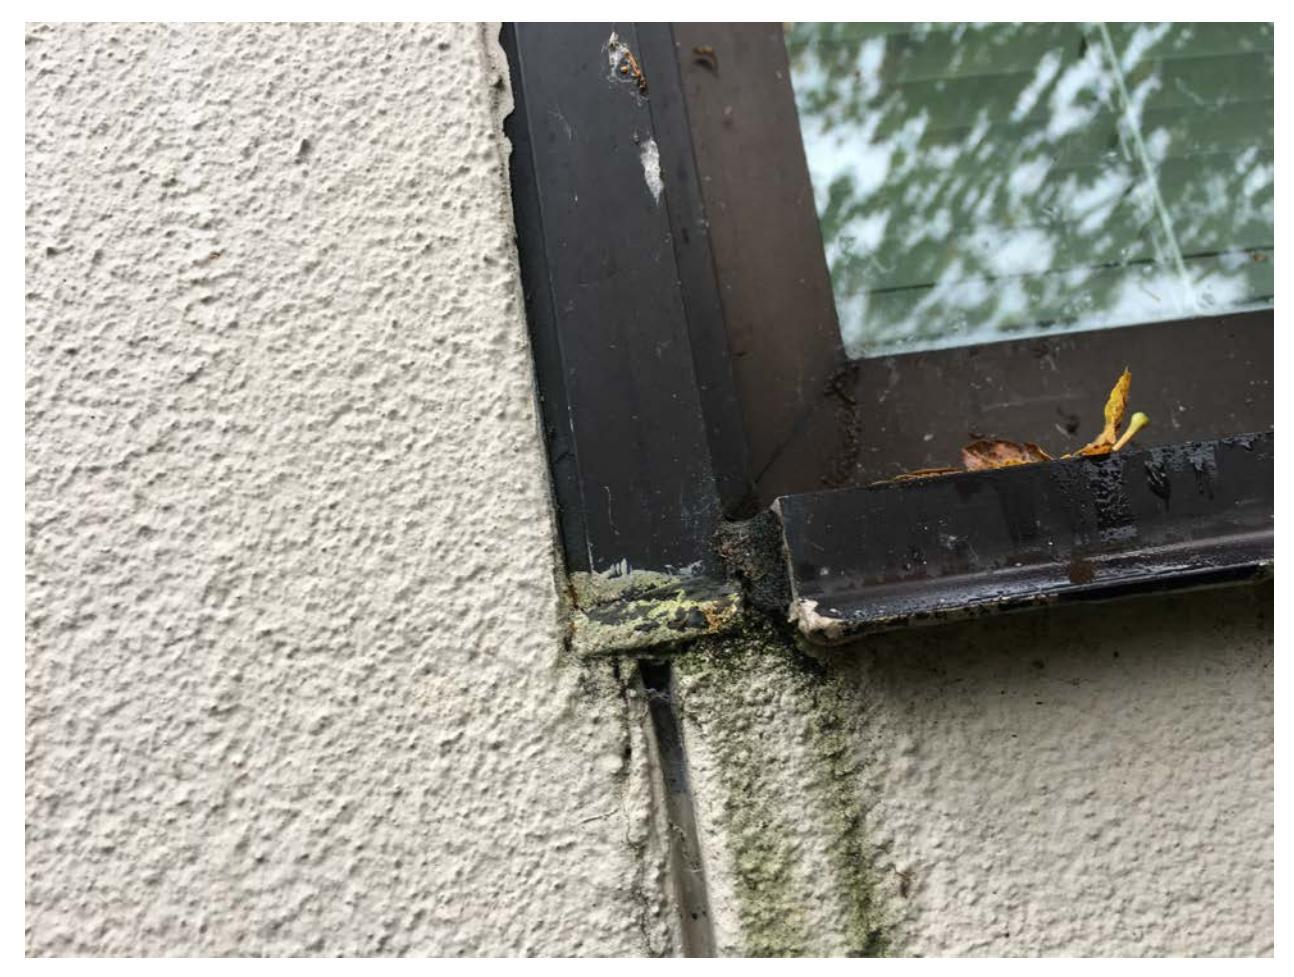
Sill flashing without sill pan and sill end dams. Sealant at corner is the only protection from moisture/dry rot

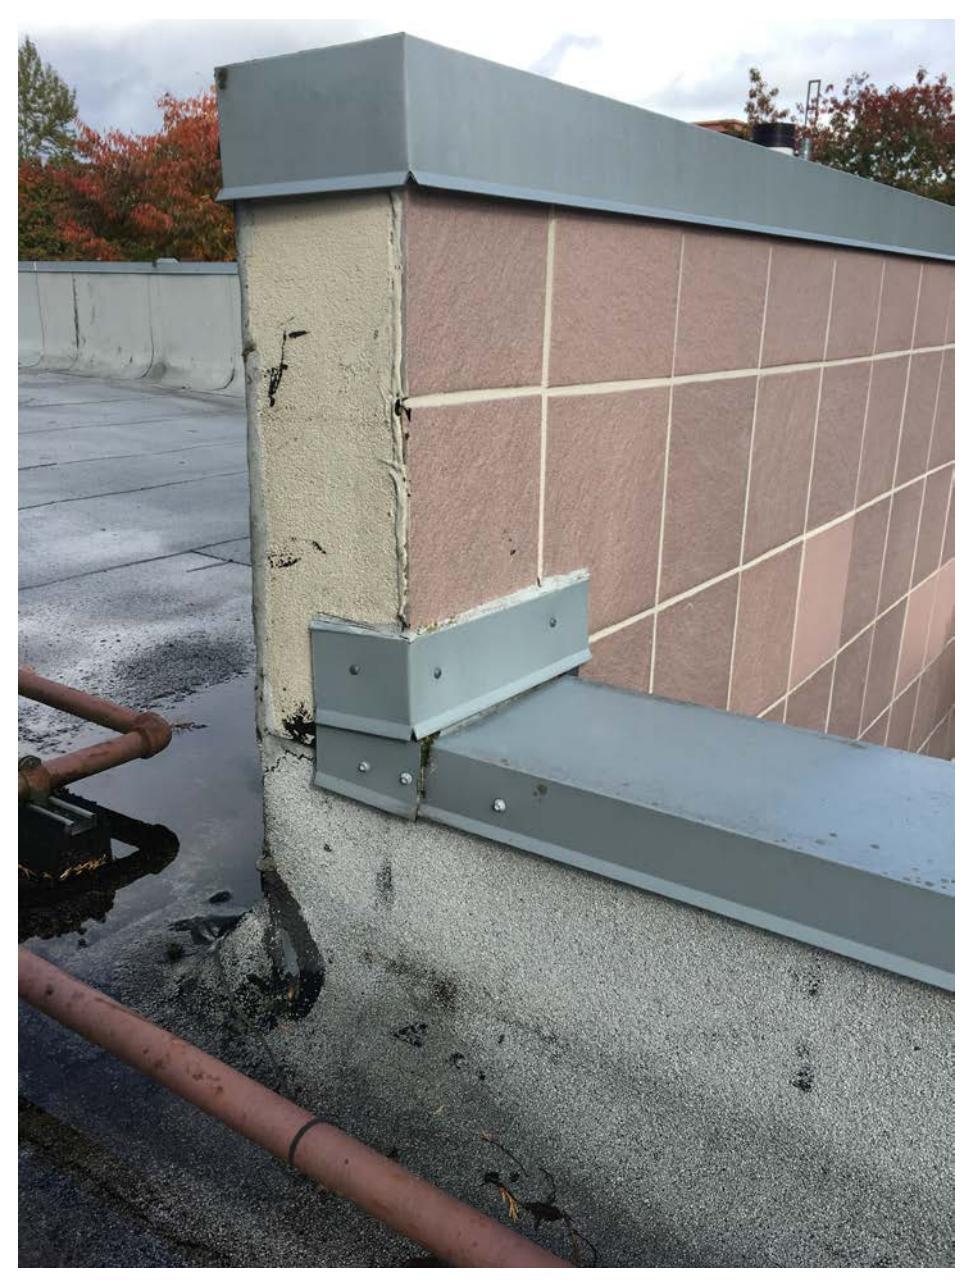
Intersection of parapets at roof showing metal surface mounted angled flashing providing protection with sealant from moisture/dry rot.

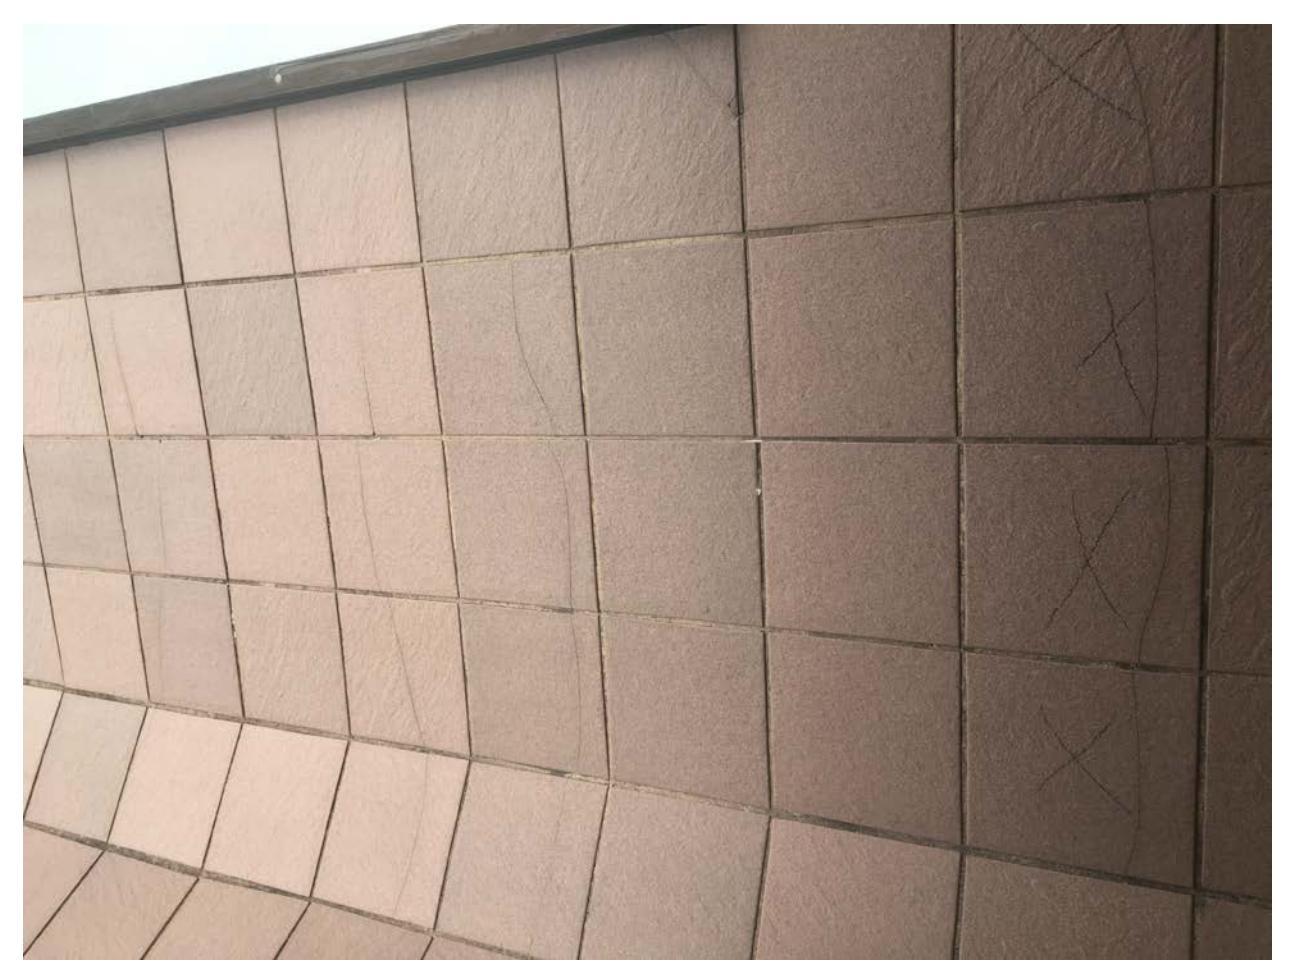
Tile cladding showing cracks. Moisture has gotten behind the tile causing cracks from thermal contraction and expansion.

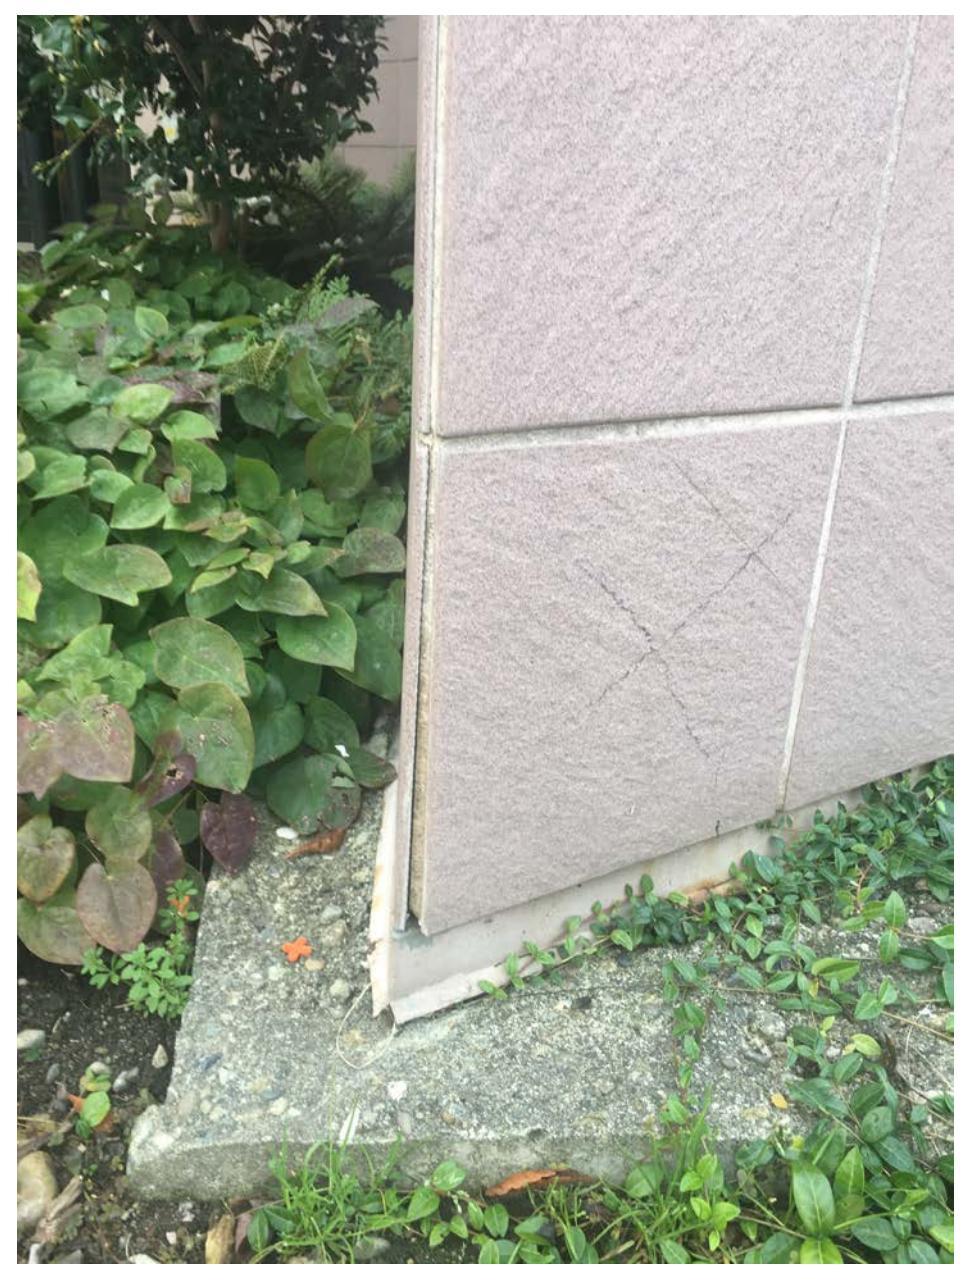
Tile cladding marked for replacement. Tile has pulled away from mortar bed.

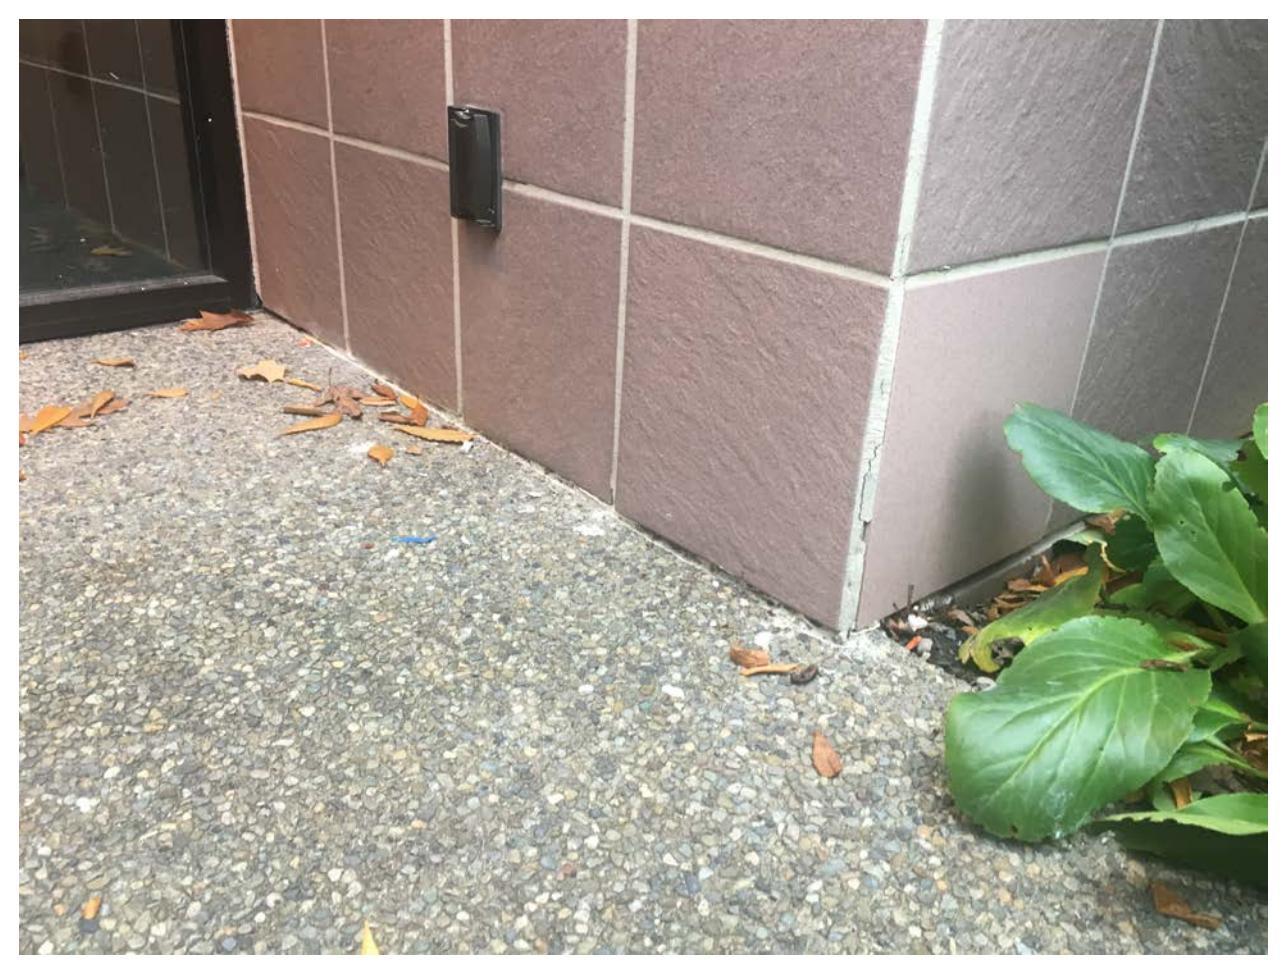
Tile at sidewalk without a 2" minimum gap and flashing. Tile grout at corner has failed and will allow moisture / dry rot to damage substrate.

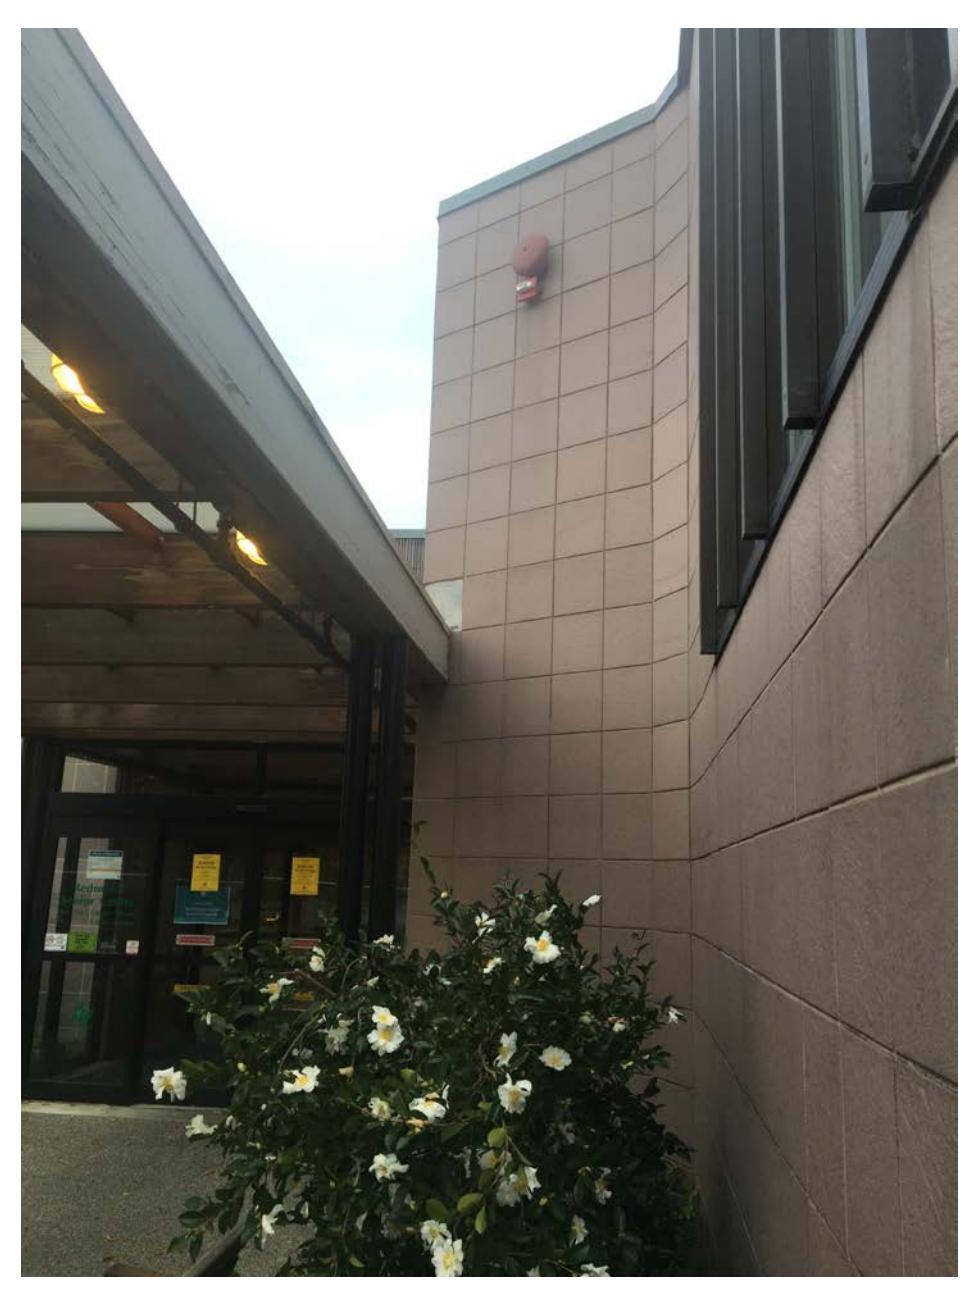
Tile above entry canopy has fallen off exposing mortar bed.

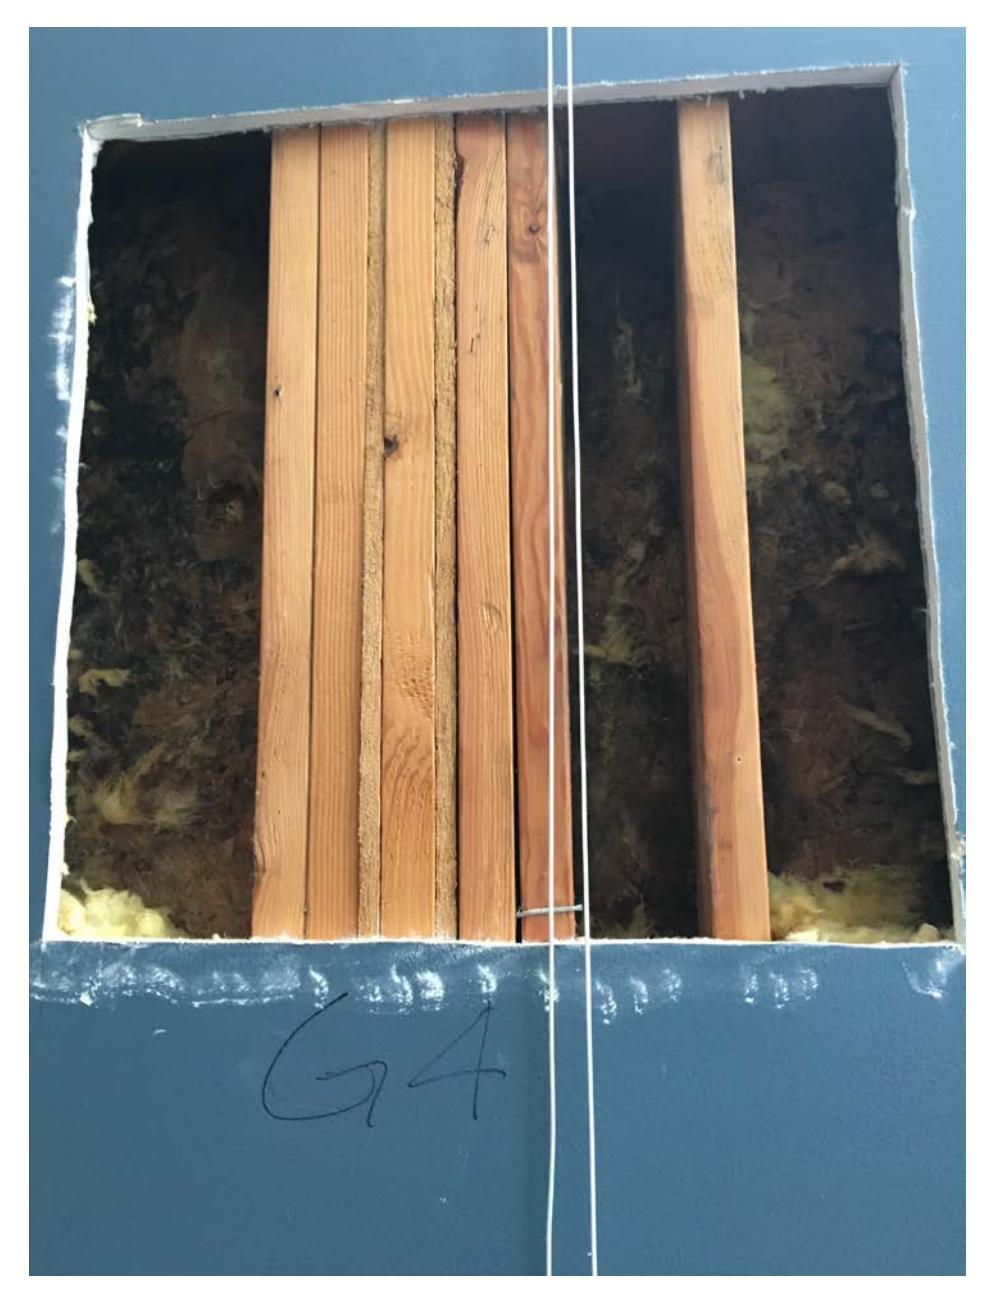
Access port cut in east wall of Meeting Room (208) showing moisture / dry rot at stucco cladding intersection.
