Attachment B: Materials and Special Inspection Examples

SPECIAL INSPECTION DAILY REPORT

ASPHALT OBSERVATIONS REPORT

Asphalt Testing Report

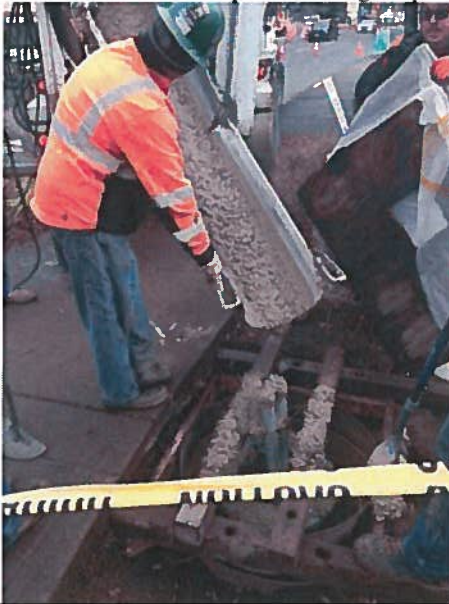
Onsite to sample and test concrete placed for the new signal pole base at Leary Way and Redmond Way. Concrete mix ID # WA40003 was provided by Cadman Concrete and was placed via truck chute and the concrete was mechanically consolidated during placement. Sampled, tested, and cast 1 set of 5-4" x 8" compressive strength specimens for laboratory testing. Set 1 info: Ambient temp. - 44°F; Concrete temp. - 62°F; Slump - 6 1/4"; cast 1 Set of 5-4"x8". Concrete was tested per ASTM C31, C143, C172, and C1064. Please see Concrete Compressive strength reports for additional concrete information.

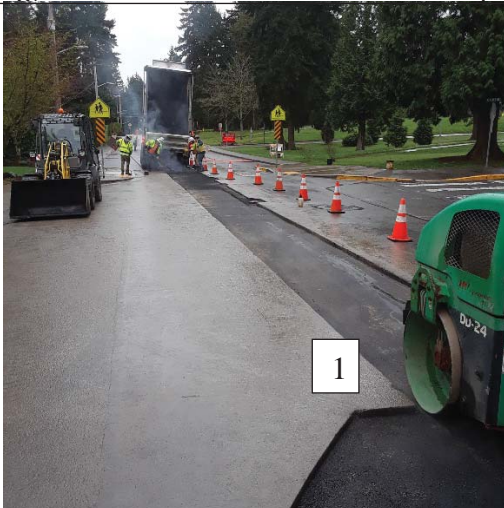
Figure 1: Soil compaction testing location

Obtained Soil/Asphalt density gauge for compaction testing from Mayes Testing Engineers Lynnwood. On site to test the final lift of Cadman D309, as instructed by the City of Redmond inspector. Took on test of the top lift of the trench backfill which met the compaction requirement of 95%. Then waited a bit and performed compaction testing on two 3" lifts of Lakeside Industries WSDOT HMA 1/2", both lifts were confirmed as passing prior to proceeding, See attachments for data on compaction.
