Title: Critical Areas Report for the
Woodside Redmond Property,
Redmond, Washington

Project Number: 2018-115-001

Prepared by: RAEDEKE ASSOCIATES, INC.
2111 N. Northgate Way Ste. 219
Seattle, Washington, 98133
(206) 525-8122

Date: April 5, 2019
Revised October 17, 2019

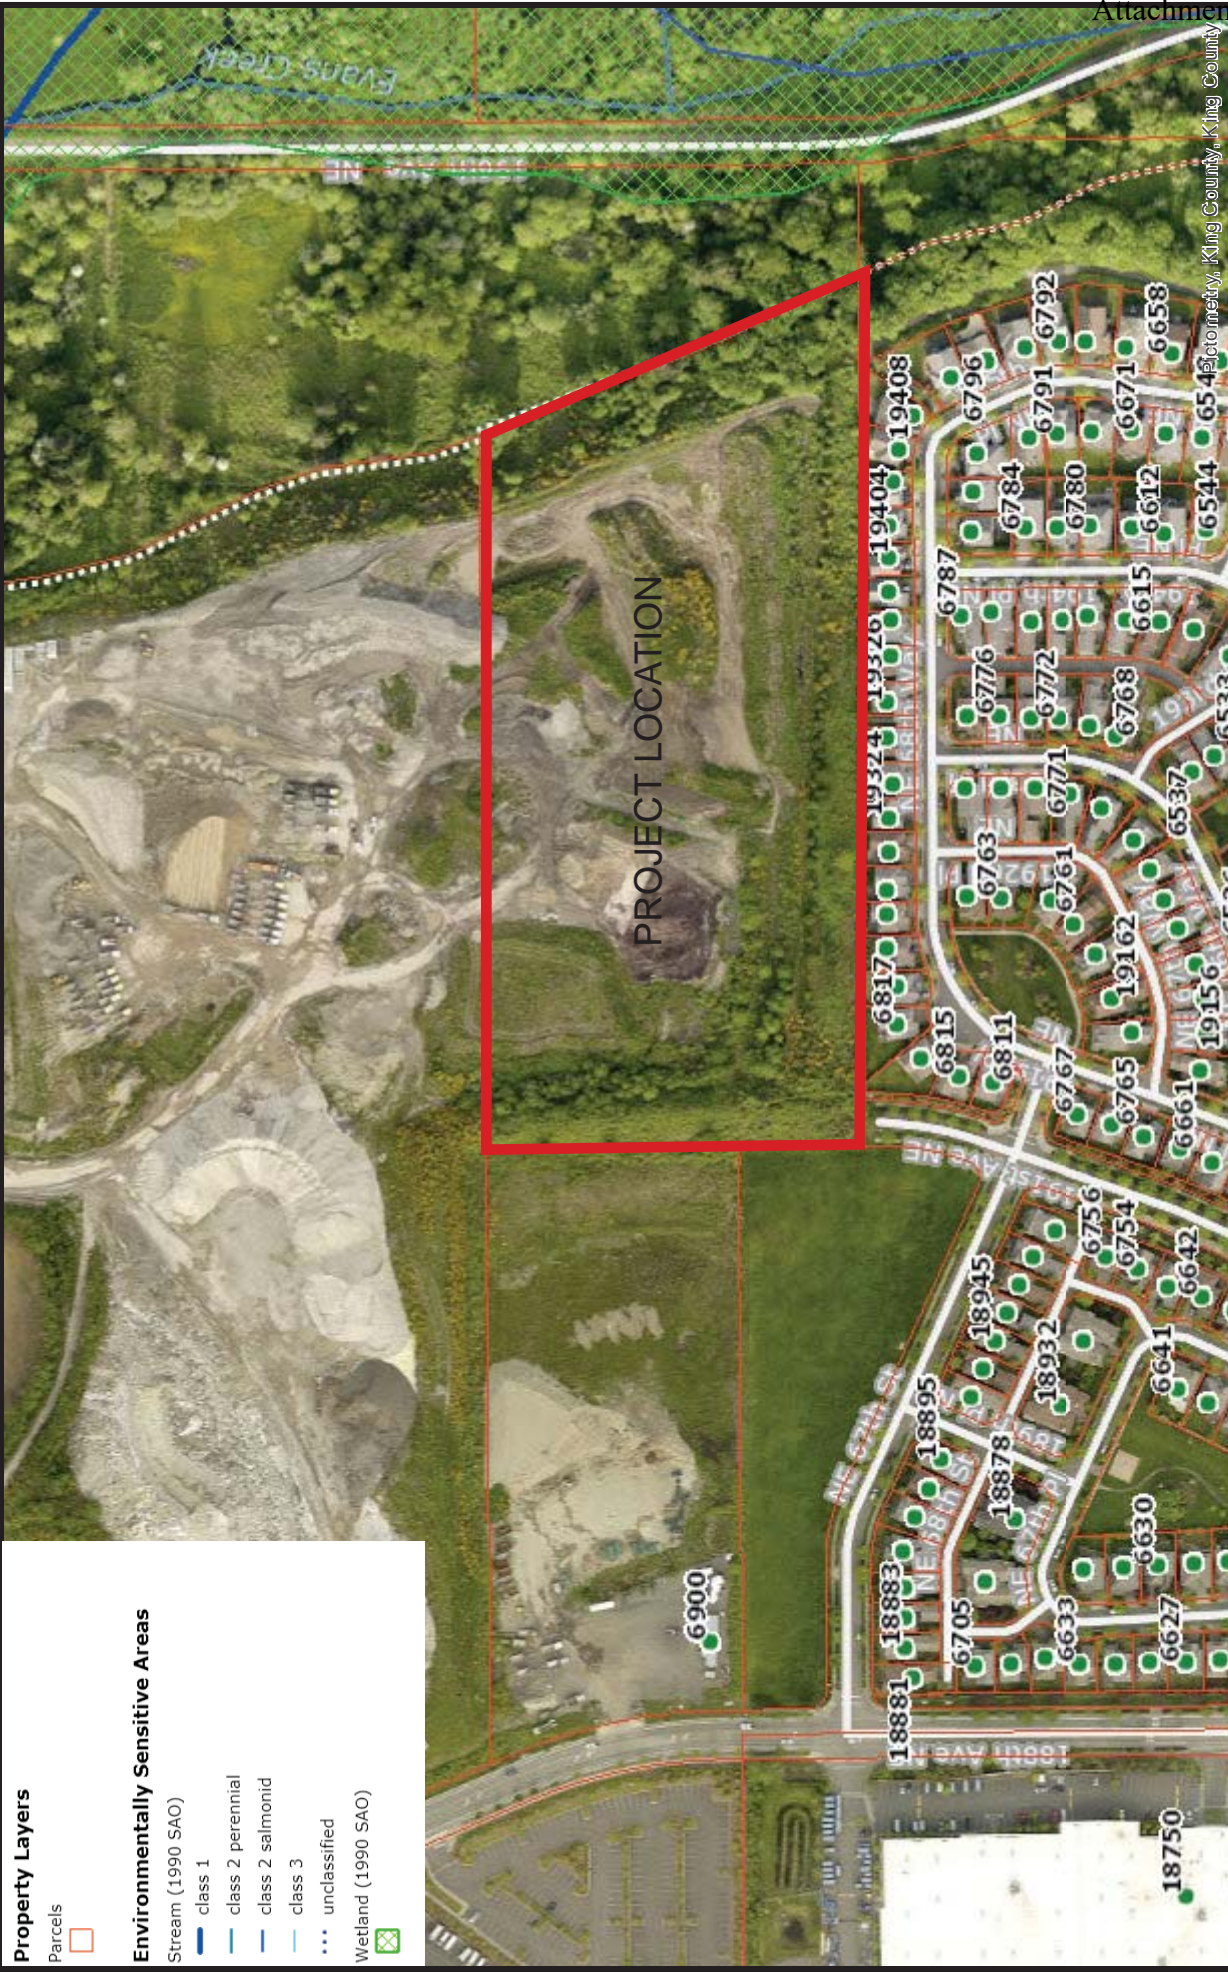
FIGURE 4

King County iMap

The King County (2018) iMap does not show any wetlands on the Woodside Redmond property (Figure 4). The iMap depicts erosion and seismic hazards along the eastern property boundary consistent with the location of the steep slopes depicted on Figure 10. The City of Redmond (2011) wetlands map also does not depict wetlands or streams on the Woodside Redmond property; however, it does depict a wetland near the southeast property boundary (Figure 5). The depicted wetland corresponds to the wetland we identified off-site to the east. The City of Redmond (2016) streams map does not depict any streams on the Woodside Redmond property (Figure 6).

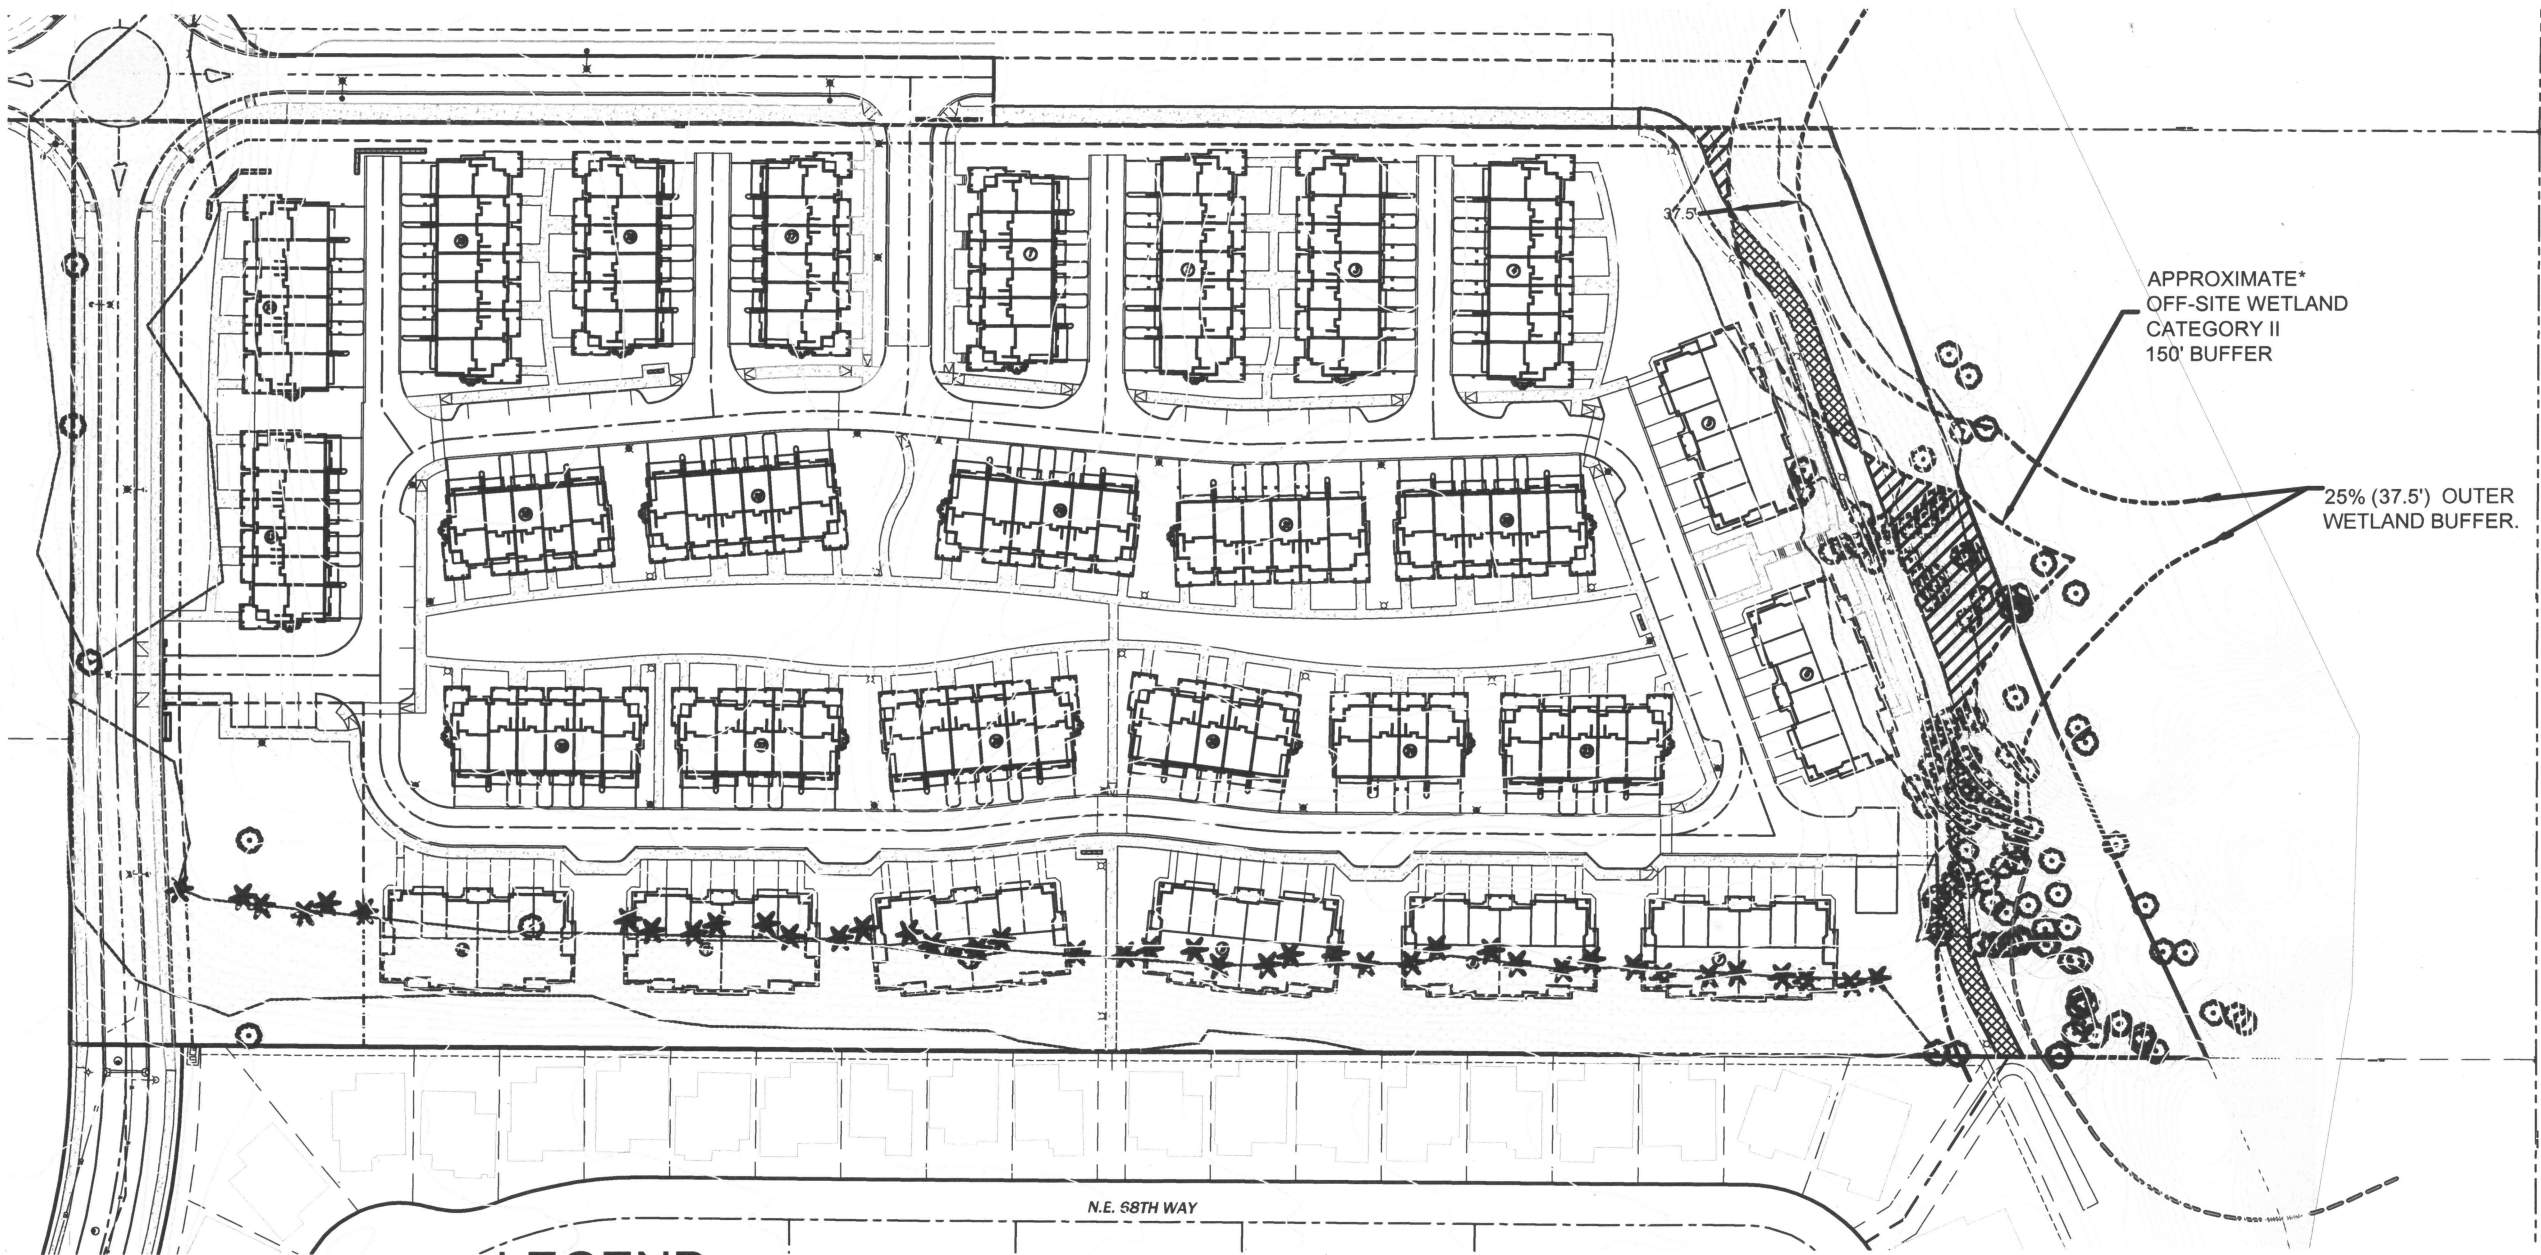
- PROPERTY LINE
- APPROX. WETLAND BUFFER LINE TO OFF-SITE WETLAND
- ▨ BUFFER IMPACT (3,109 SF)
- ▩ BUFFER GIVE (5,240 SF)

As outlined above, the proposed site plan avoids direct impacts to the off-site wetland located to the east of the project site. However, the proposed site plan would cause impacts to the wetland buffer within the eastern portion of the project site where a pedestrian trail would be created. Buffer averaging is proposed to allow for construction of the pedestrian trail within the wetland buffer, as discussed above. The proposed buffer averaging will increase the total area of buffer provided for the wetland by approximately 2,100 sf than would be provided if the standard 150-foot buffer were applied.
