## **REPORT OF GEOTECHNICAL ENGINEERING SERVICES**

Woodside  
7039 196<sup>th</sup> Avenue NE  
Redmond, Washington

For  
Polygon Northwest Company  
October 4, 2019

GeoDesign Project: Polygon-161-01

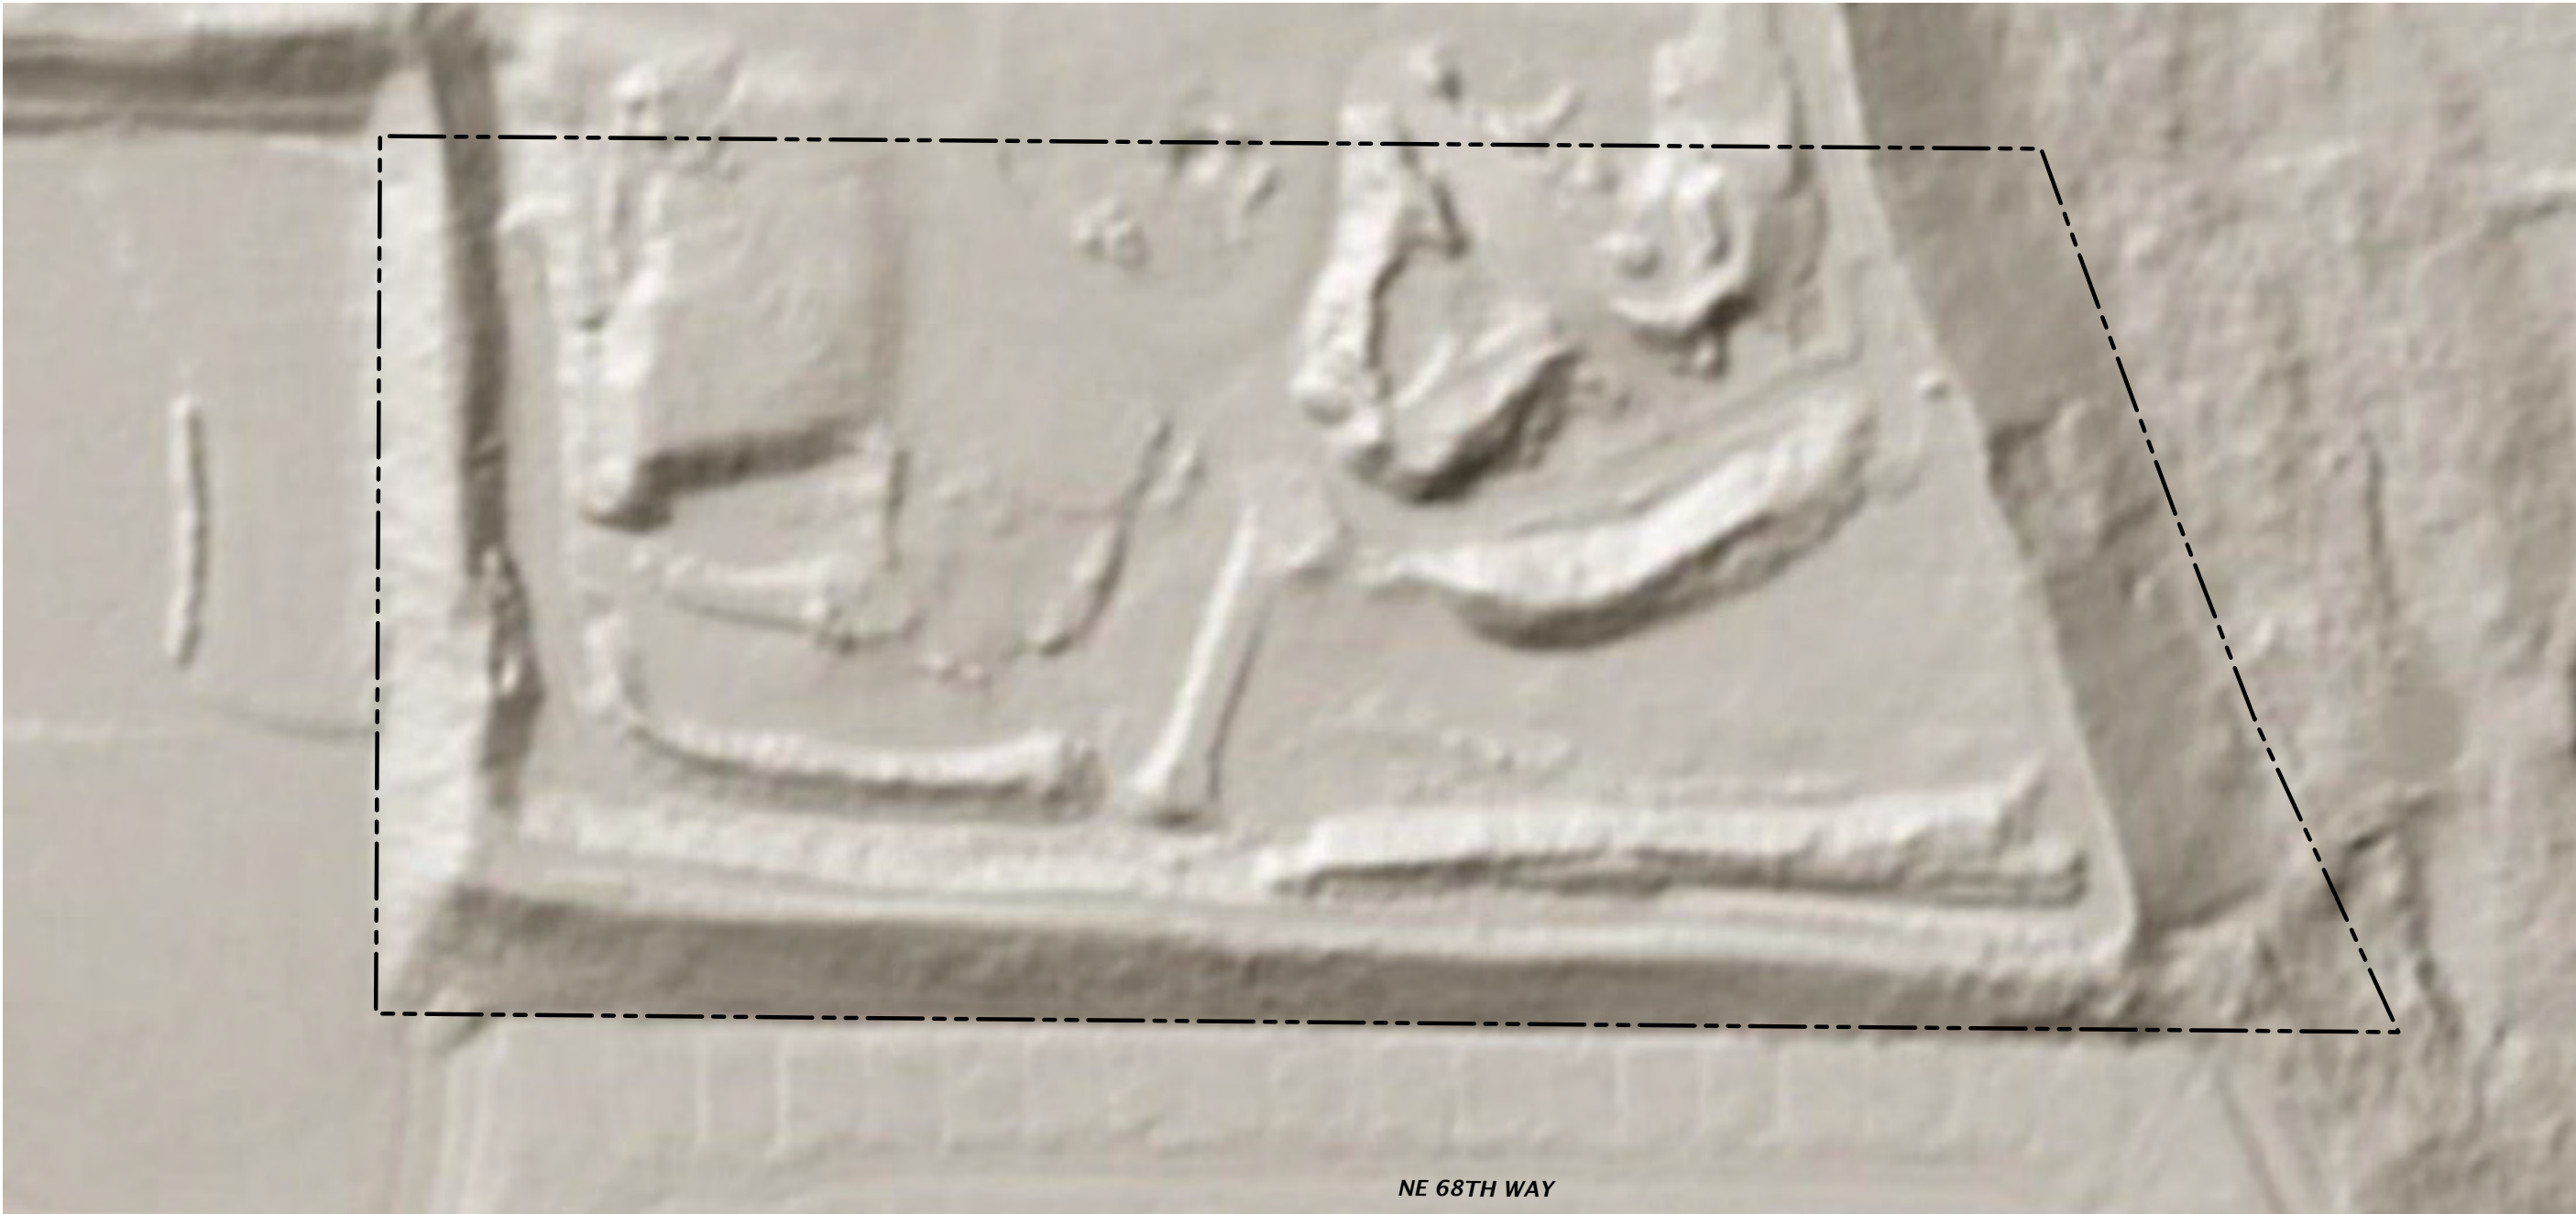
## NATIVE SOIL CROSS SECTION LOOKING NORTH
