1. Old Firehouse Teen Center Facility Discussion

ATTACHMENTS:
Attachment A: Community and Stakeholder Outreach and Involvement
Attachment B: Facility Condition Report - July 2025

FACILITY CONDITION ASSESSMENT

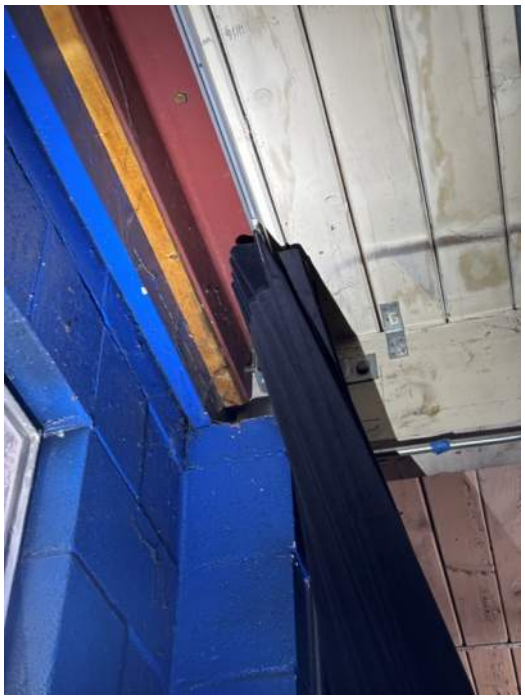
The roof diaphragm appears to consist of straight-sheathed 1x or 2x decking spanning between solid sawn wood beams (*Image VI.6)*. The decking may have an additional wood layer above; however, that could not be verified. In many parts of the building, especially the Show Room, Game/Rec Room and Couch/TV Room, the wood decking and beams have indications of water damage including warping and discoloration. One wood beam in the showroom has extensive checking in the grain that may require structural reinforcing after additional investigation (*Image VI.7)*. There is a discontinuation of the CMU not shown on the retrofit plans along the Gridline D in the show room which is infilled with light frame wood wall, it is unclear if this was a modification to the original wall construction (*Image VI.4)*.

Image VI.4 Steel column and wood framed wall in Showroom

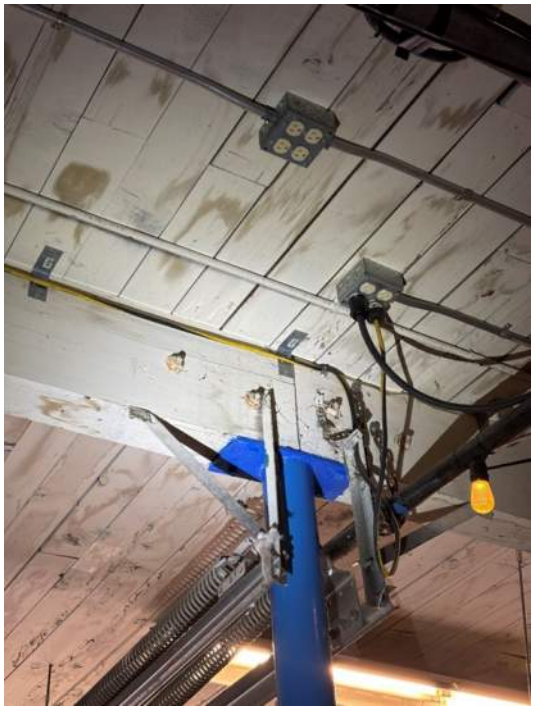
Image VI.5 Roof framing at pilaster in Showroom

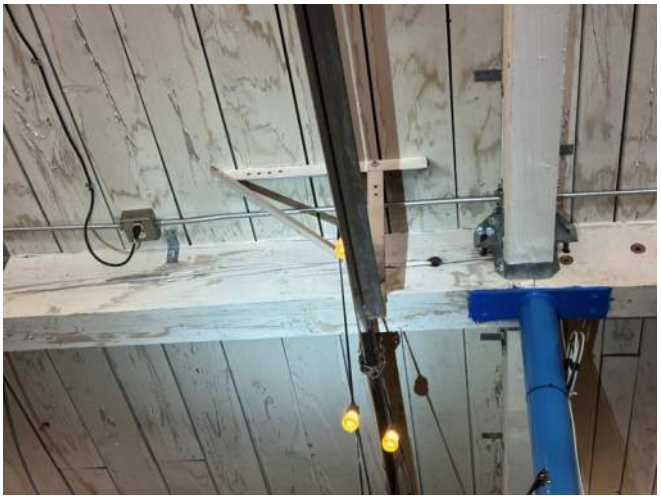
Image VI.7 Beam with large wood check in Showroom

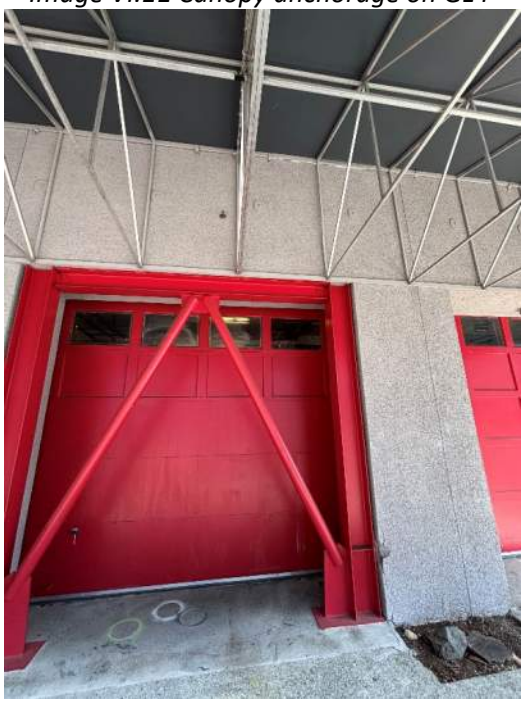
Image VI.13 Braced Frame on GL F

Image VI.14 Water-damaged roof decking in couch room

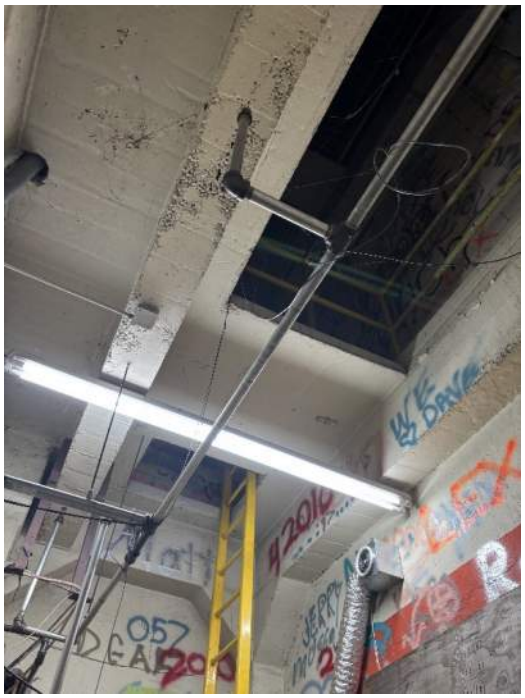
Image VI.15 Hose Tower from first floor

Image VI.16 Hose Tower concrete frame with poor consolidation

Additionally, the Hose Tower is the greatest structural concern and poses a risk of breaking apart in a seismic event if it is not removed or strengthened. It could be a potential life safety issue and damage the rest of the building. The tower's cast in place concrete frame requires strengthening and the CMU façade is beyond repair and needs to be rebuilt with reinforced CMU or replaced with a light façade panel.

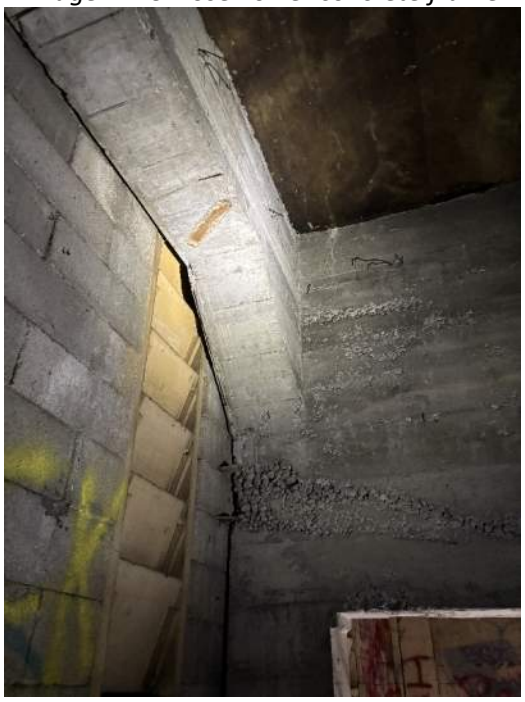
Image VI.20 Hose Tower and louver in CMU wall

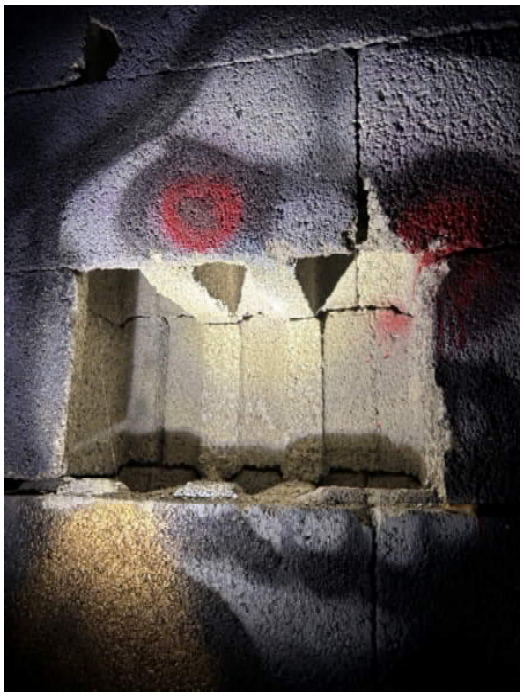
Image VI.22 Broken CMU block in Hose Tower wall

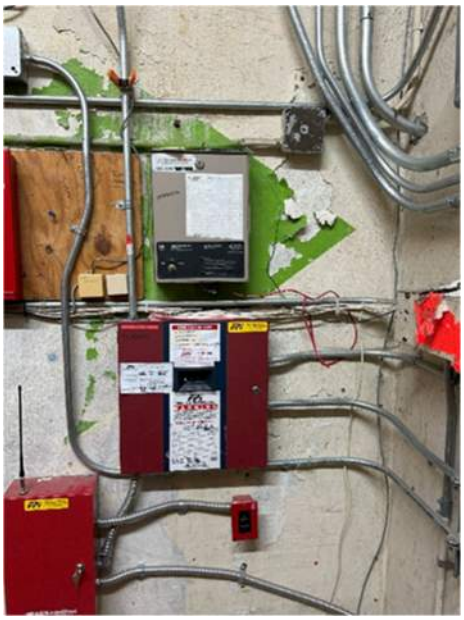
show no deficiencies. The system is outdated although it appears to be functioning adequately. Fire alarm distribution devices appear to meet code requirements.

Figure E3 – Fire Alarm Panel

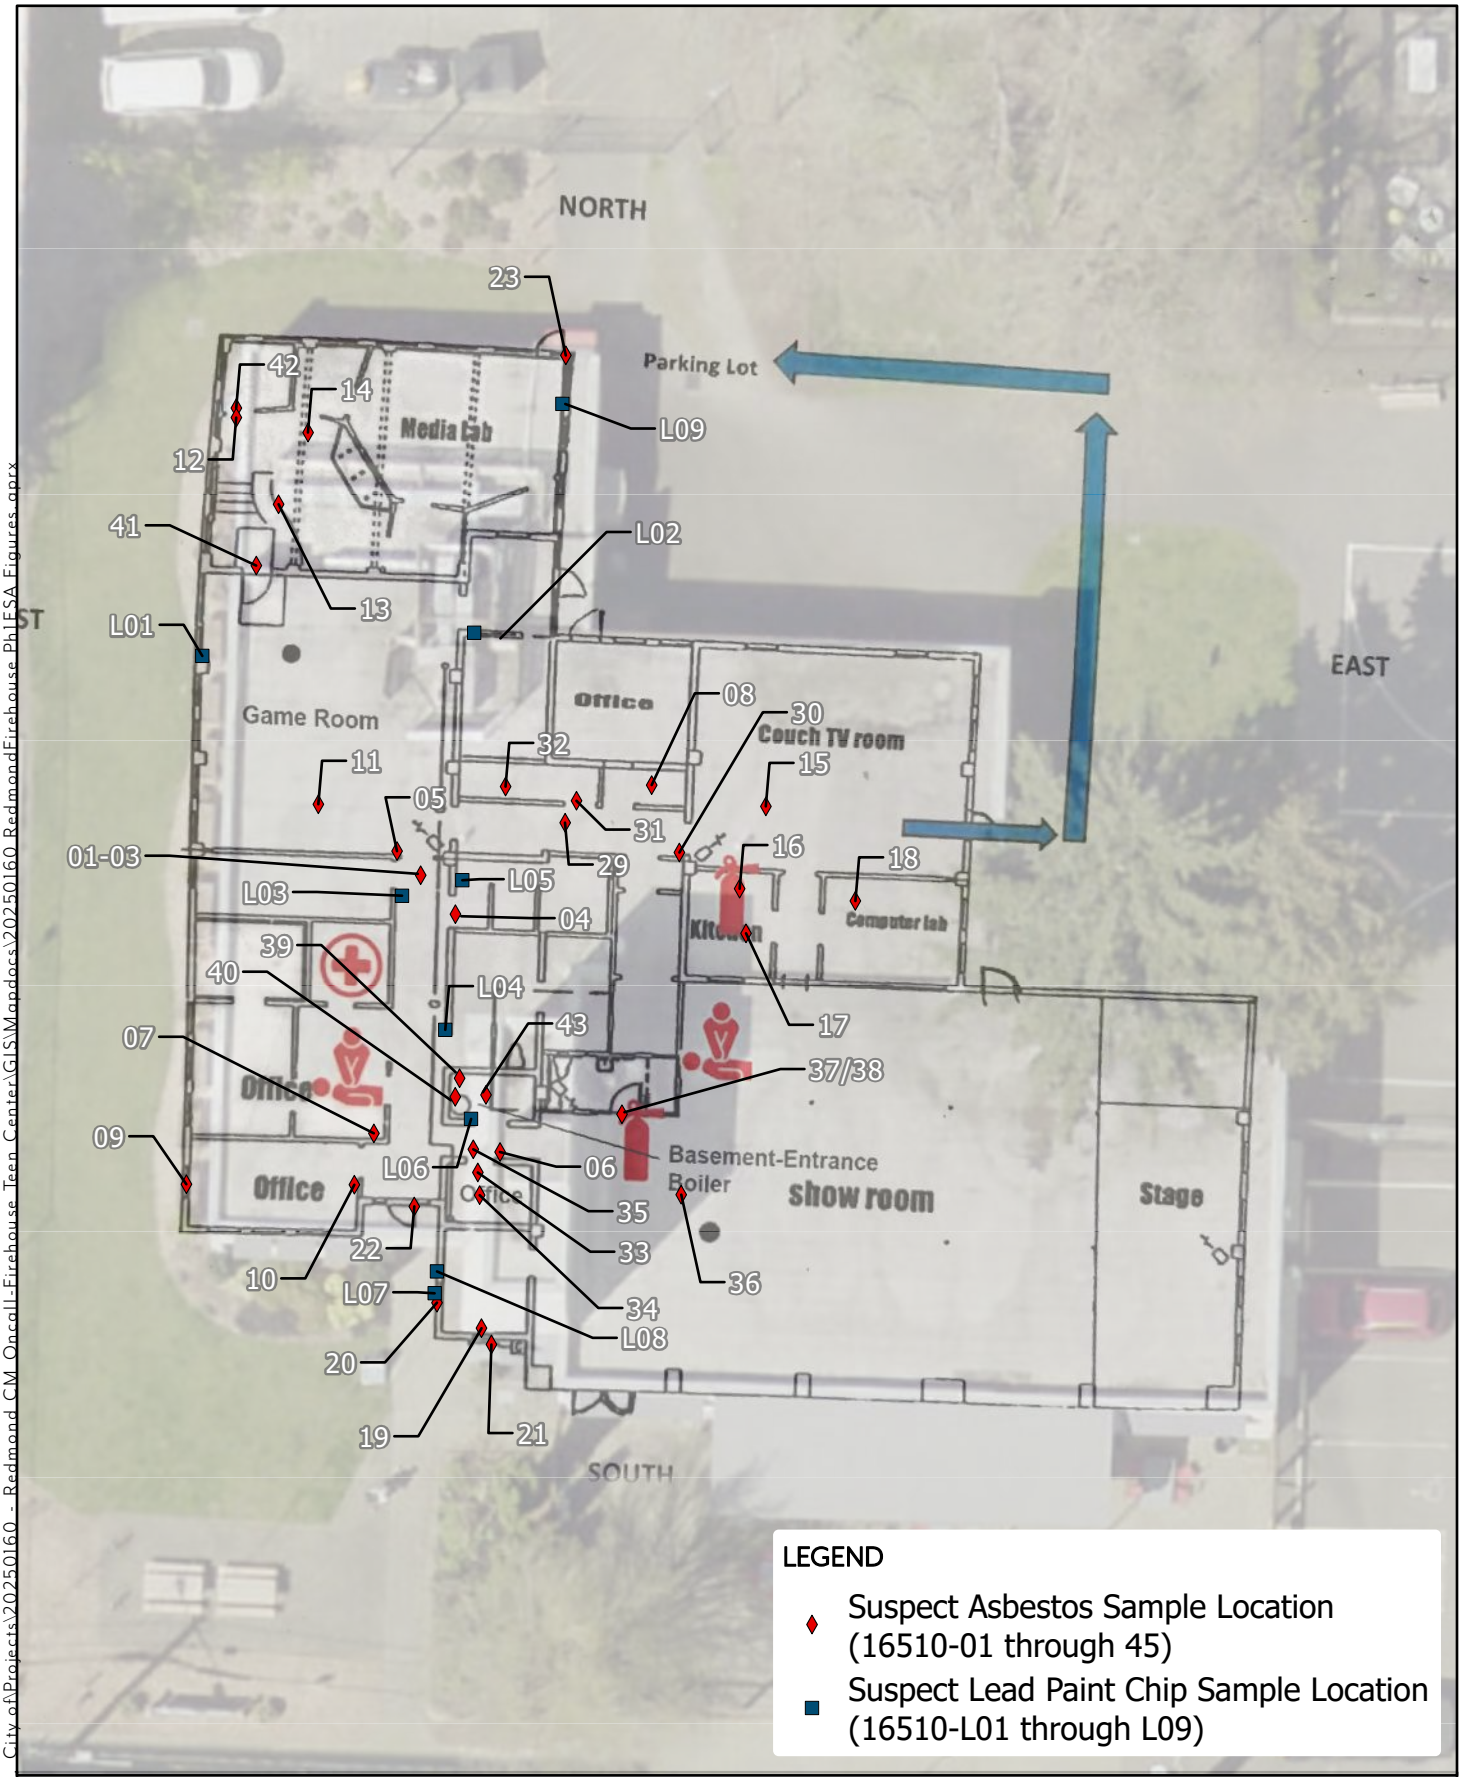
City of Redmond Old Firehouse Teen Center
Limited Hazardous Building Materials Survey
APN: 1225059059
Figure 2 - Sample Locations (Interior and Exterior)

Perteet collected a total of 45 samples (16510-01 through 45) of suspect ACM from the interior and exterior of the Property building. Sample locations are presented on Figure 2 and 3, and analytical results are provided in Table 1. Laboratory analytical reports are provided in Appendix B. No ACM was identified during this survey.

Perteet collected a total of 8 paint chip samples (16510-01 through 08) from representative interior and exterior painted surfaces at the Property building. Sample locations are presented on Figure 2, and laboratory analytical results are provided in Table 2. The laboratory analytical reports are provided in Appendix B. Pereet's survey indicated detectable concentrations of lead in paint as follows:

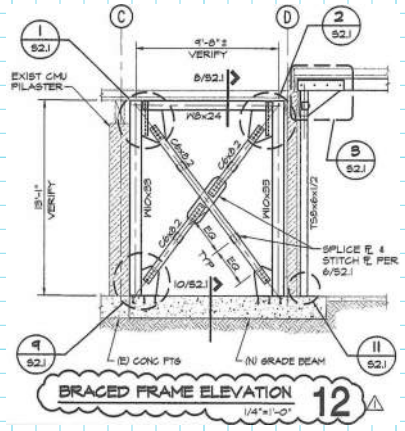
COLUMN IN BRACE FRAME ALONG GRIDLINE 5

nf = 1 Total number of frames in the direction of loading
V = 382.3 k Pseudo Seismic Force
hn = 13.17ft
L = 9.67ft
Ms = 2.5 CP, ASCE 41-17 EQN 4-11 FOOTNOTE
Acol = 9.71in^2 W10X33

p_ot = 0.667*382.3k*13.17ft/9.67ft/1/9.71in^2/2.5
= 14.31ksi < 0.3*Fy = 15ksi

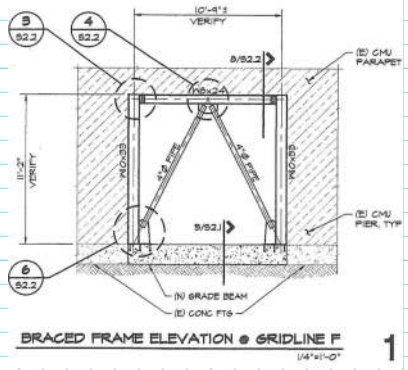
COLUMN IN BRACE FRAME ALONG GRIDLINE F

nf = 1 Total number of frames in the direction of loading
V = 257.1 k Pseudo Seismic Force
hn = 11.17ft
L = 10.75ft
Ms = 2.5 CP, ASCE 41-17 EQN 4-11 FOOTNOTE
Acol = 9.71in^2 W10X33

p_ot = 0.667*257.1k*11.17ft/10.75ft/1/9.71in^2/2.5
= 7.40ksi < 0.3*Fy = 15ksi

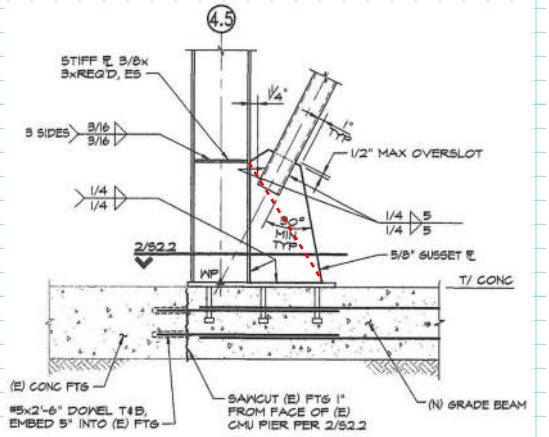
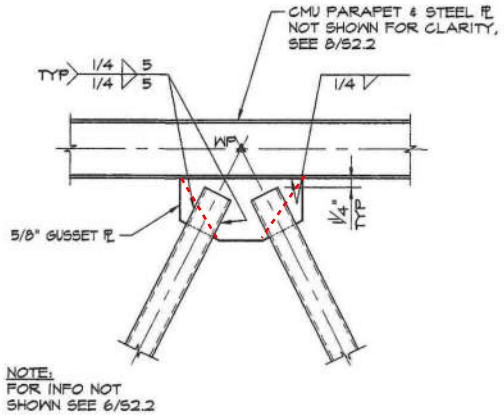
X-BRACE CONNECTION CAPACITY FOR PIPE BRACE
DOES NOT EXCEED BUCKLING AND YIELD CAPACITY OF BRACE

INVERSE V-BRACE CONNECTION CAPACITY FOR PIPE BRACE
EXCEEDS BUCKLING AND YIELD CAPACITY OF BRACE
