City of Redmond

Agenda Study Session

Facilities Condition Assessment Update

Facility Condition Assessment

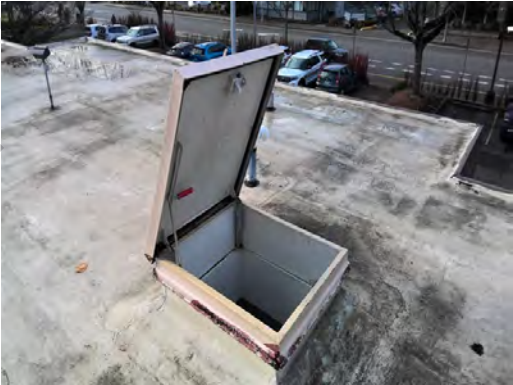
Deficient Material: **Roof Hatch**
Ladder length is short, no safety handle extension at either hatch, and no safety fall protection guard or gate.

Remedial Action:
Extend steel ladder and provide collapsible safety handle extension. Install rooftop fall protection guard and gate around access hatches.

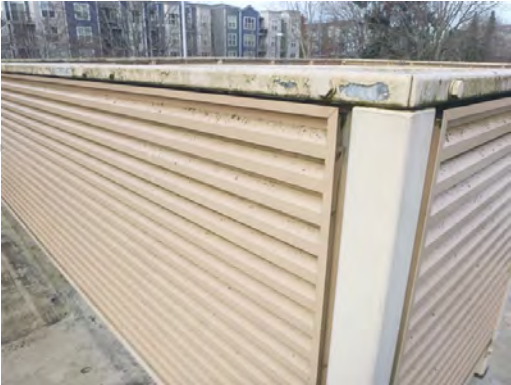
Deficient Material: Mechanical Screen
Metal mechanical screen paint finish is worn and fading.

Remedial Action:
Sand areas, prime, and paint.

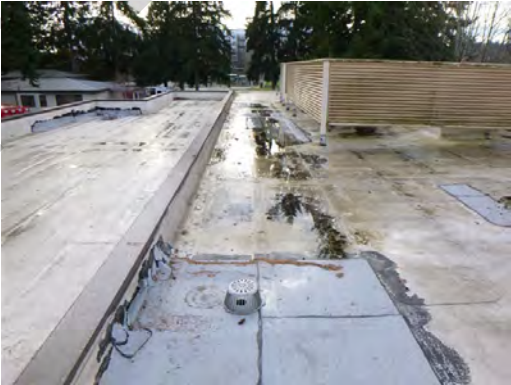
Deficient Material: **Roof Drains**
Several roof drain bodies missing. Several companion overflow roof drains missing. Some roof drain piping insulation missing. Significant ponding on roof, especially to east of office area to SW.

Remedial Action:
Install approximately four roof drain assemblies including four overflow roof drains, and insulate approximately six 50-foot runs of roof drain piping at each location.

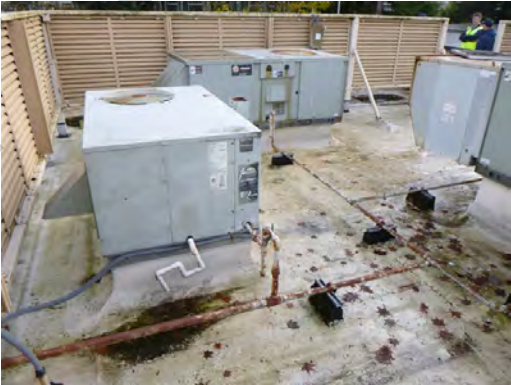
Deficient Material: Gas Piping
Rooftop gas piping to nine rooftop gas-pack units is rusting and corroding.

Remedial Action:
Replace rooftop gas piping in conjunction with needed gas-pack unit replacement.

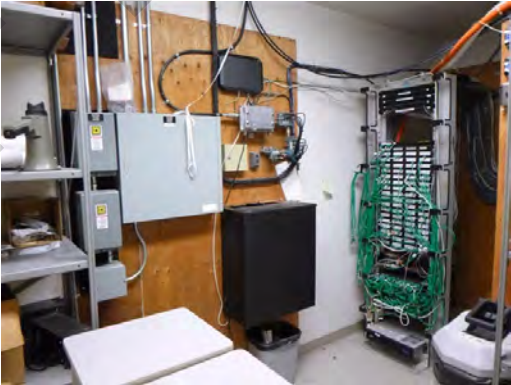
Deficient Material: **Communications Cooling**
No dedicated cooling for the main telecom room.

Remedial Action:
Install ductless split cooling for main telecom room, nominally 1.5-ton system.

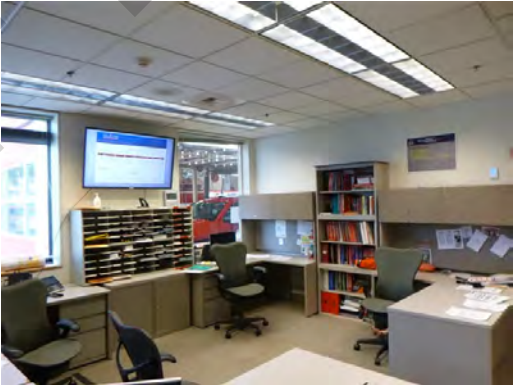
Deficient Material: **Air Flow Balance**
Unclear air flow balance throughout, except apparatus bays.

Remedial Action:
Conduct re-TAB (test, adjust, and balance) throughout, ideally in conjunction with other work such as new rooftop units, duct cleaning, and/or rezoning.

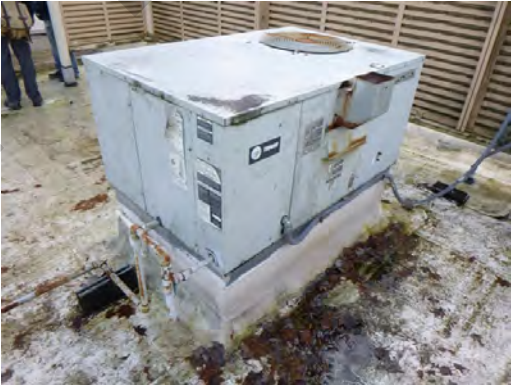
Deficient Material: **Roof Top Units**
All rooftop units at end of life, with multiple and increasing failures, and no economizer (free cooling), except for the largest unit.

Remedial Action:
Replace rooftop gas-pack units with new high-efficiency type including full economizer.

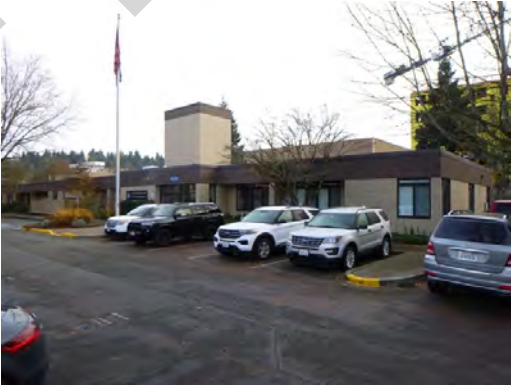
Deficient Material: Energy Efficiency
Energy use intensity (EUI) is 112 which 173% of the WA State Clean Buildings target of 65 for fire stations.

Remedial Action:
Conduct an energy audit to reduce EUI in support of city sustainability programs. Budget for audit and tune-up only; capital improvements depend on energy audit results.

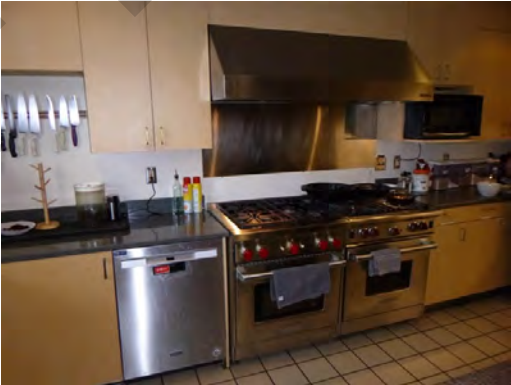
Deficient Material: Kitchen Hood
Type 2 heat and moisture only hood at station house kitchen serving two gas-fired ranges.

Remedial Action:
Replace with Type 1 grease hood, including fire suppression and make-up air system.

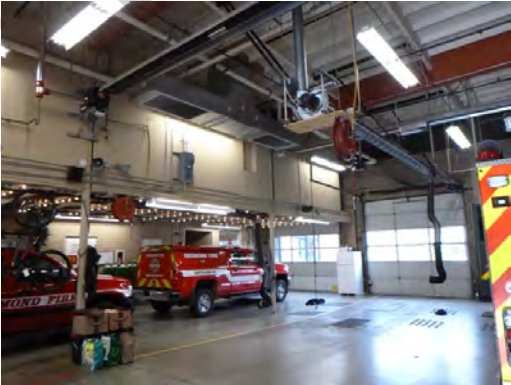
Deficient Material: **Vehicle Engine Exhaust**
Existing Nederman system is increasingly aged and obsolete, with separate exhaust fans for each served bay, and with electrical disconnect height exceeding code limit.

Remedial Action:
Replace the Nederman vehicle engine exhaust system with a modern type, including a single exhaust fan interlocked with the general ventilation system and with disconnect height per code.

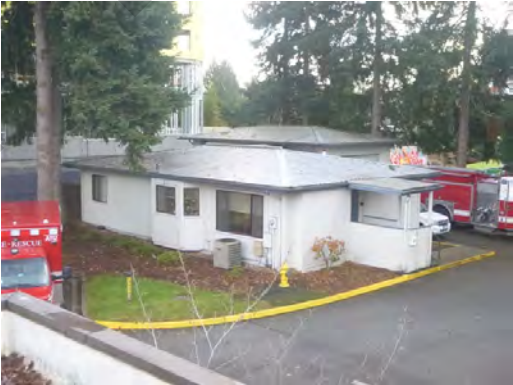
Deficient Material: Metal Roof
Roof at end of life and leaking.

Remedial Action:
Remove roofing, repair water-damaged deck where occurs, install ice and water shield and synthetic under roofing, and install new low-slope rated metal roofing with proper flashings and new gutters and downspouts.

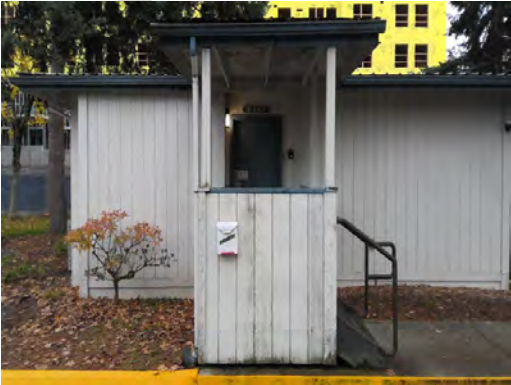
Deficient Material: Covered Walk
Front porch at end of life with rotting plywood, wood roof extension, perimeter low wall, deck, and stair.

Remedial Action:
Demo and rebuild porch, deck, and stair.

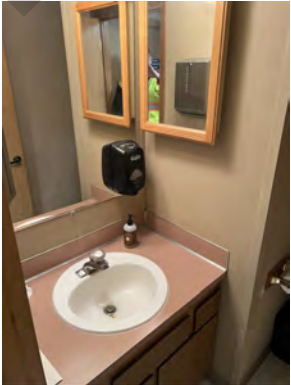
Deficient Material: Plumbing Fixtures
Water closet, lavatory, shower, sink, deep sink, and wall box are all aged, some minor damage; approaching end of life.

Remedial Action:
Replace plumbing fixtures.

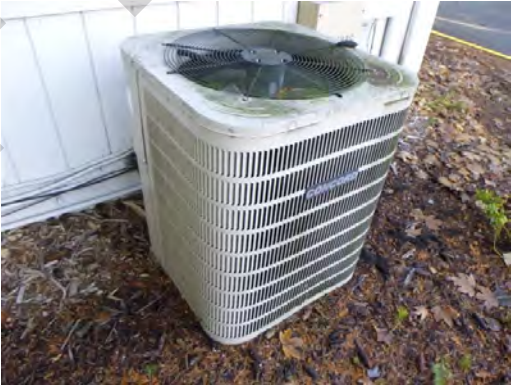
Deficient Material: Communications Room Cooling
Heat pump condensing unit at end of life with intermittent failure reported.

Remedial Action:
Replace upon complete failure.

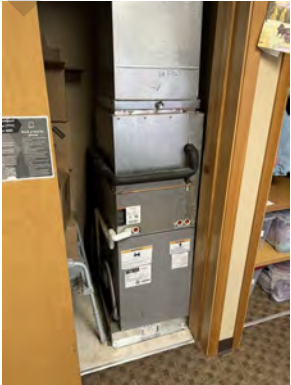
Deficient Material: Apparatus Bay HVAC
Aging heat pump furnace with increasingly obsolete R-22 refrigerant; system is leaking.

Remedial Action:
Replace prior to complete failure in conjunction with replacement of outside condensing unit and upgrade to high-efficiency modern refrigerant (R-410A) working fluid.

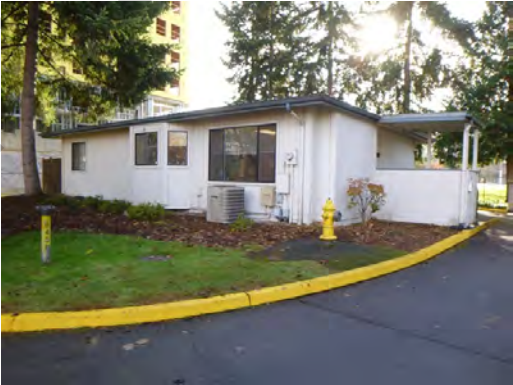
Deficient Material: Fire Sprinkler System
No fire sprinkler installed.

Remedial Action:
Install fire sprinkler system.

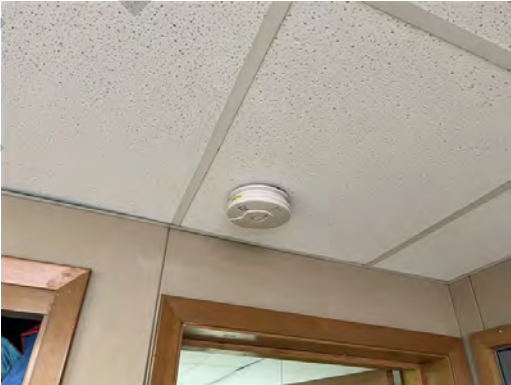
Deficient Material: Fire Alarm
No fire alarm system.

Remedial Action:
Install fire alarm system.

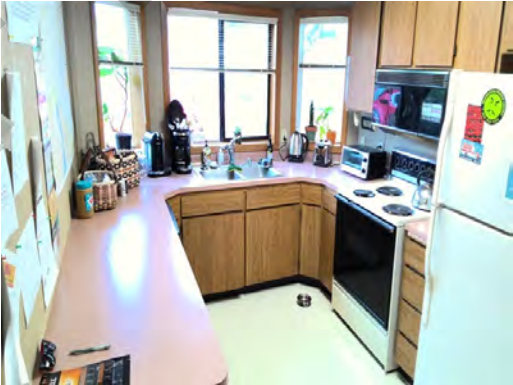
Deficient Material: Kitchen Cabinets
Worn and dated wood cabinets and plastic laminate countertop.

Remedial Action:
Replace kitchen casework and include ADA compliance.

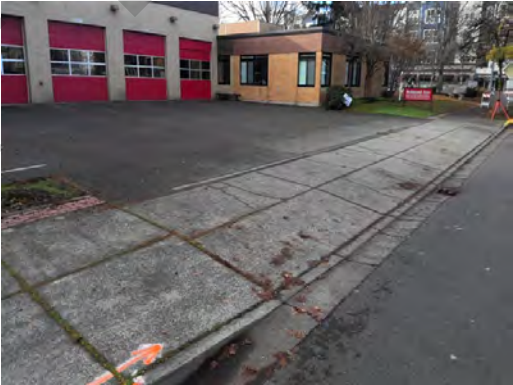
Deficient Material: Concrete Pavement
Concrete apparatus apron at sidewalk cracked and degrading.

Remedial Action:
Demo existing, compact sub-grade, and repour high-strength curb cut.

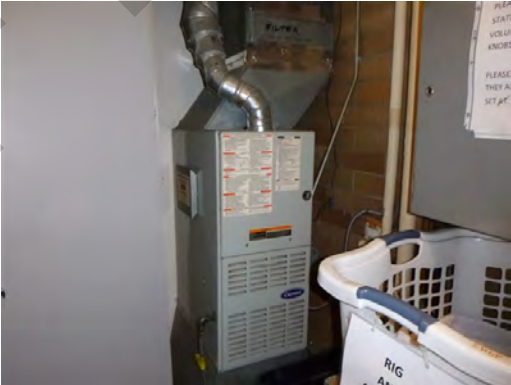
Deficient Material: Furnaces
Aging apparatus bay gas-fired forced-air furnace nearing end of life, with increasing failures.

Remedial Action:
Budget to replace promptly upon failure; replace with high-efficiency (condensing) furnace.

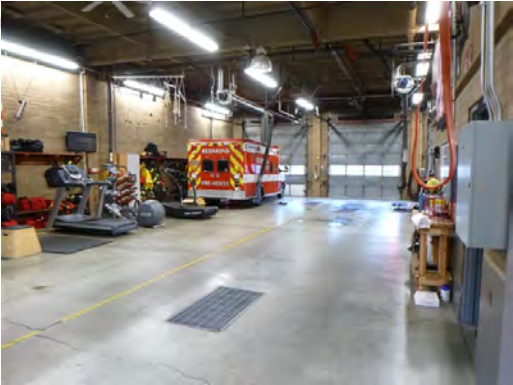
Deficient Material: Apparatus Bay HVAC
No ventilation (outside air and exhaust) for the apparatus bays.

Remedial Action:
Install apparatus bay ventilation per code, including CO and NOx control.

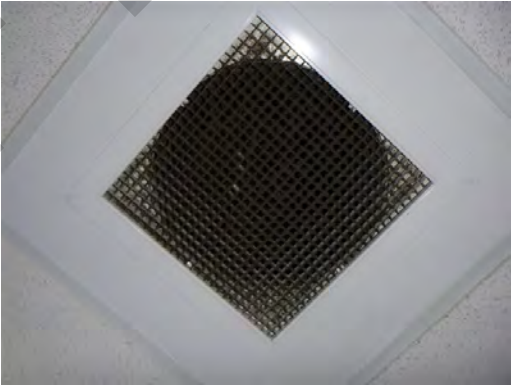
Deficient Material: Ductwork
Observed ductwork is dirty, with unclear air flow balance.

Remedial Action:
Clean, test, and adjust ductwork and air flow upon replacement of associated station house rooftop units and apparatus bay furnace.

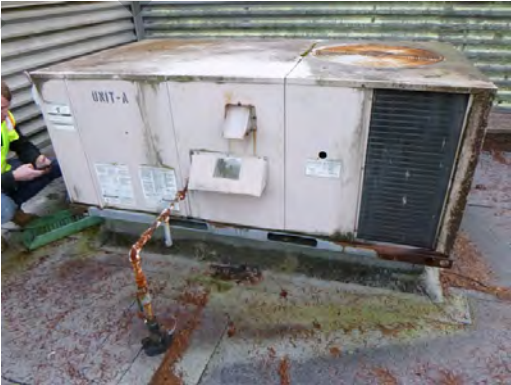
Deficient Material: Rooftop Units
Station house rooftop gas-pack units at end of life with rust and corrosion. Repair parts are becoming increasingly difficult to obtain.

Remedial Action:
Replace rooftop units with modern high-efficiency type.

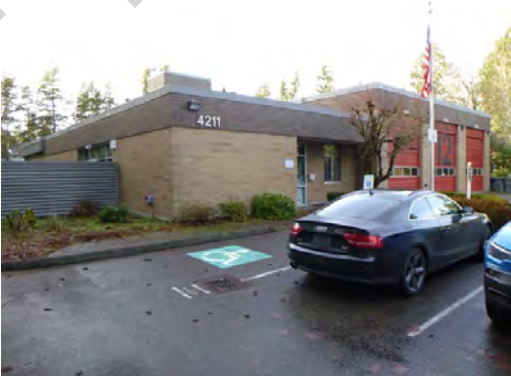
Deficient Material: **Energy Efficiency**

Fire Station 12 is the second highest energy using station in the city, with an energy use intensity (EUI) of 214, which is 328% of the WA State target for fire stations. This high energy use is attributed to: 1) Older thermal envelope, 2) Inefficient forced-air apparatus bay heating system, 3) Aged and failing station house HVAC rooftop units, and 4) Mostly older light fixtures and controls.

Conduct an energy audit including thermal envelope infrared thermography. This cost estimate is for audit and tune-up, not capital project work.

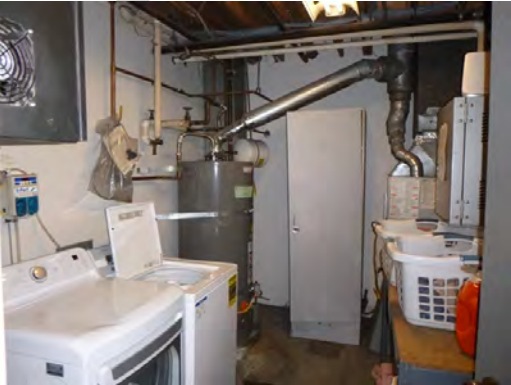
Deficient Material: Data System
Potentially mission critical data equipment located in dusty, damp, and potentially hot laundry and mechanical room.

Remedial Action:
Relocate data equipment to a proper data closet or room with cooling per city standard.

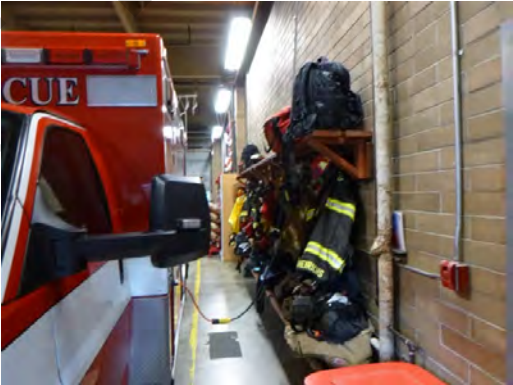
Deficient Material: Bunker gear drying
Bunker gear is dried on racks along apparatus bay walls, but the apparatus bay has no outside air ventilation.

Remedial Action:
Form a new bunker gear drying room to include both heat and ventilation to remove humidity as the gear dries.

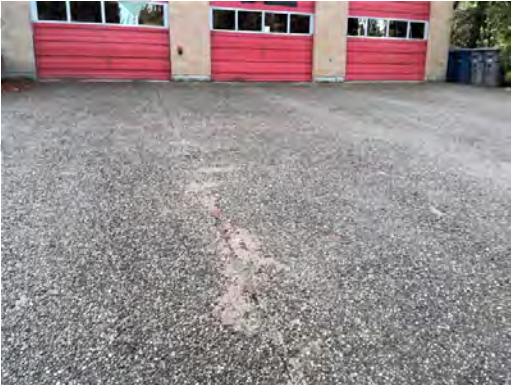
Deficient Material: Concrete Pavement

Concrete pavement drive apron at front of building and at rear of apparatus bays, exposed aggregate chipping, settlement cracking at drive curb cut. Trucks appear to have difficulty making the turn and run off into landscaping.

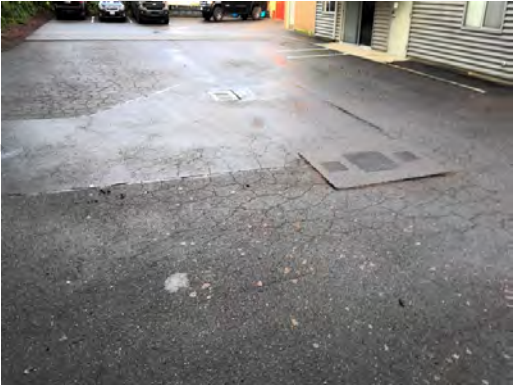
Deficient Material: Roadways
Asphalt drive degraded, concrete curbs broken.

Remedial Action:
Demo curbs. Install new curbs (consider cast-in-place vs extruded for durability). Cut and structurally fill settlement areas near vault. Grind and top coat all asphalt. Repaint parking stripes.

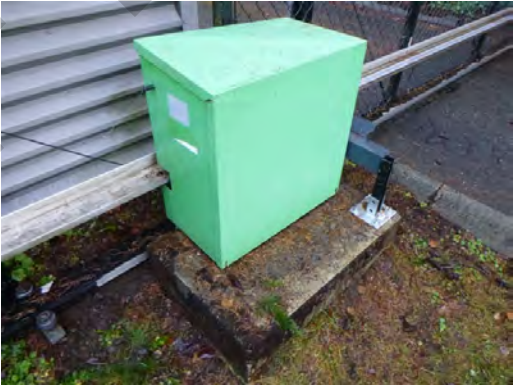
Deficient Material: Gate operator
Motorized gate operator failing with increasingly erratic control behavior.

Remedial Action:
Replace gate motor operator.

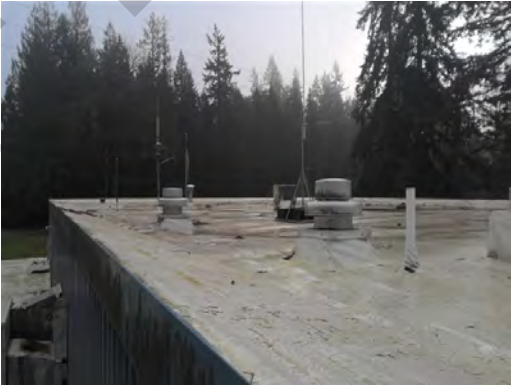
Deficient Material: Wood Decking

Past water damage concerns and soft springy deck. Plywood on wood joists at firehouse addition with unfaced batt insulation on underside of deck (no vapor barrier, unclear how airspace provided, and no evidence of airspace ventilation provided). Roof deck has elevation differences and angled edges; some places are up to 3/4-inch difference. Deck is not smooth or flush. No fall restraint. No fixed access transfer to high apparatus bay roof. No seismic upgrade has occurred.

Install fall restraint and access system. With diaphragm repairs, include seismic upgrade and add plywood decking to strengthen. Add rigid insulation below roof membrane to meet or exceed energy code and move dew point to outside of roof diaphragm.

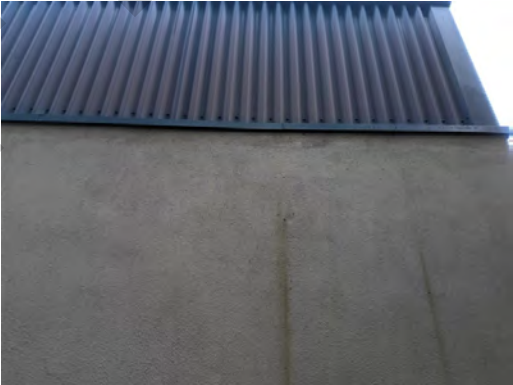
Deficient Material: Exterior Siding
EIFS needs cleaning and repainting. Metal cladding with algae growth and faded paint. Moss areas on brick.

Remedial Action:
Clean entire facade. Repaint metal with industrial exterior metal paint. Repaint EIFS with compatible paint system.

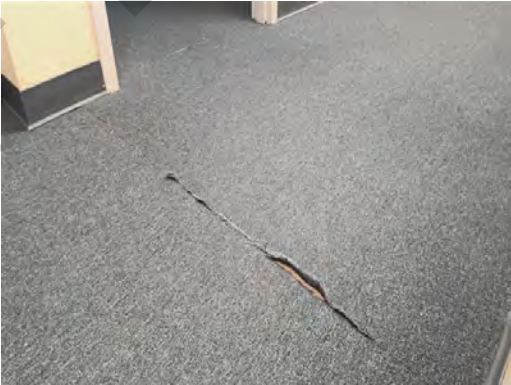
Deficient Material: Floor Finishes
Carpeting is worn and stained in most areas. Sheet vinyl in laundry area is worn and stained with seams failing.

Remedial Action:
Remove carpet and replace with new carpet. Remove vinyl flooring and replace with commercial-grade vinyl flooring.

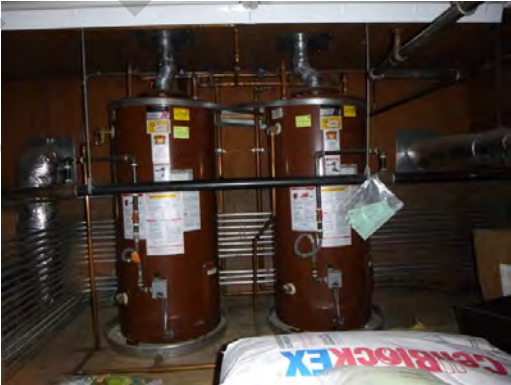
Deficient Material: Domestic Hot Water Heater
Domestic hot water heaters are approaching end of life.

Remedial Action:
Replace domestic hot water heaters with high-efficiency type upon failure.

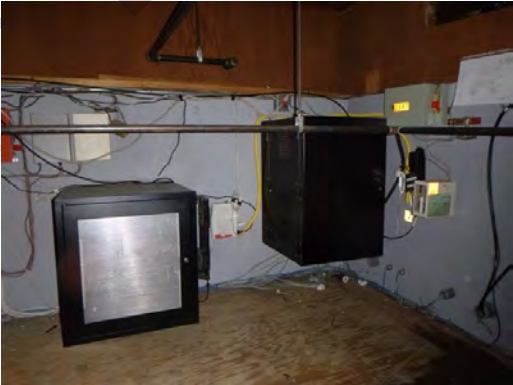
Deficient Material: Communications Cooling
Hot mezzanine location for mission-critical communication and station tone alarm locution system.

Remedial Action:
Create cooled mission-critical communications room.

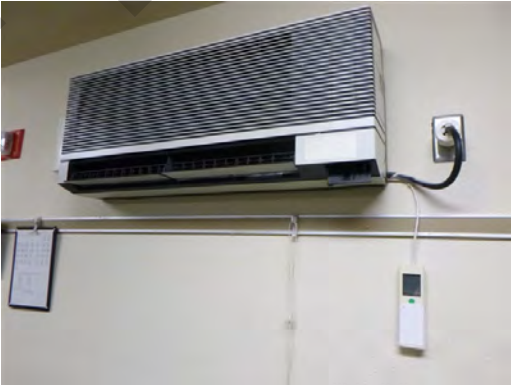
Deficient Material: Ductless Split
Aged ductless split system serving training room is at end of life and barely functional.

Remedial Action:
Replace ductless split.

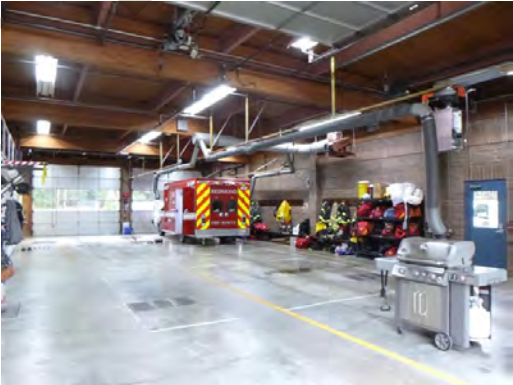
Deficient Material: Apparatus Bay Ventilation
No general ventilation system for apparatus bay.

Remedial Action:
Install general ventilation for apparatus bay.

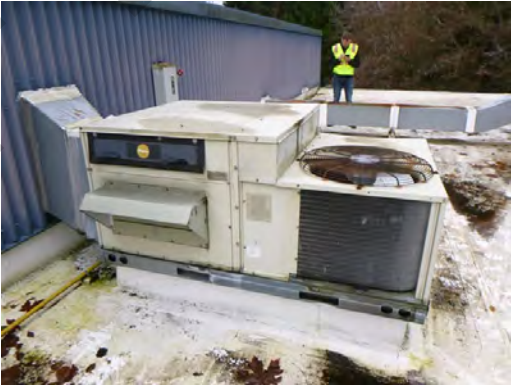
Deficient Material: **Roof Top Units**
Rooftop units are old, inefficient, and barely functioning.

Remedial Action:
Replace with modern rooftop units before complete failure.

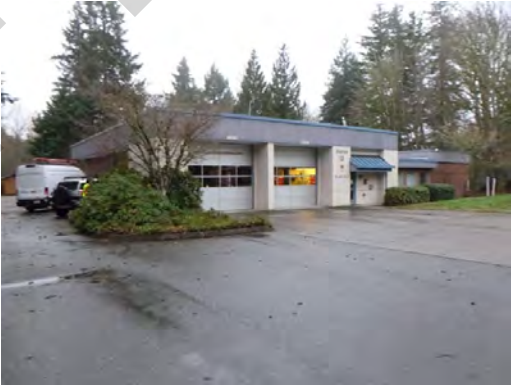
Deficient Material: Energy Efficiency
Energy use intensity (EUI) is 164, which is 252% of the WA State Clean Buildings target for fire stations.

Remedial Action:
Conduct an energy audit; this cost estimate for audit and tune-up only, not capital improvements.

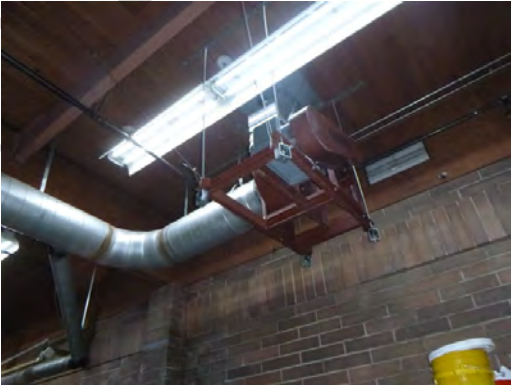
Deficient Material: Engine Exhaust
Nederman engine exhaust is aging.

Remedial Action:
Refurbish engine exhaust system prior to failure.

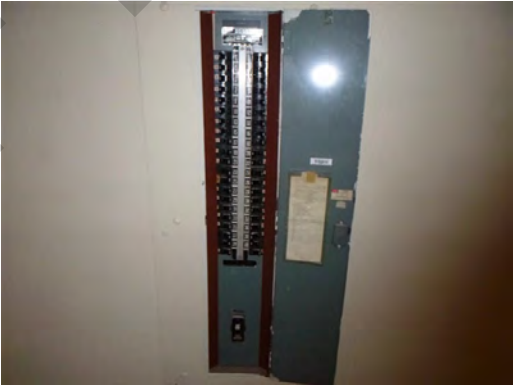
Deficient Material: Electrical Panel
Original FPE Panel B is aged and obsolete.

Remedial Action:
Replace Panel B with modern panel.

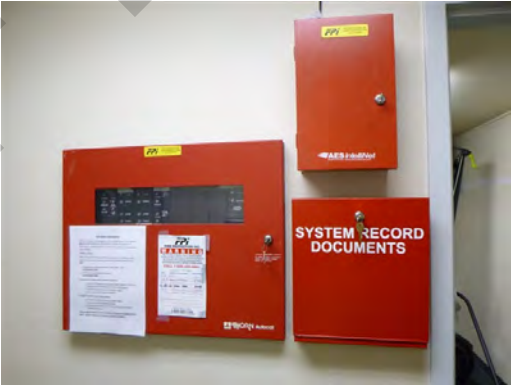
Deficient Material: Fire Alarm
Obsolete zoned fire alarm system.

Remedial Action:
Upgrade to modern addressable system.

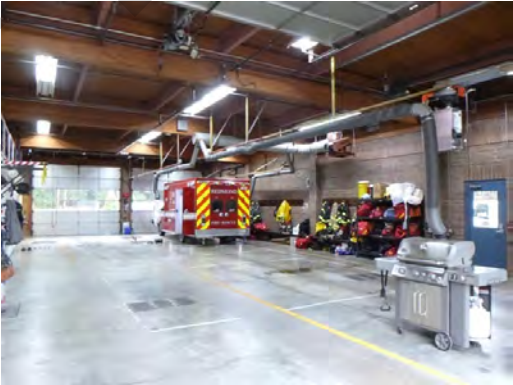
Deficient Material: Garage door openers
Three of four garage door openers are original.

Remedial Action:
Budget to replace immediately upon failure.

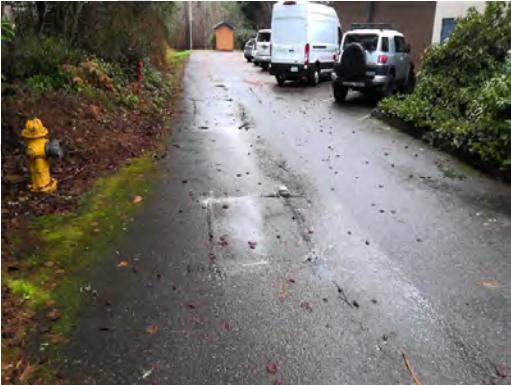
Deficient Material: Roadways
Asphalt drive pavement aging, standing waves starting, pitting, rough patches, alligating, and wear in some places.

Remedial Action:
Remove and replace existing asphalt where deteriorated near building with full depth section, suitable for fire truck loading. Seal other cracks.

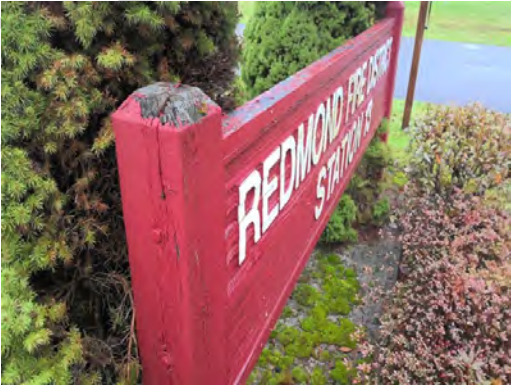
Deficient Material: Monument Sign
Monument sign with rotting wood.

Remedial Action:
Remove and replace (recommend creating city standard monument signage or use most recent monument sign as the new standard).

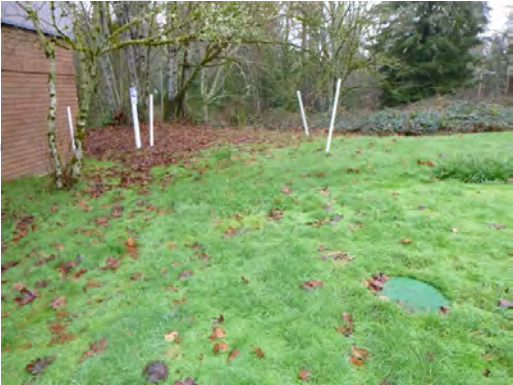
Deficient Material: Septic System
Aging septic system with design for replacement currently underway.

Remedial Action:
Renew septic system prior to failure.

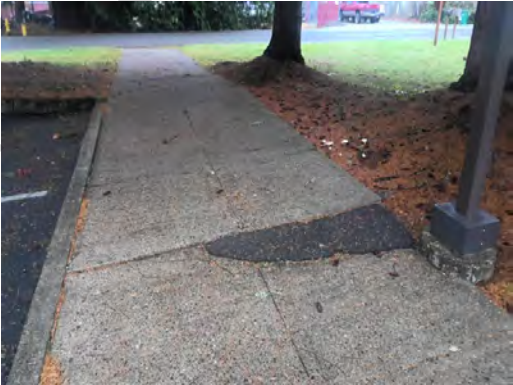
Deficient Material: Concrete Sidewalk
The sidewalk from the right-of-way has sections of root uplift and settlement of the concrete walk in numerous panels, presenting growing trip hazards.

Remedial Action:
Demo sidewalk, trim tree roots, regrade, and repour concrete walk to public right-of-way.

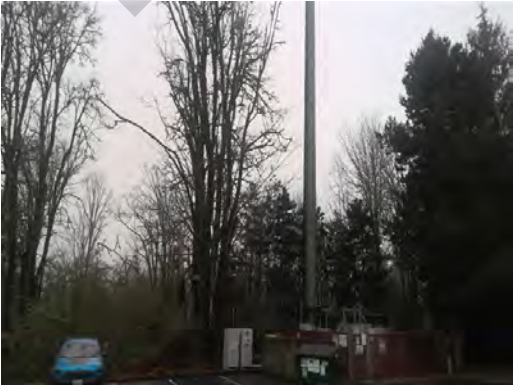
Deficient Material: Landscaping
Dead tree is a hazard to parking area and may impact adjacent cell tower. Other areas with shrubs against face of building causing premature degradation and presenting hiding spaces and pest vector pathway to building.

Remedial Action:
Remove dead tree, prune landscaping a minimum of 2 feet from face of building.

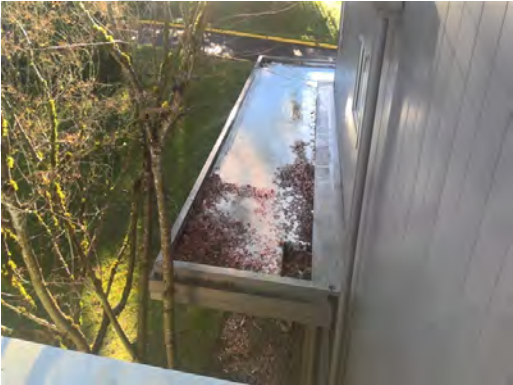
Deficient Material: **Roof Access**
No fall protection on roof or canopies for safe maintenance and no fixed ladder access to high roof.

Remedial Action:
Install fall protection for maintenance. Install permanent ladder to access high roof from lower roof (or cut in door/hatch from hose tower onto high roof).

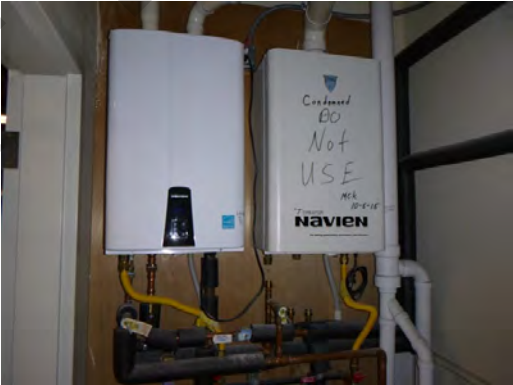
Deficient Material: Domestic Hot Water Heaters
One of the two tankless gas-fired domestic hot water heaters is failed.

Remedial Action:
Replace failed water heater.

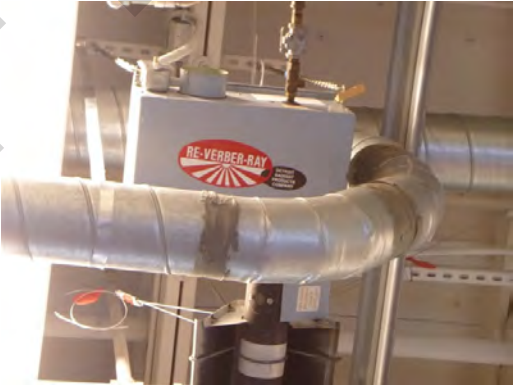
Deficient Material: Radiant heaters
1996 gas-fired infrared heaters for apparatus bays approaching end of life, with apparent excessive run-time due to ventilation issues in apparatus bay.

Remedial Action:
Budget to replace upon failure or complete obsolesce (unable to obtain parts). Ideally, correct apparatus bay ventilation issue (no engineered make-up air system) prior to replacing heaters.

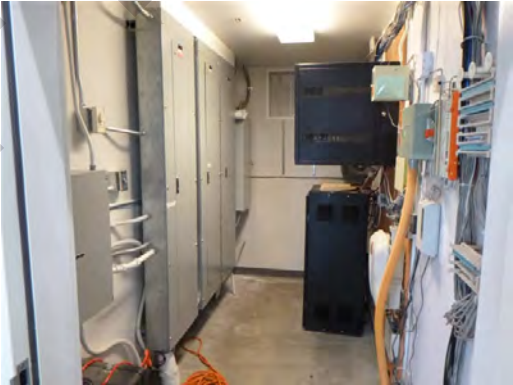
Deficient Material: Communications Cooling
No dedicated cooling for the main electrical and telecom room.

Remedial Action:
Install 1-ton dedicated ductless split-Dx cooling system for the telecom room, leaving the existing transfer and exhaust air ventilation system in place as back-up.

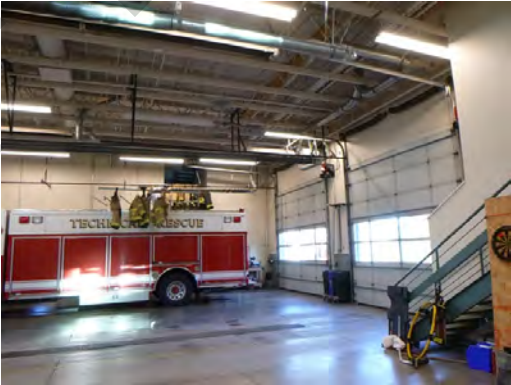
Deficient Material: Apparatus bay ventilation

Apparatus bay exhaust with failed make-up air system. Station staff leave the hose tower door open to the apparatus bay to allow outside air into the apparatus bay via the hose tower high exhaust louver, which is failed open. This workaround appears to continually allow cold air into the apparatus bay, in turn driving excessive infrared heater operation.

Repair both apparatus bay make-up and hose tower relief air louver motor operators and associated controls.

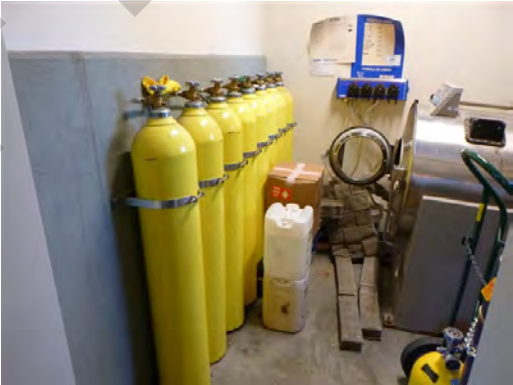
Deficient Material: HVAC
No HVAC service to several shop and utility spaces.

Remedial Action:
Provide HVAC service to shop and utility spaces, including small unit heaters and exhaust fans.

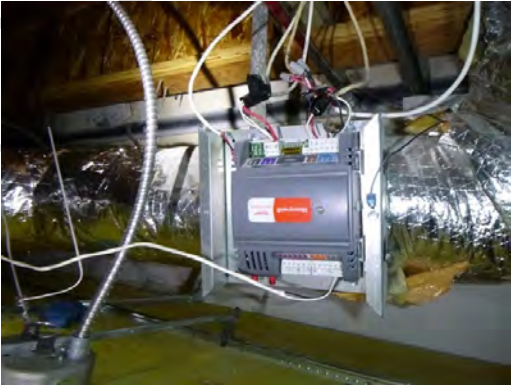
Deficient Material: Commissioning
All four station house rooftop units were replaced in 2021 and duct heaters added to the dormitory system in 2022, with reported safety issues, and unclear programming and safety.

Remedial Action:
Complete independent third-party commissioning of the four new rooftop units, including control system programming, the dormitory variable volume and temperature system, and the new electric duct heaters.

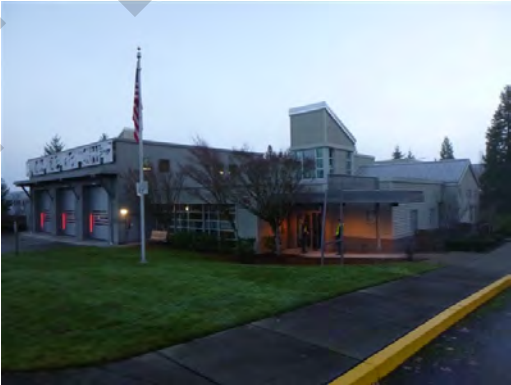
Deficient Material: Energy use
High energy use, which suggests both issues to resolve and opportunities to improve.

Remedial Action:
Conduct an energy audit, including infrared thermography of the thermal envelope and implement corrective action to reduce energy use.

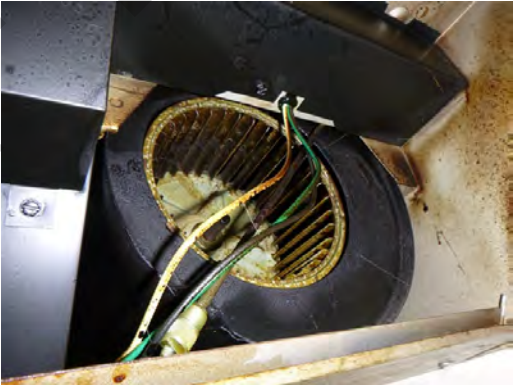
Deficient Material: Grease hood
Significant grease build-up on residential-grade range hoods, increasing risk of kitchen fire.

Remedial Action:
If grease cooking is to continue, replace one range hood with a Type 1 grease hood and associated make-up air and fire suppression.

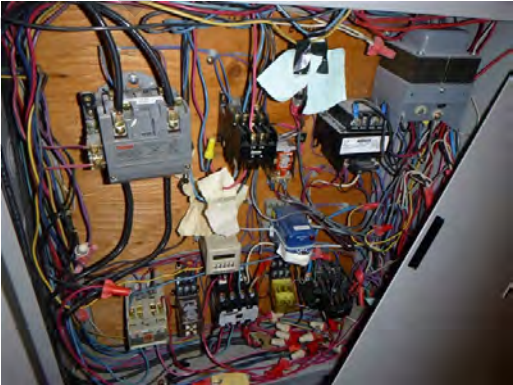
Deficient Material: Location
Aged and poorly wired locution system.

Remedial Action:
Renew.

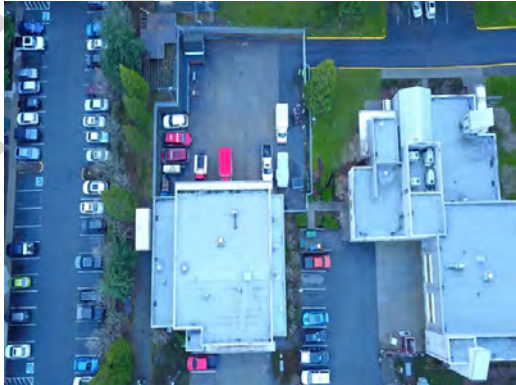
Deficient Material: Fall Protection
There is no fall protection on the roof to facilitate safe maintenance.

Remedial Action:
Install fall protection system. (See also System B3020 - Roof Openings opportunity to provide roof access.)

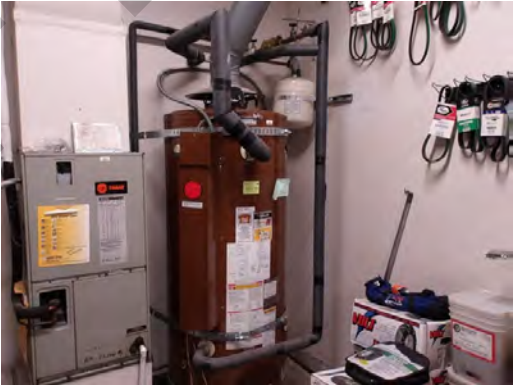
Deficient Material: Domestic Hot Water Heater
Original standard-efficiency (80%) hot water heater nearing end of life.

Remedial Action:
Budget to replace upon failure with modern high-efficiency type.

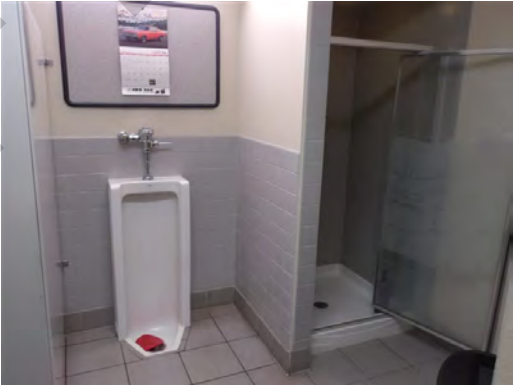
Deficient Material: Water piping
The waste piping is aged and corroding, with need to treat piping regularly to keep flowing.

Remedial Action:
Clean, test, inspect. reconfigure, and selectively renew waste piping.

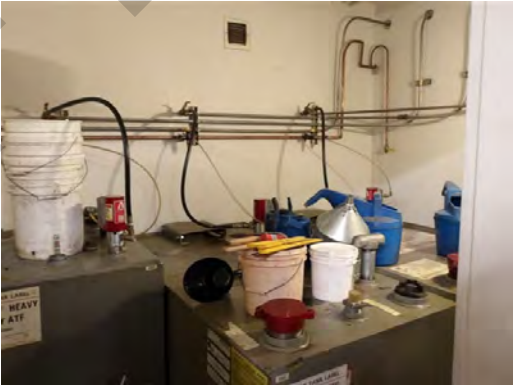
Deficient Material: Shop Fluids Room

Shop fluids room is minimally ventilated with unclear hazardous occupancy (H-occupancy) rating. The combustible fluid storage tanks are vented direct to the space and emergency venting is missing from the two larger engine oil tanks. The transmission fluid tank includes emergency venting devices, but no vent to roof. While the light fixtures are explosion resistant, the light switches are not, and there is a non-rated motor disconnect in the space, plus vehicle battery operated pump is present on one of portable pump packages in this room. While fire sprinkler is present, there is no smoke or heat detection. The fluids room walls appear to be of non-rated construction, and there is no apparent fluids spill containment other than the tanks themselves.

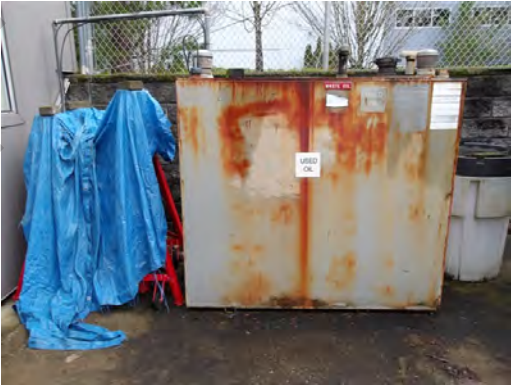
Deficient Material: Waste Oil Tank
Waste oil tank is rusted and corroded with standing water on top.

Remedial Action:
Schedule replacement including protective canopy.

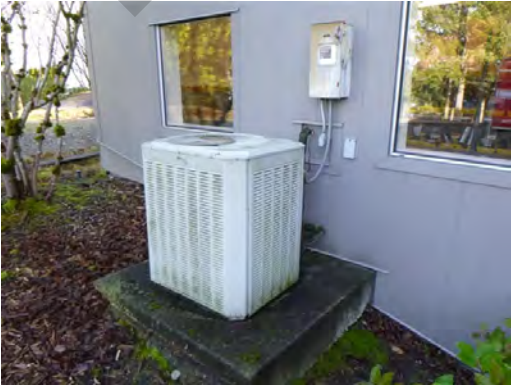
Deficient Material: Condensing Unit
Condensing unit reportedly failed.

Remedial Action:
Replace condensing unit.

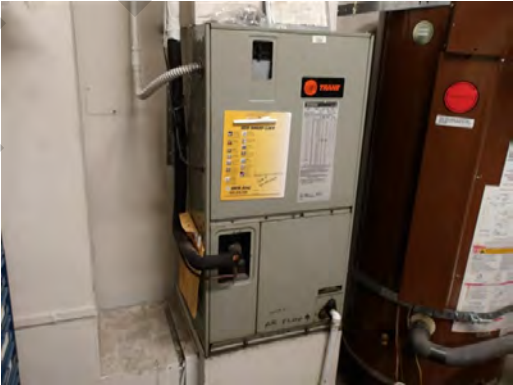
Deficient Material: Heat pump furnace
The office and break room heat pump furnace appears failed, with no heat delivered and portable heaters in use.

Remedial Action:
Replace the failed heat pump furnace.

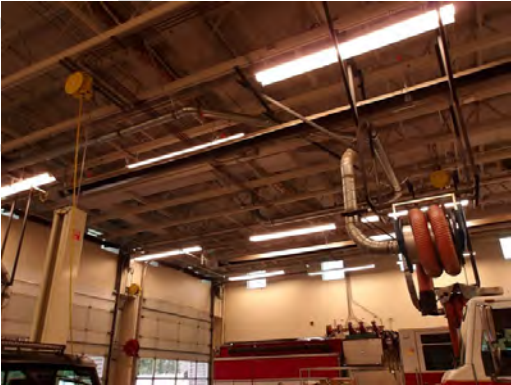
Deficient Material: Vehicle engine exhaust
Aged and rusting rooftop vehicle engine exhaust fan.

Remedial Action:
Replace exhaust fan promptly upon failure.

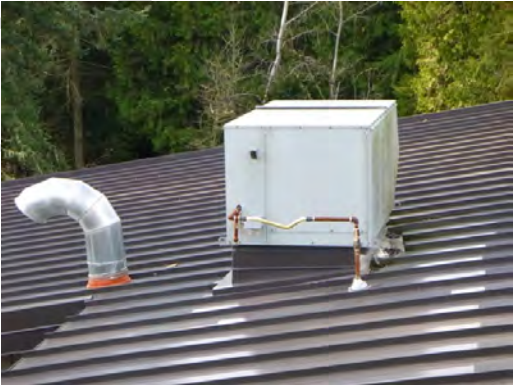
Deficient Material: Make-up Air Units
Unclear make-up air unit operability, with control panels blank.

Remedial Action:
Fully service, test, and restore operability to the three make-up air units.

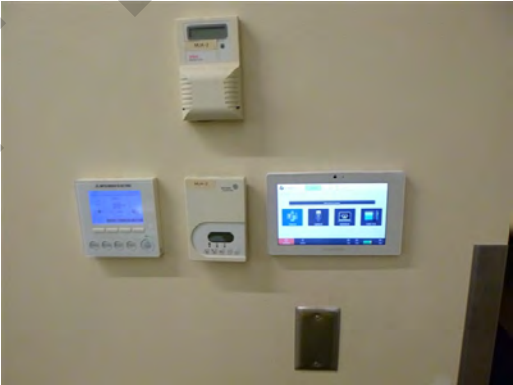
Deficient Material: DDC
Proprietary variable refrigerant flow and multiple standalone programmable controls with unclear and suboptimal programming, collectively with unclear ventilation and moderately high energy use.

Remedial Action:
Install fully networked controls with remote access by facilities to proactively manage the building.

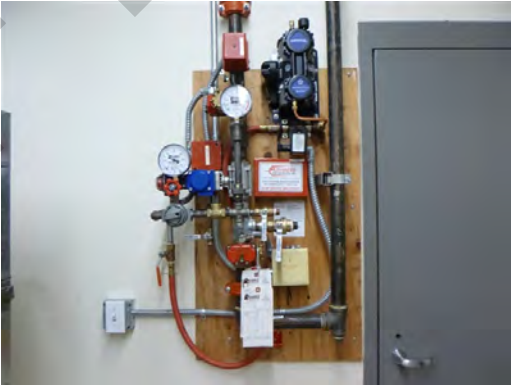
Deficient Material: Dry-pipe Sprinkler
Failed hose tower proprietary dry-pipe fire sprinkler system.

Remedial Action:
Replace with non-proprietary system and restore protection ASAP.

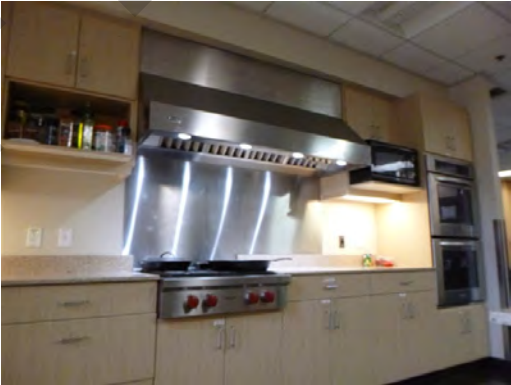
Deficient Material: Grease Hood
Grease dripping at kitchen range grease hood, without fire suppression system.

Remedial Action:
Install kitchen grease hood fire suppression system.

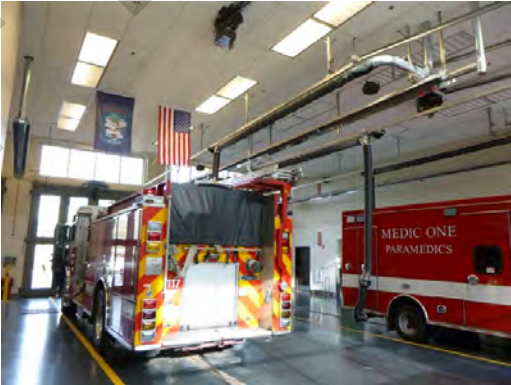
Deficient Material: Fast-acting door
Fast-acting door mechanical single-point-of-failure pin.

Remedial Action:
Improve door mechanism.

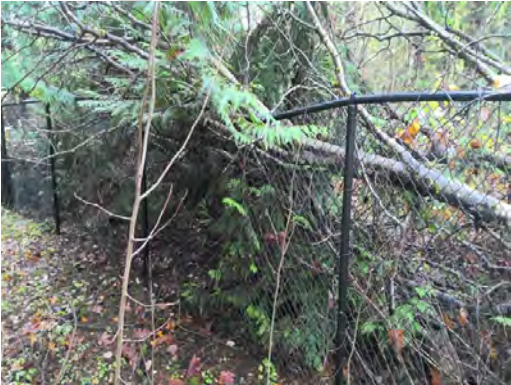
Deficient Material: Chain Link Fencing
Fallen trees have damaged perimeter powder-coated chain link fencing in numerous locations.

Remedial Action:
Remove limbs and vegetation. Repair damaged sections.

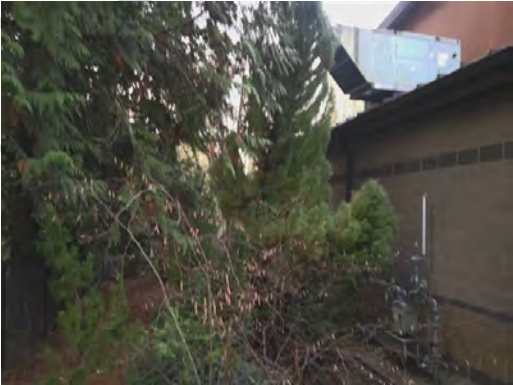
Deficient Material: Landscaping

Trees and landscape encroaching building and causing maintenance issues and degradation to building, also providing pest vector into building.

Remove adjacent encroaching tree, limb away other trees, prune back other landscape away from facade. Recommend retaining a minimum of 24 inches clear.

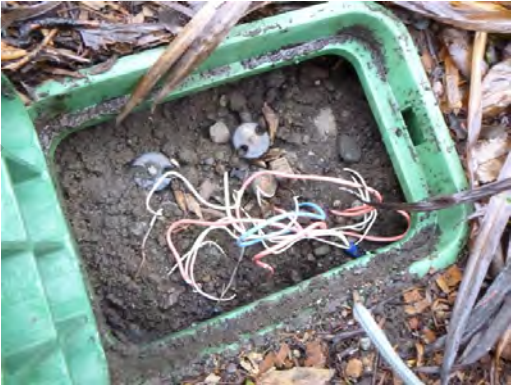
Deficient Material: Irrigation
Failed front permanent irrigation system resulting in dead and dying landscape plantings.

Remedial Action:
Renew front irrigation system.

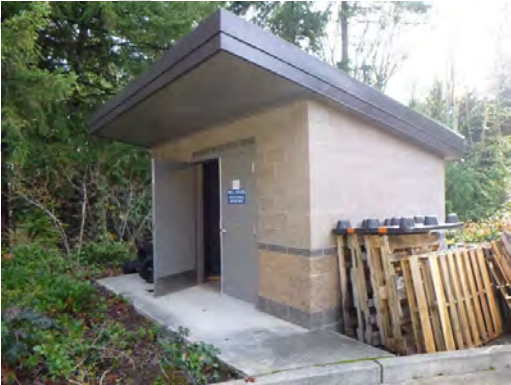
Deficient Material: Well water system
Failed irrigation well-water system.

Remedial Action:
Service and renew well-water system.

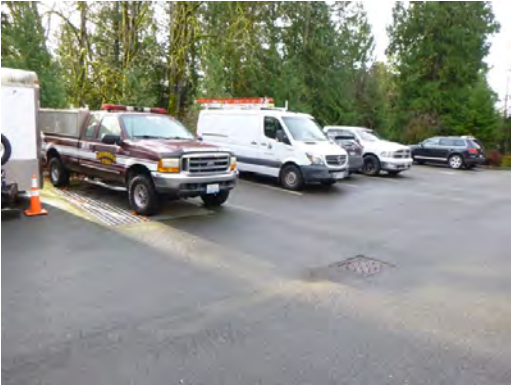
Deficient Material: Detention Vault
Reportedly, the storm water detention vault has never been serviced. From a limited view, it appears organic matter is building up in the bottom of the vault.

Remedial Action:
Clean and service detention vault.

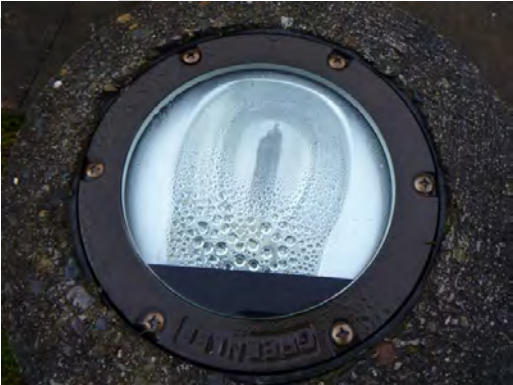
Deficient Material: In-ground Fixtures
Multiple in-ground up-light fixtures have leaking seals with water intrusion; several have failed lamps.

Remedial Action:
Renew in-ground fixtures including waterproof seals and modern LED lamps.

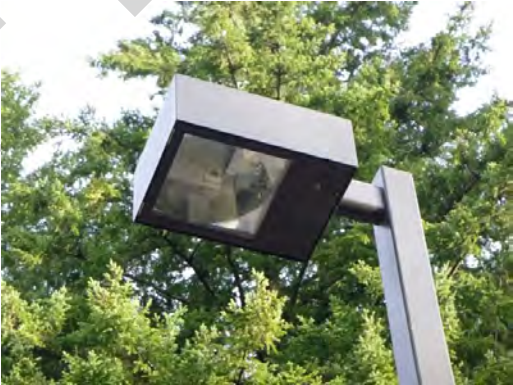
Deficient Material: Pole Lighting
Reportedly, pole lights are incorrectly wired, requiring special transformers. Aging HID lamps are still installed at some fixtures.

Remedial Action:
Correctly wire all pole light fixtures and upgrade all to hardwired LED.

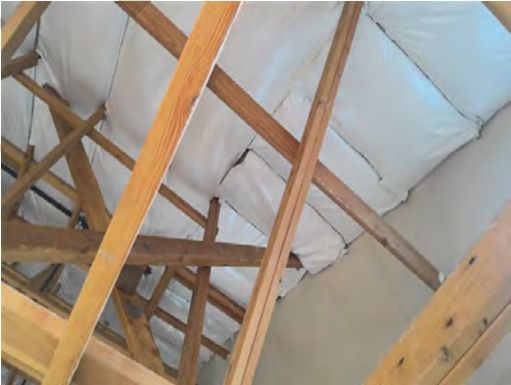
Deficient Material: Vapor Barrier
Insulation vapor barrier seams only face stapled and not fully sealed, areas with significant gaps and sags.

Remedial Action:
Seal all seams and penetrations of vapor barrier with vapor barrier tape to prevent latent interior moisture from reaching insulation and condensing on underside of wood sheathing. Inspect conditions in attic space above ceilings and conduct the same sealing.

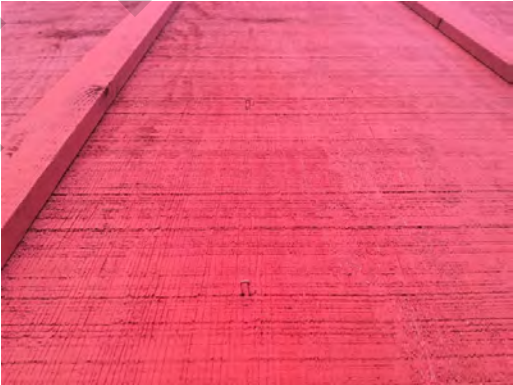
Deficient Material: Wood Siding
Wood lap siding improperly attached with roofing face staples, staples are popping out and panels are loose.

Remedial Action:
Screw panels into sheathing, paint heads to match siding.

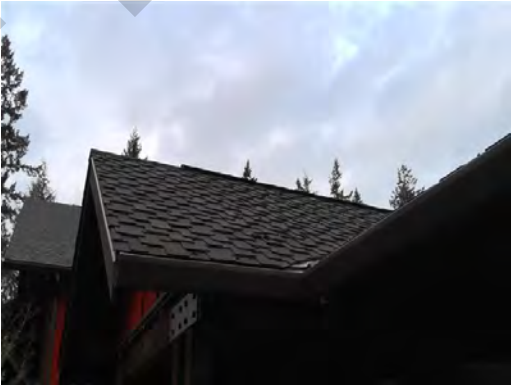
Deficient Material: Asphalt Shingles
Composite architectural asphalt shingle roofing nearing end of life. Bare tar exposed and loose granules. No fall restraint except for untested and non-certified D-rings on high-bay peak. No roof access provided.

Remedial Action:
Remove roofing, install certified fall restraint system and new roofing, including new ice and water shield flashings if not present or of expected quality, and synthetic subroofing. Investigate opportunity to provide permanent roof access.

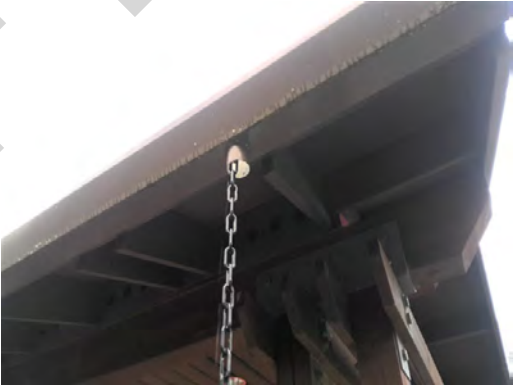
Deficient Material: Rain Chains
Gutter seams require constant resealing. Undersized drain holes cause backups with debris. Plastic rain chains reported as causing recurring maintenance issues.

Remedial Action:
With a reroof, remove gutter opening and plastic chains, provide new gutters, eliminate rain chains, and provide downspouts to manage storm runoff to storm sewer.

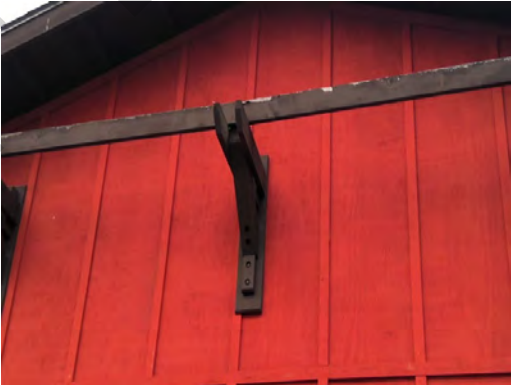
Deficient Material: Projections
Ornamental wood knee/kick outrigger braces not flashed on top and suspect rot based on detail and exposure.

Remedial Action:
Inspect and repair or replace. Add metal top cap flashing.

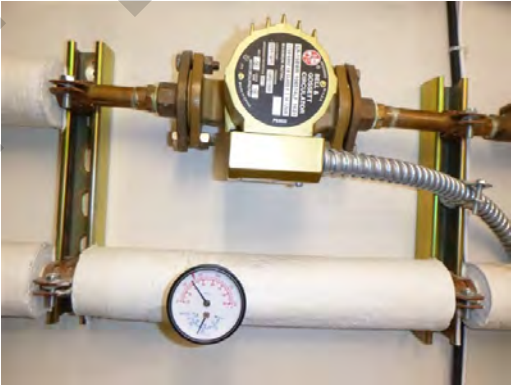
Deficient Material: Hot water piping
Hot water pipe leaks due to unusually high system temperature and light-duty residential Type M copper tubing.

Remedial Action:
Replace light-duty copper tubing with medium-duty copper and/or PEX tubing and reduce system hot water temperature to 120 to 130 deg F.

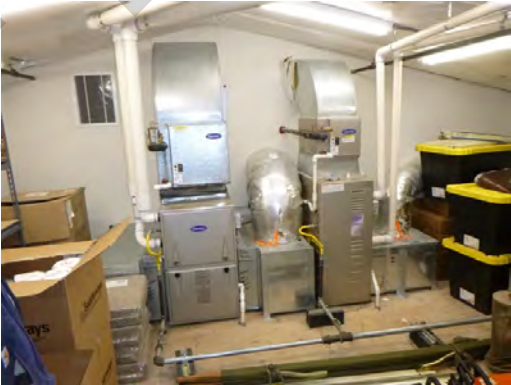
Deficient Material: **Furnaces**
2005 police precinct furnace F-1 approaching end of life with failing controls.

Remedial Action:
Budget to replace police precinct furnace F-1 upon complete failure.

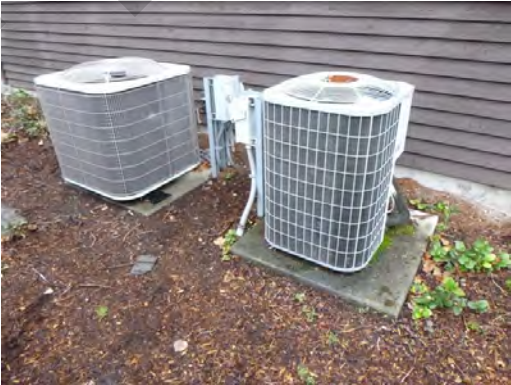
Deficient Material: Condensing Unit (CU)
Police precinct air conditioning outside condensing unit has failed and is being replaced. Station house condensing unit is aged and could fail at any time.

Remedial Action:
Complete replacement of police precinct condensing unit, and budget to replace the station house condensing unit upon failure.
