City of Redmond

Agenda Study Session

Facilities Condition Assessment Update

Facility Condition Assessment

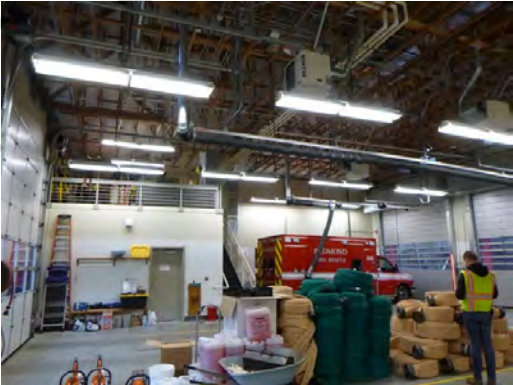
Deficient Material: Unit Heaters
Apparatus bay gas-fired unit heaters damaged by uncontrolled construction dust from 2021 tenant improvement work.

Remedial Action:
Fully service all three unit heaters.

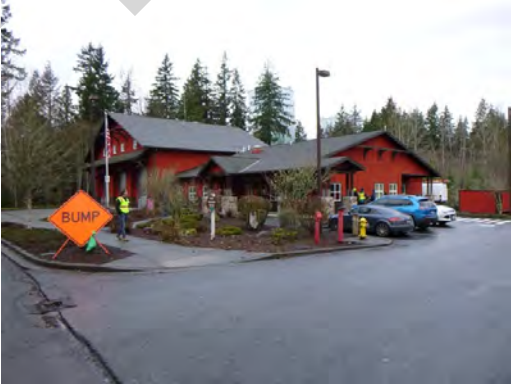
Deficient Material: **Energy Efficiency**
High energy use for a relatively new fire station, which includes 2021 improvements, increasing the city's operating and maintenance cost for this station. Some suspects are thermal envelope, gas-fired unit heaters instead of radiant for apparatus bays, dysfunctional interlock between apparatus and vehicle engine exhaust system, and marginal station house HVAC system zoning.

Remedial Action:
Conduct an energy audit, including thermal envelope infrared thermography and implement energy efficiency and conservation measures to reduce energy use.

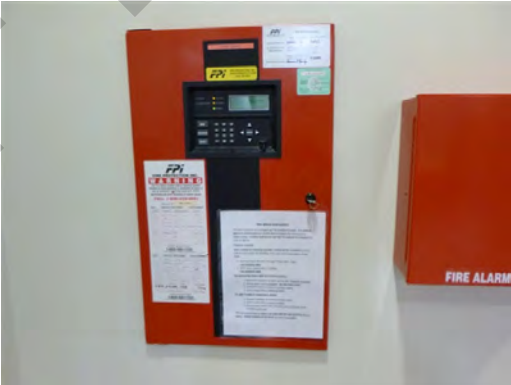
Deficient Material: Fire alarm control panel
Aging fire alarm control panel, with obsolete landline alarm call.

Remedial Action:
Budget to replace upon failure or obsolescence and upgrade to modern wireless alarm transmission.

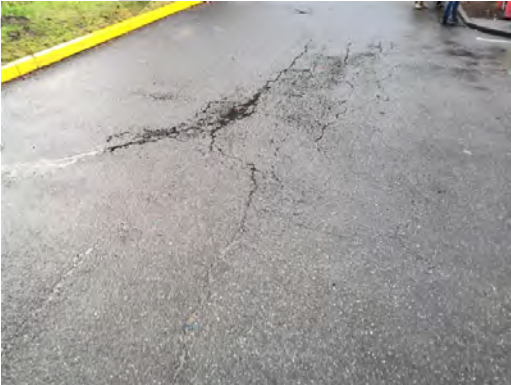
Deficient Material: Asphalt Paving
Asphalt access drive alligating and cracking.

Remedial Action:
Clean and seal cracks, continue monitoring.

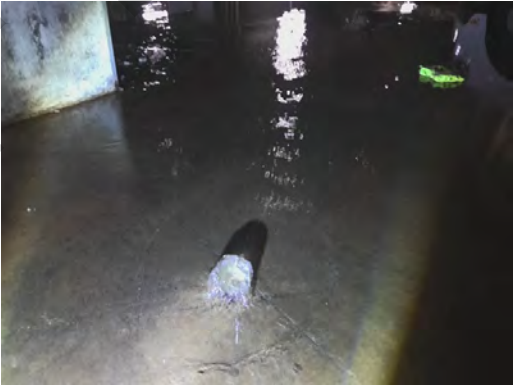
Deficient Material: Sub-Grade Waterproofing

Reseal slab holes and crack leaks with a pressure injection concrete waterproof sealer like an acrylate injection waterstop resin as demolition of sub-grade and all new construction with new waterproof sub-grade systems would be cost prohibitive and disruptive.

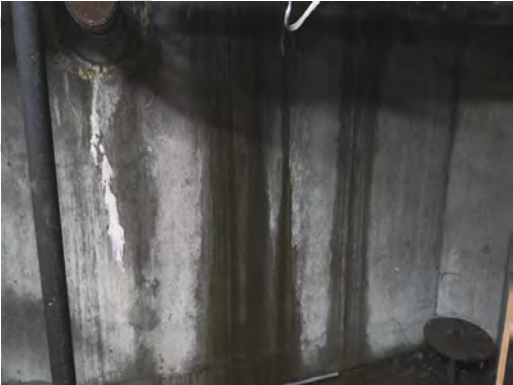
Deficient Material: **Waterproofing**
West end water intrusion through wall. Efflorescence and water intrusion.

Remedial Action:
Excavate and install waterproofing with drainage mat/capillary break, drained to footing drain.
Clean and paint interiors.

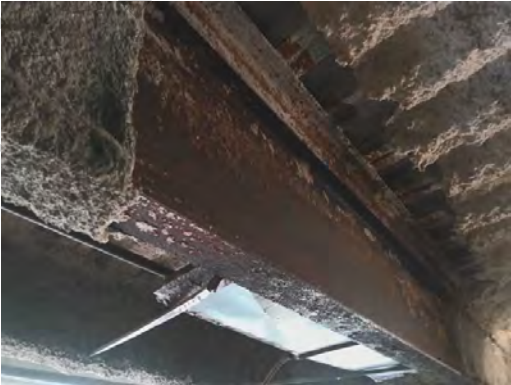
Deficient Material: Steel Frame
Roof structure below ground covered roof areas is significantly damaged with moisture intrusion, causing corrosion and destruction of fire protection coating.

Remedial Action:
Repair intrusion issues per B3010 Roof Coverings, strip fire protection from area to extent of damage and corrosion, sandblast corroded steel, repair and reinforce corroded steel as necessary, prime and coat steel with industrial exterior steel coating system to thwart future exposure corrosion, reapply fire protection.

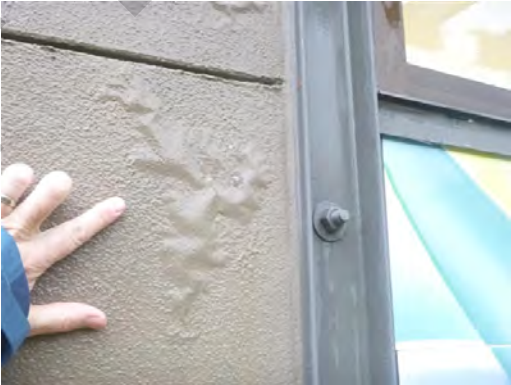
Deficient Material: Cement Plaster
Moisture intrusion is causing cement plaster paint bubbling.

Remedial Action:
Investigate moisture intrusion sources (likely panel joints and flashing interfaces). Strip paint. Adjust flashings and panel joint sealants. Alternatively, recommend considering installing alternative prefinished metal cladding in lieu of stucco plaster.

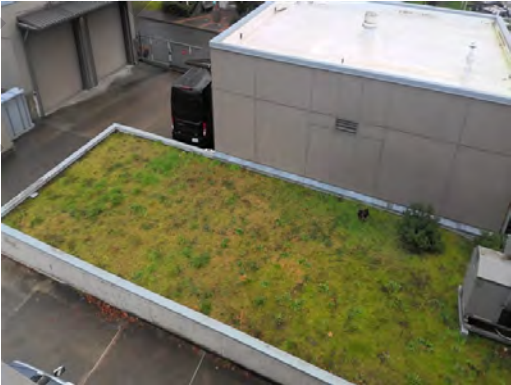
Deficient Material: Below Grade Roof Membrane
Torch down asphalt roof. At grade roof, plaza and green roof leaking over the garage and gun range. Leaks are causing significant corrosion, blistering fire coating, and damaging structure. There may be no membrane below plaza concrete.

Remedial Action:
Demo landscape. Install new waterproof membrane and capillary break with drains and filter fabric. Construct new green roof above. At plaza concrete, sandblast, prep, and install waterproof traffic coating integrated with refreshed area drains.

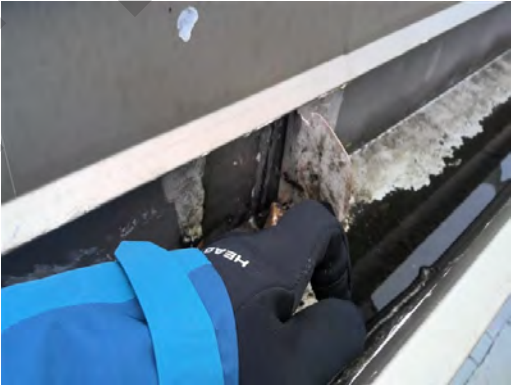
Deficient Material: Metal Gutters and Roof
Ongoing leaking from gutter lengths and poor joint design. Metal-to-metal seams with joint sealant on long runs fail every summer with heat expansion and contraction movement.

Remedial Action:
Remove and replace gutters and gutter support with proper application and joint detailing to accommodate thermal movement.

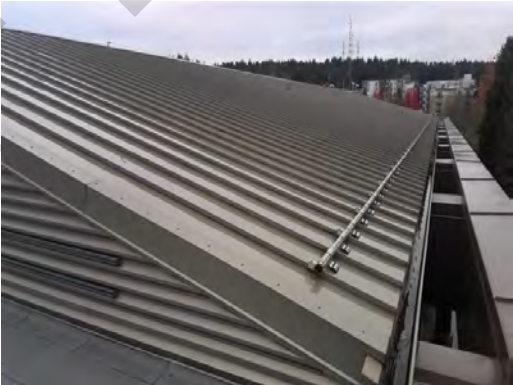
Deficient Material: Roof Access

Gutters on sloped roofs are inaccessible for maintenance. While there is a fall restraint cable near the ridge of the steep and slick standing seam roof, it is neither reasonably nor readily accessible. As a result, gutters cannot be safely or regularly cleaned and now have significant plant growth. Recent renovations removed parapet fall protection pathway to access scuppers over the north roof section over the training room, making it unsafe to access for maintenance and drain cleaning.

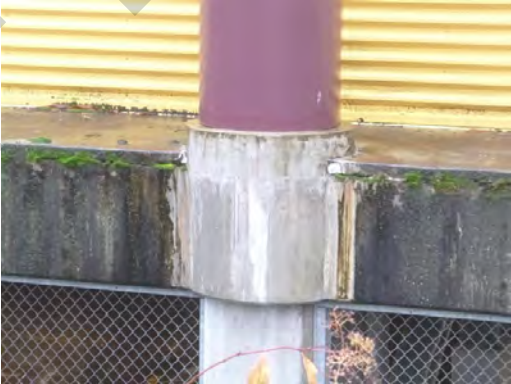
Deficient Material: Concrete Deck
Concrete topping slab sill at south projection cracked and leaking, degrading systems below.

Remedial Action:
Demo topping slab, install membrane and flashing, pour new with slope to drain away, top with waterproof traffic coating.

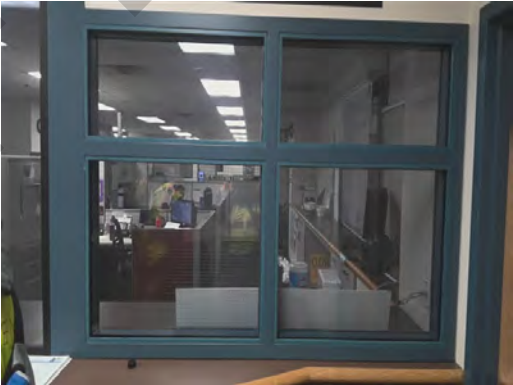
Deficient Material: Interior Windows
Interior relite windows with wire glass (now considered a safety hazard). Does not appear to be ballistic glazing at public-facing windows.

Remedial Action:
Remove and replace wire glass with properly rated laminated safety glass.

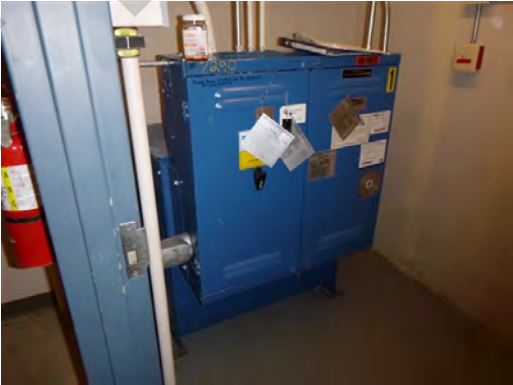
Deficient Material: Elevator
Aging elevators nearing end of useful life, with aged controls and mechanisms, accelerated by basement flooding water intrusion into elevator hoistway pits.

Remedial Action:
Renew elevators, including addition of pumped elevator sump pumps.

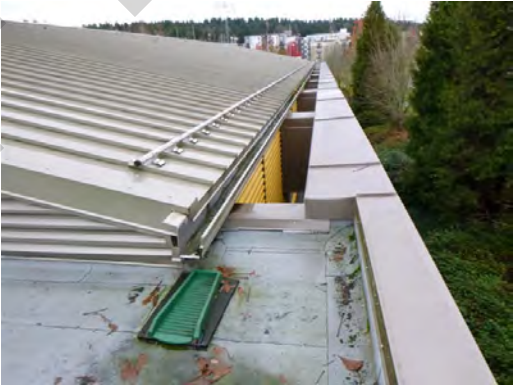
Deficient Material: Gutter Access
Dangerous gutter access to clean south gutter, hence plants are growing in this gutter, reducing its function and shortening gutter life.

Remedial Action:
Provide engineered access to the south gutter.

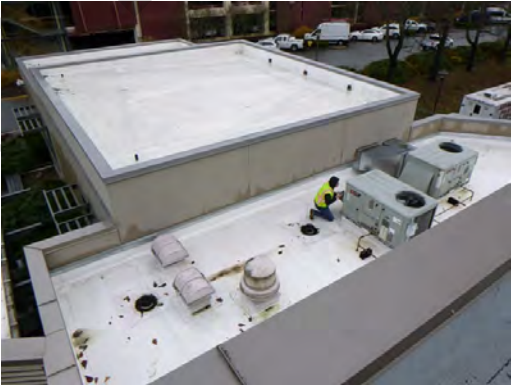
Deficient Material: Roof Access
No roof access to mid-level west end roofs and 2006 addition roofs.

Remedial Action:
Provide permanent roof access to all areas with equipment requiring regular maintenance.

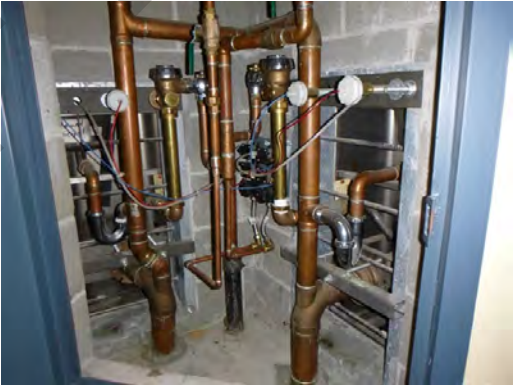
Deficient Material: Piping Insulation
Damaged or missing domestic hot water pipe insulation in some areas, wasting energy and water, as hot water wait times are higher to some fixtures.

Remedial Action:
Repair or replace pipe insulation.

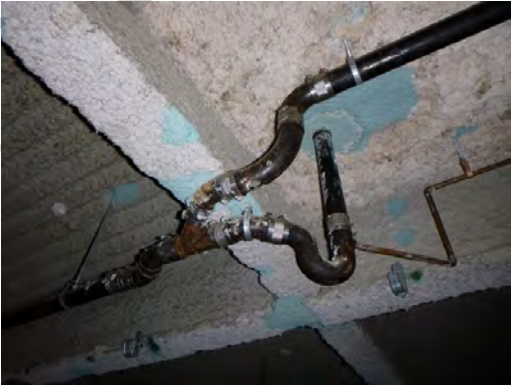
Deficient Material: Drain, Waste, and Vent Piping
Drain, waste, and vent (DW&V) piping is low-sloped and deteriorating throughout, but especially at parking garage level.

Remedial Action:
Clean, inspect, test, and repair or replace DW&V piping; increase slope to improve drainage where possible.

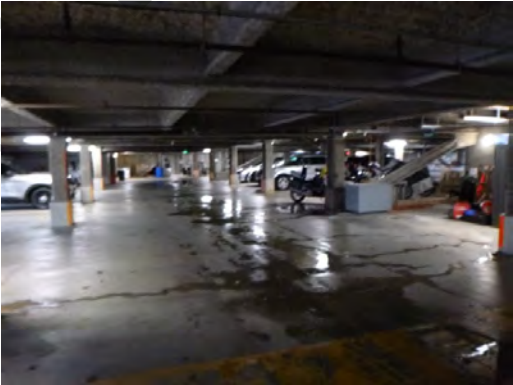
Deficient Material: **Piping Insulation**
No drain, waste, and vent piping insulation and heat trace system in the unconditioned parking garage.

Remedial Action:
Heat trace and insulate parking garage exposed waste piping.

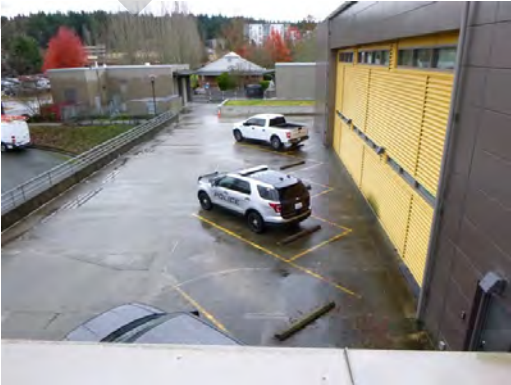
Deficient Material: Floor Drains
Dumpster storage area missing floor drains to sewer; currently drains to storm.

Remedial Action:
Provide floor drains to sewer.

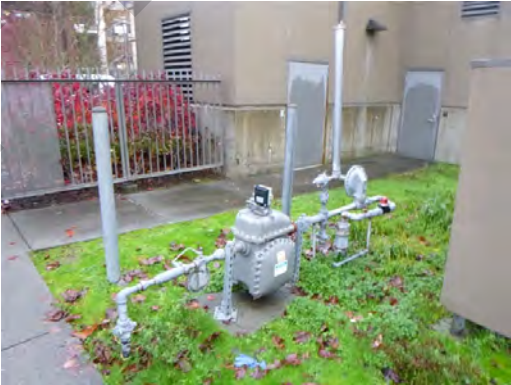
Deficient Material: Gas Service
Insufficient gas meter capacity subsequent to LED lighting upgrade, increasing load on boiler plant.

Remedial Action:
Upgrade to modern 3,000 cfh rotary meter and increase gas line size where needed.

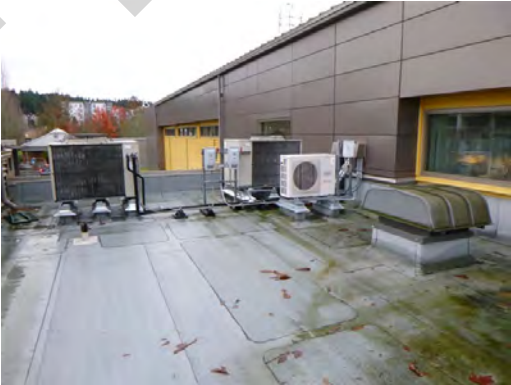
Deficient Material: Communications Cooling
The 911 data room load has significantly decreased from more efficient equipment loads inside, resulting in equipment short-cycling and failures.

Remedial Action:
Engineer and install a right-sized 911 data center cooling system.

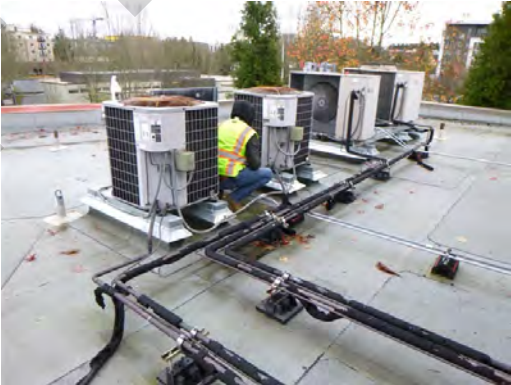
Deficient Material: Condensing Unit
Several older condensing units and inside units for mission-critical spaces, including for intermediate distribution frame and back-up to other systems (N+X).

Remedial Action:
Replace aging mission-critical space split-Dx cooling systems prior to failure.

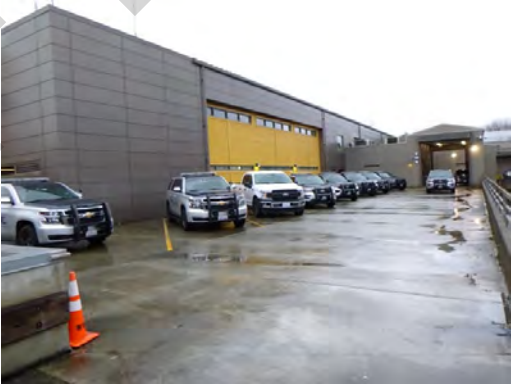
Deficient Material: Norcom 911 cooling
Newly formed Norcom 911 call center and data room do not have dedicated cooling.

Remedial Action:
Provide dedicated cooling for the new Norcom 911 center.

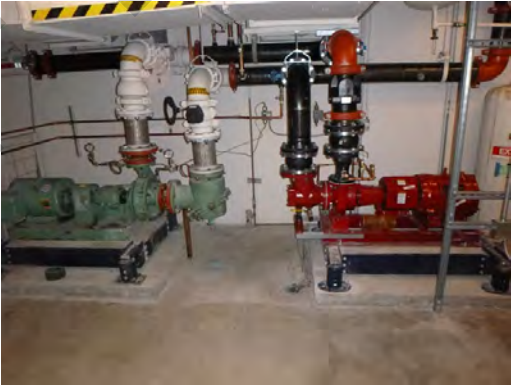
Deficient Material: Pumps
One of two condenser water pumps is original and aged.

Remedial Action:
Renew condenser water pump.

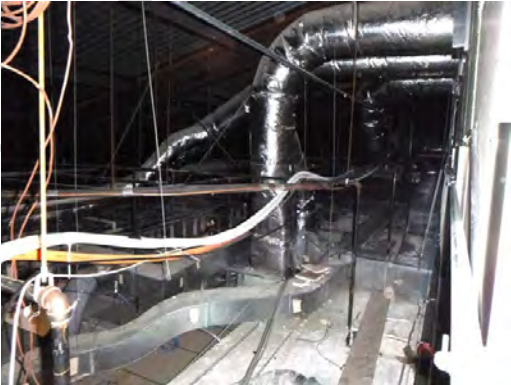
Deficient Material: Ductwork
Damaged, leaking, dirty, and unbalanced ductwork.

Remedial Action:
Clean, repair, seal, and leak test ducts. Conduct test, adjust, and balance (TAB) on entire HVAC system.

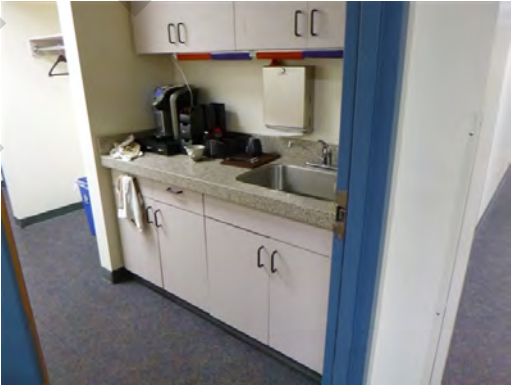
Deficient Material: Exhaust
No apparent exhaust for kitchenette, break room, and copy center.

Remedial Action:
Install exhaust per code.

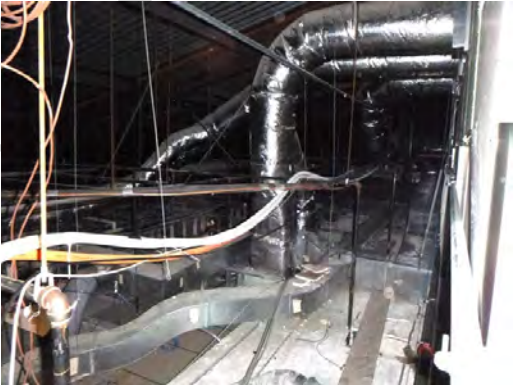
Deficient Material: Outside Air
Little or no outside air to some water-source heat pumps. Dirty, non-code-compliant outside air intake plenums.

Remedial Action:
Bring outside air plenum up to code and provide minimum outside air to all spaces per code.

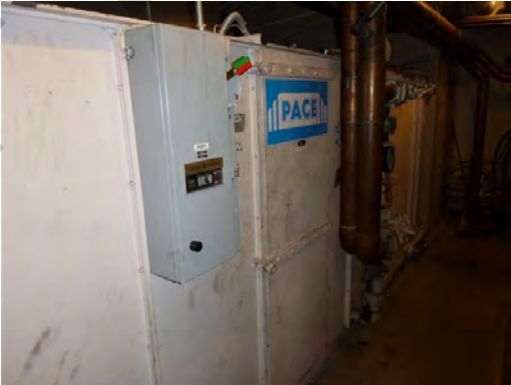
Deficient Material: Outside air pre-heat
Insufficient outside air preheat for AHU-1 (which is a 100% outside air unit), made worse by upgrade from fluorescent to LED lighting throughout, resulting in increasing too cold complaints.

Remedial Action:
Install preheat piping and controls for AHU-1.

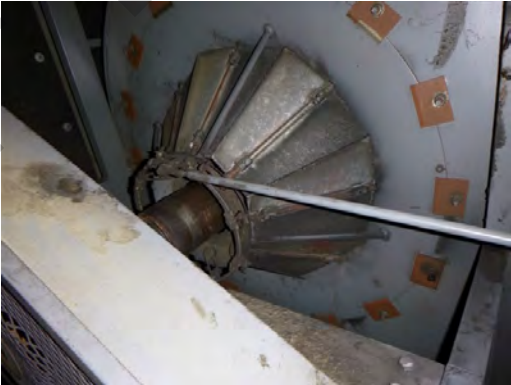
Deficient Material: Ventilation Air Balance
Obsolete inlet guide vane whole-building supply and exhaust air control, plus missing building air pressure control.

Remedial Action:
Replace AHU-1 and EF-1 inlet guide vane control with variable frequency drive control and provide active building pressure control, coordinated with other exhaust and outside air intake systems.

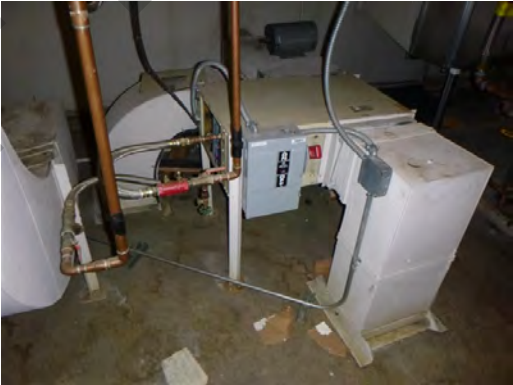
Deficient Material: Water Source Heat Pumps
Water-source heat pumps at end of life.

Remedial Action:
Schedule replacement of all water-source heat pumps not already replaced.

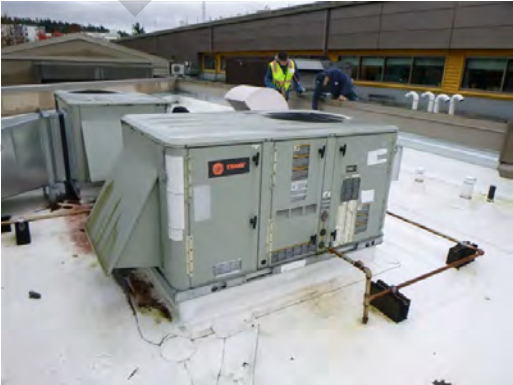
Deficient Material: Rooftop Units
Evidence storage rooftop gas-pack units approaching end of life.

Remedial Action:
Budget to replace upon failure.

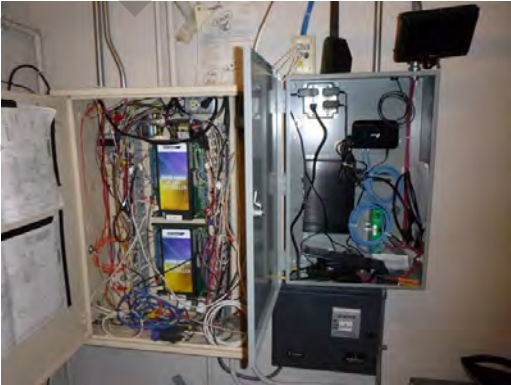
Deficient Material: Controls

Replace the control system with new fully-integrated controls per city standard.

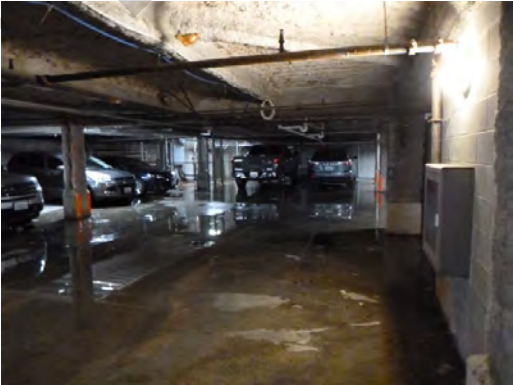
Deficient Material: Garage Exhaust
Portions of parking garage may not meet code ventilation requirements.

Remedial Action:
Install code minimum ventilation in parking garage.

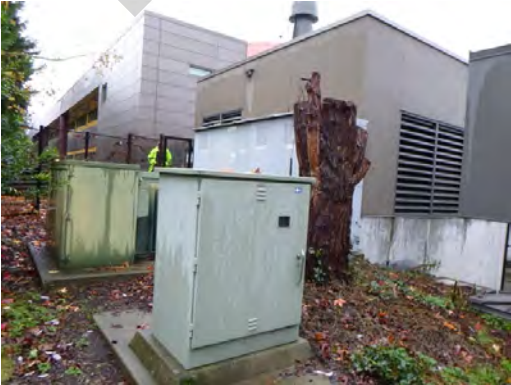
Deficient Material: Electrical Distribution

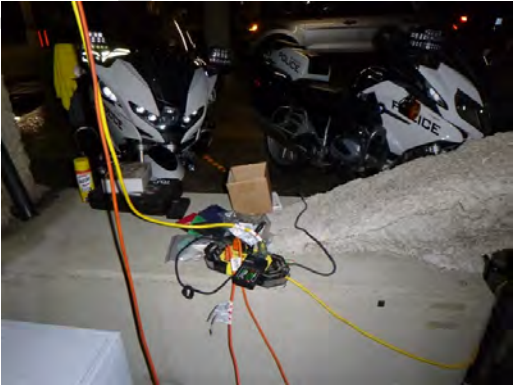
Deficient Material: **Lighting & Branch Wiring Devices**
Insufficient electrical outlets in parking garage.

Remedial Action:
Add ground fault interrupter (GFI) electrical outlets, circuits in parking garage.

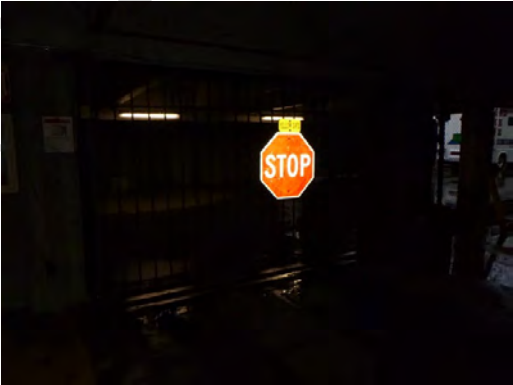
Deficient Material: **Lighting & Branch Wiring Devices**
Insufficient lighting, poor lighting level in parking garage driving lanes.

Remedial Action:
Add lighting fixtures and controls over driving lanes.

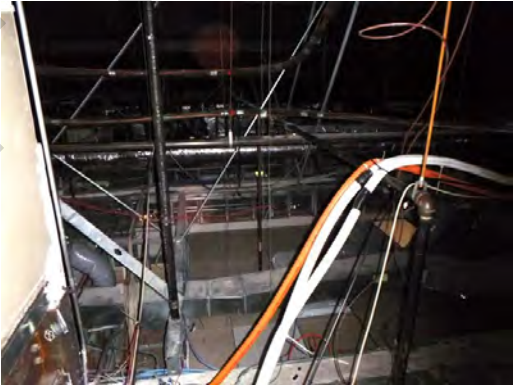
Deficient Material: Cable plant

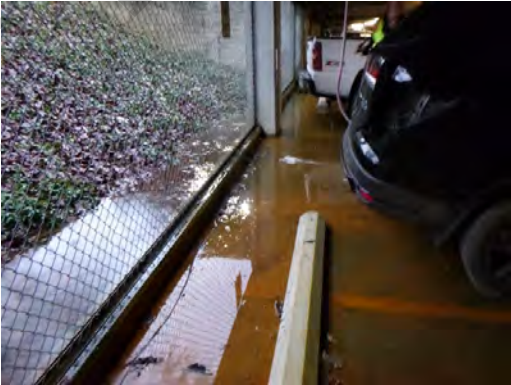
Deficient Material: Vehicle evidence storage
Crime suspects are breaking into the garage vehicle evidence storage area and stealing evidence, due to low fence and aged electronic security.

Remedial Action:
Design and construct secure vehicle evidence storage area with appropriate physical security and enhanced electronic security.

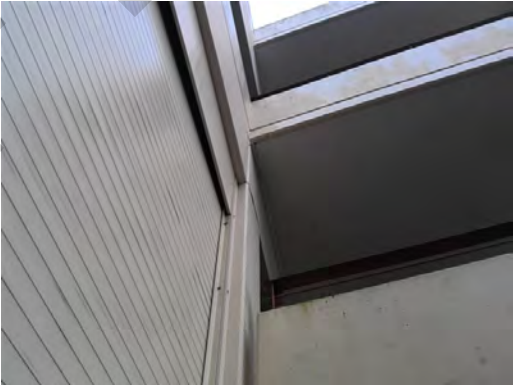
Deficient Material: Concrete Column

It appears there may have been a shift in the structure in the NW corner to the right over the overhead coiling door. Column appears out of plumb in relation to the beam and structure above with a 1/4" crack at the intersection.

Have a structural engineer evaluate the structure and provide any recommend structural repairs if deemed needed. Continue monitoring.

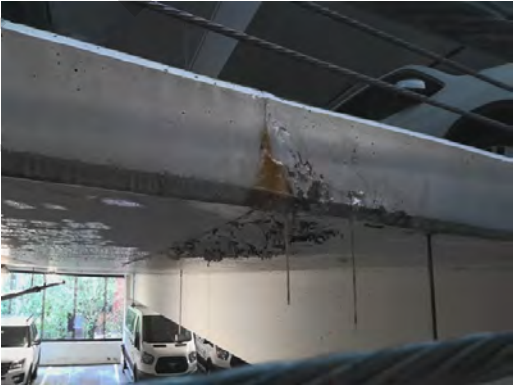
Deficient Material: Concrete Deck
Areas of moisture intrusion causing stalactites and damage to underside of deck, appears to be failed cold joint sealants.

Remedial Action:
Strip and seal cold joints on deck slabs. Continue monitoring.

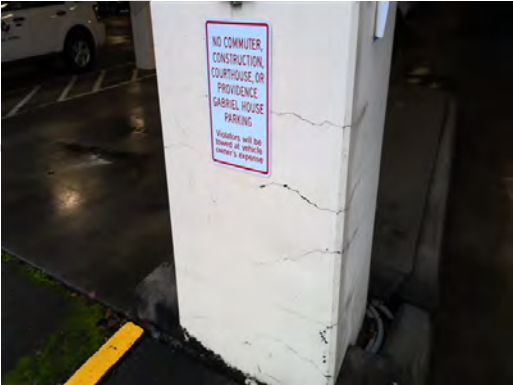
Deficient Material: Concrete Structure

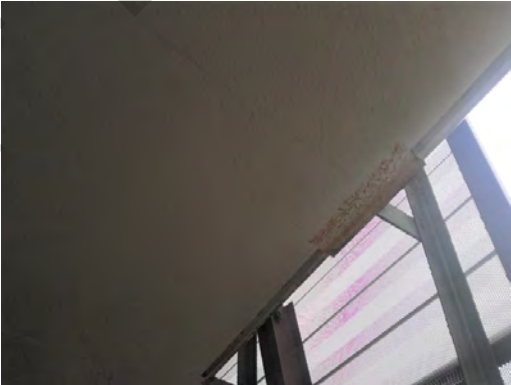
Deficient Material: Steel
Steel shows rust in several locations.

Remedial Action:
Clean rust off areas. Treat, prime, and paint with exterior industrial metal coating system.

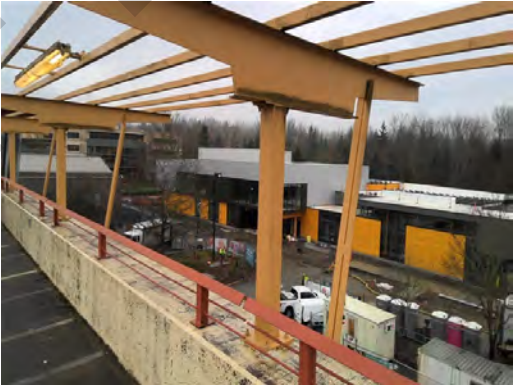
Deficient Material: Steel Canopy and Sun Shades
Steel canopies and steel sunshades. Heavy algae and dirt.

Remedial Action:
Remove and treat any rust, clean, prep, and paint.

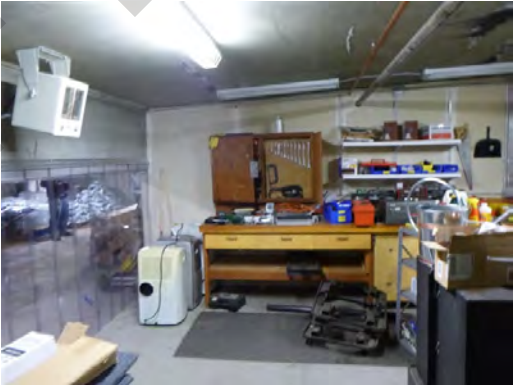
Deficient Material: Ventilation
Semi-heated workshop area in former storage area under ramp at first floor with no ventilation.

Remedial Action:
Provide code minimum ventilation for shop area.

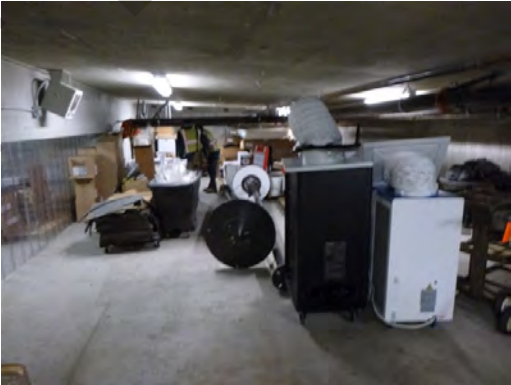
Deficient Material: Fire Sprinkler Density
Shop/storage room combustible material may exceed sprinkler density capacity.

Remedial Action:
Assess and upgrade sprinkler as needed.

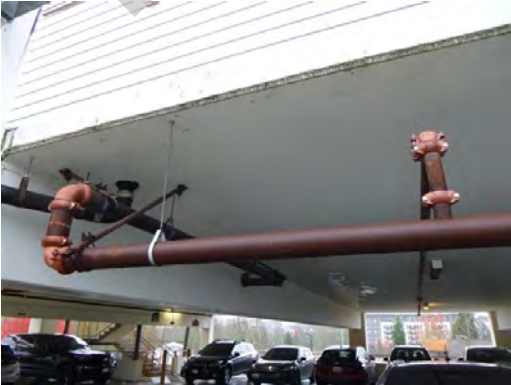
Deficient Material: Fire Sprinkler Piping
Unprimed/unpainted, exposed fire sprinkler piping is rusting and corroding.

Remedial Action:
Clean, prime, and paint fire sprinkler piping.

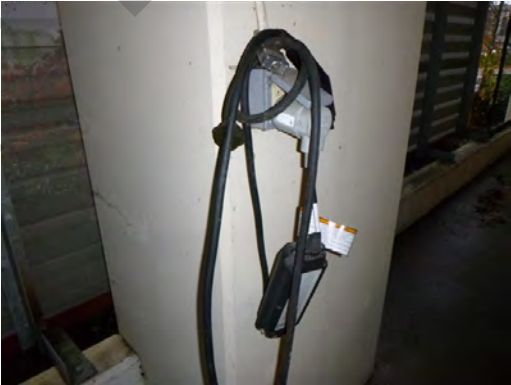
Deficient Material: Electric vehicle charging
At least one makeshift electric vehicle (EV) charging station.

Remedial Action:
Replace with proper EV charging station.

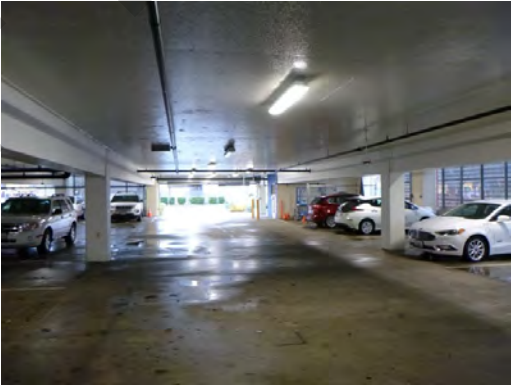
Deficient Material: Lighting Fixtures
Original fluorescent lamps and ballasts are failing.

Remedial Action:
Replace older lamps and ballasts.

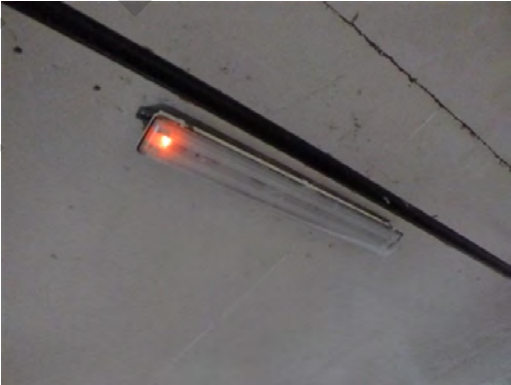
Deficient Material: Emergency lighting
Failed batteries for most tested emergency light fixtures.

Remedial Action:
Replace batteries.

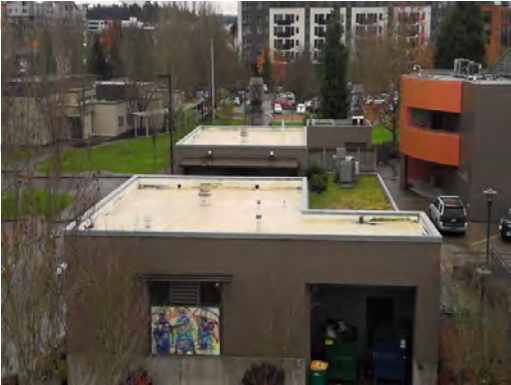
Deficient Material: Roof Access
No roof access, no fall restraint system.

Remedial Action:
Install internal ladder and roof hatch (with modern OSHA safety system), install fall restraint to support safe access for maintenance.

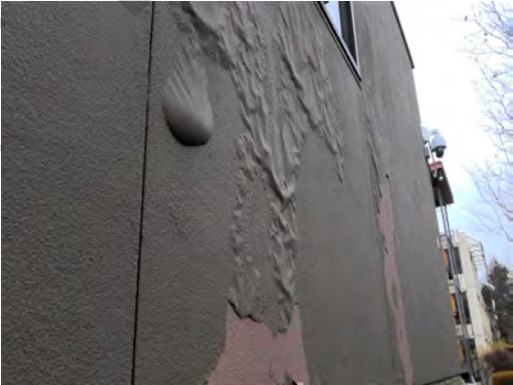
Deficient Material: Cement plaster siding
Significant moisture intrusion issues with stucco cladding details leading to paint blistering and peeling off stucco siding.

Remedial Action:
Investigate flashings and joint detailing, strip finishes and seal joints, add head flashings as needed, prime, and coat with compatible elastomeric paint system. Alternatively, clad with metal rain screen cladding to match recent work on main building (adding drip flashing details).

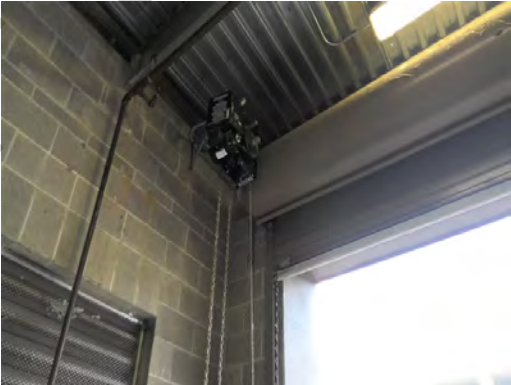
Deficient Material: Coiling Door

Investigate cause of door inoperability and replace components as needed.

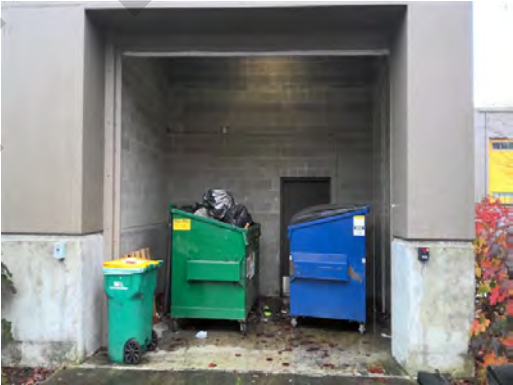
Deficient Material: Sanitary Floor Drain
No floor drain for trash storage area.

Remedial Action:
Install two floor drains leading to sanitary sewer as required by code.

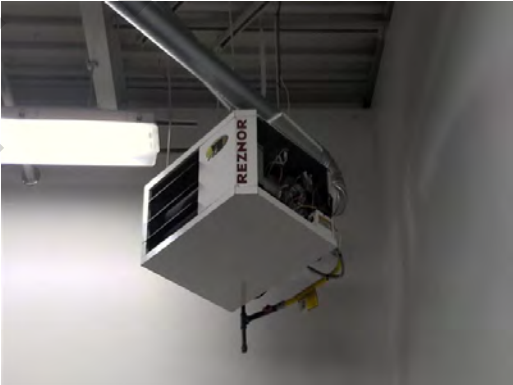
Deficient Material: Unit Heater
Single gas-fired Reznor unit heater, non-functional, space not being heated.

Remedial Action:
Replace failed unit heater.

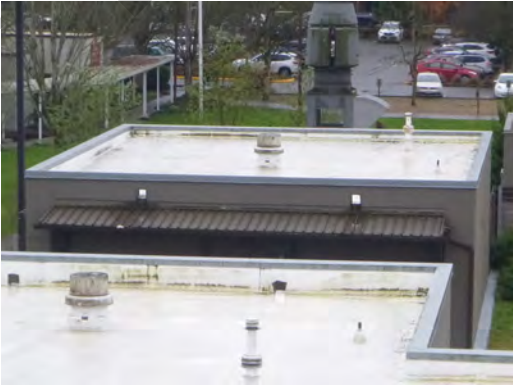
Deficient Material: Roof Access
No roof access, no fall restraint system.

Remedial Action:
Install internal ladder and roof hatch (with modern OSHA safety system), install fall restraint to support safe access for maintenance.

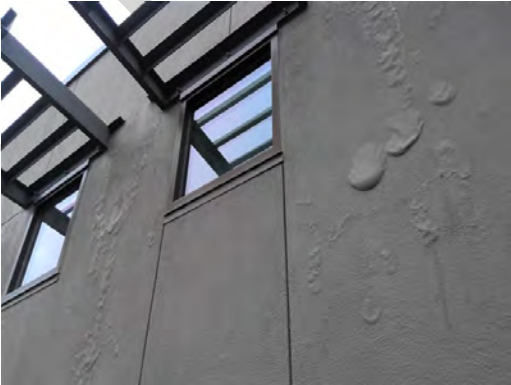
Deficient Material: Cement plaster siding
Significant moisture intrusion issues with stucco cladding details leading to paint blistering and peeling off stucco siding.

Remedial Action:
Investigate flashings and joint detailing. Strip finishes and reseal joints, add head flashings as needed, prime, and coat with compatible elastomeric paint system. Alternatively, clad with metal rain screen cladding to match recent work on main building (adding drip flashing details).

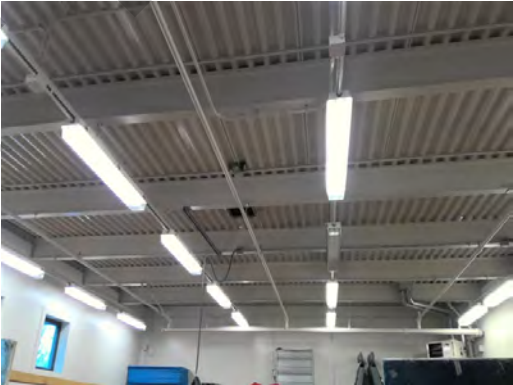
Deficient Material: HVAC System

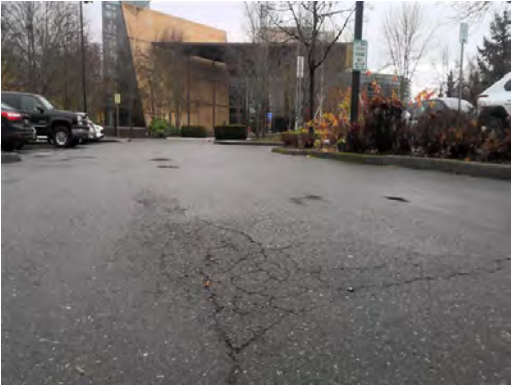
Deficient Material: Asphalt Parking

Some cracking and areas of settlement and cracking in City Hall SE lot. Potholes between the parking garage and Public Safety Building.

Clean and seal cracks to thwart weed and moisture intrusion and prolong system life. Monitor settlement areas. Repair and patch potholes.

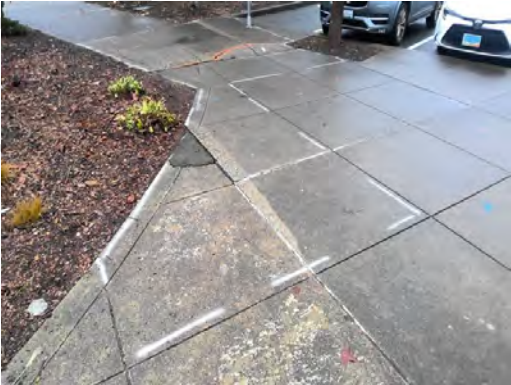
Deficient Material: Concrete Pavement

Areas with significant root upheaval and damage, causing trip hazards. Many have had maintenance trimming.

Saw cut and demolish areas of plaza and NE 85th Street sidewalks that are experiencing upheaval and settlement trip hazards. Trim roots, compact, and repour concrete.

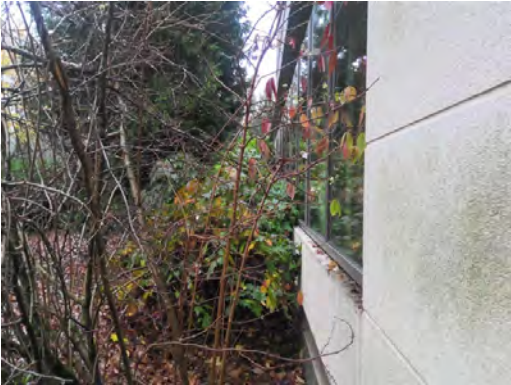
Deficient Material: Landscaping
Areas of plant materials growing against the buildings (creating maintenance/degradation issues to facade) providing security hiding spaces, and potential pest vector pathways.

Remedial Action:
Prune/trim and remove vegetative material away from face of buildings, and prune to remove hiding spaces.

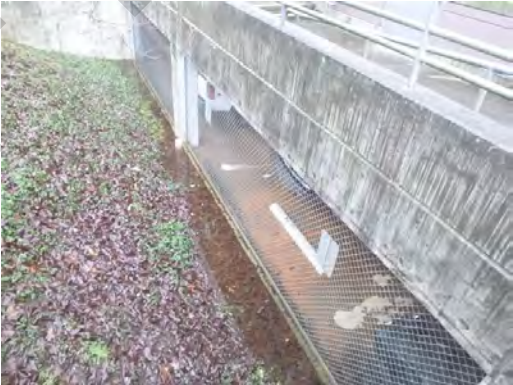
Deficient Material: Storm Service

Supplement drainage of ditches with additional overflow sump and pumps to extract excess storm water away from building in high-flow conditions.

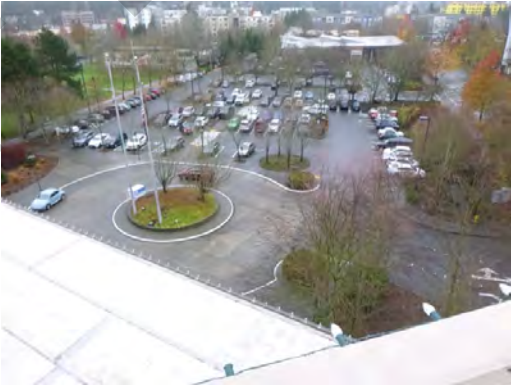
Deficient Material: Exterior lighting
Many exterior lights on during daytime hours.

Remedial Action:
Clean, service, and program fixtures and controls to work properly such that exterior lighting is on at night and off during the day.

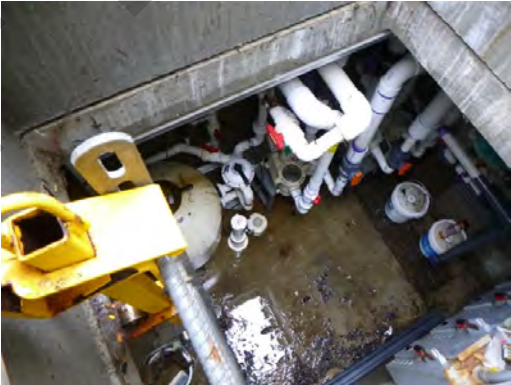
Deficient Material: Water feature
Aged City Hall water feature pump system, with at least one pump failed and signs of rust, corrosion, and other deterioration in the pump vault.

Remedial Action:
Renew the water feature pump system, including replacement of failed pump(s).

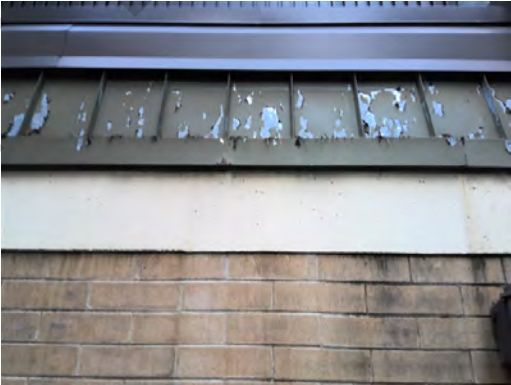
Deficient Material: Metal Siding
Areas of high standing seam cladding with paint finish peeling and failing.

Remedial Action:
Strip, prime, and repaint with exterior rated metal industrial paint coating.

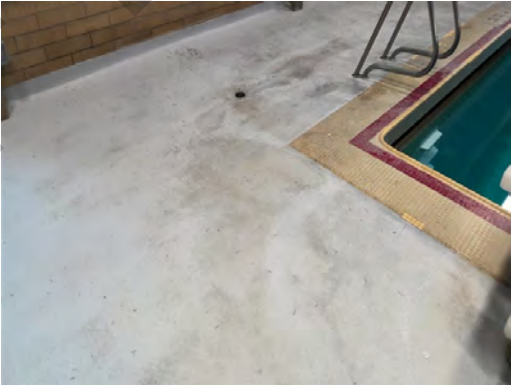
Deficient Material: Floor Finishes
Epoxy floors are porous in areas, creating non-uniform discoloration and are hard to clean, making the floors look dirty.

Remedial Action:
In lieu of stripping and reinstalling existing flooring, investigate possibility of coating with new non-slip pool deck traffic coating over existing.

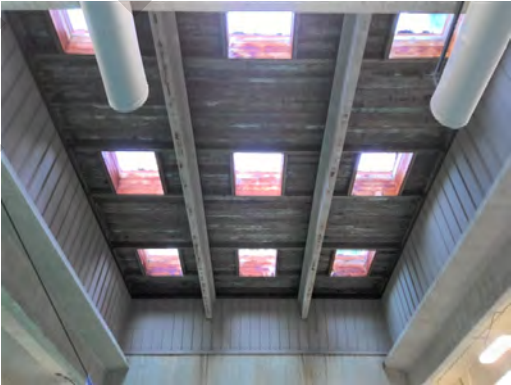
Deficient Material: Wood
The wood purlins and ceiling at the pool skylights, in addition to the concrete beams are heavily stained.

Remedial Action:
Clean stains from materials. Prime and paint or stain exposed decking and wood purlins.

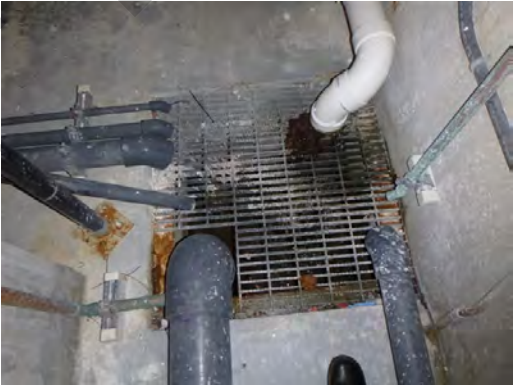
Deficient Material: Floor Drains
Pool mechanical room floor drain is plugged and backs-up. The sump pit is damaged with collapsing main drain line.

Remedial Action:
Renew pool mechanical room floor and sump drains.

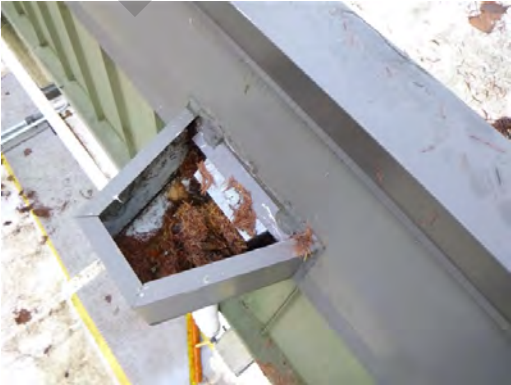
Deficient Material: Downspouts
PVC roof drain leaders and downspouts are makeshift, failing, and readily plugged by tree debris. Scupper box overflows are undersized and quickly blocked by tree debris.

Remedial Action:
Design and install a robust engineered scupper, leader, and downspout system to include high-capacity debris screens; coordinate with pool and facility maintenance staff to ensure maintainability of the roof drain system.

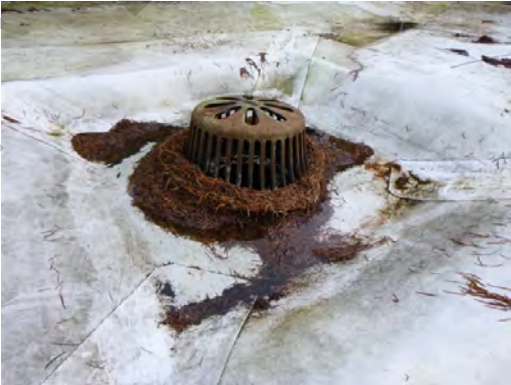
Deficient Material: **Overflow Roof Drains**
No overflow roof drains for lobby and locker room roof area, resulting in water intrusion into occupied space below.

Remedial Action:
Install overflow roof drains per code. This is in addition to separate deficiency on overall roof drain system.

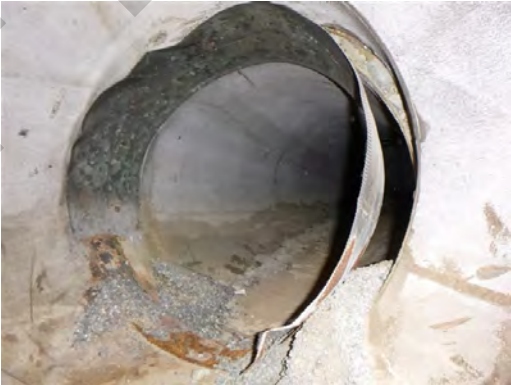
Deficient Material: Ductwork
Underground duct has corroded, collapsed, and failed, potentially leading to ongoing building and pool system structural damage.

Remedial Action:
Fill duct with solid material to prevent further collapse and structural failure of the building or pool.

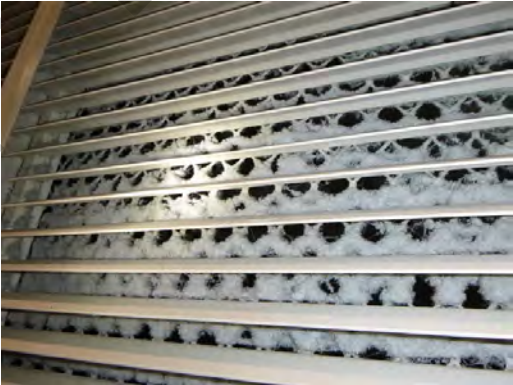
Deficient Material: Pool HVAC

Clean and maintain pool room HVAC system, including cleaning AHU-1 heat recovery core where contaminated from failed filters. Correct AHU-1 fan controls to operate fans within safe limits. Investigate air quality at pool surface. Check flexible duct for proper air distribution and adjust air cannon use accordingly.

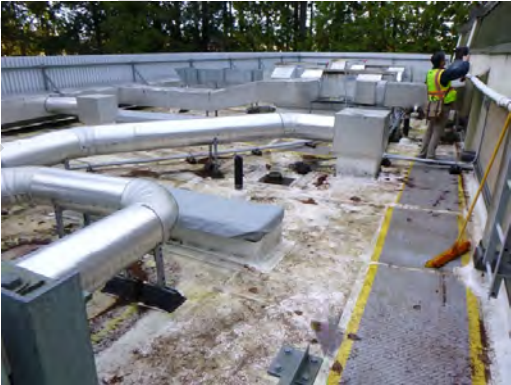
Deficient Material: Rooftop Ductwork
Rooftop ductwork for lobby, office, and locker room areas, blocking access to rooftop units for maintenance. Climbing over ductwork is damaging the ductwork and is a safety risk for maintenance staff.

Remedial Action:
Install several fixed duct bridges to facilitate safe access to equipment (RTU-1 and -2).

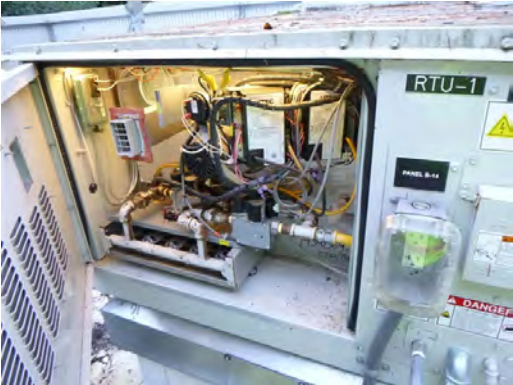
Deficient Material: Make-Up Air Unit

The two lobby, office, and locker room rooftop units were installed, then reportedly left in place without being laid-up for one to two years, and have had controls and other internal component failures since.

Fully factory service RTU-1 and -2 and restore to like-new condition.

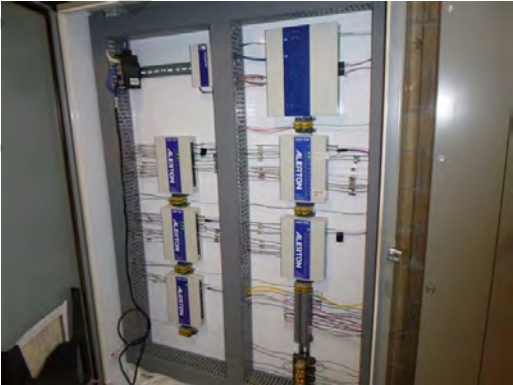
Deficient Material: Controls

High energy use intensity (EUI) of 350, which is 479% of State target for pool buildings, with signs of suboptimal control, including extremely high AHU-1 exhaust and return fan speeds, suspected in part to attempt to maintain inside humidity by increasing outside air flow, but outside air is 100% rH due to wet weather. The high speed of AHU-1 fans creates excessive noise in the park and surrounding community. Additionally, there appears to be little or no insulation at walls and roof.

Conduct energy audit and tune-up the control system to sharply reduce energy use, and wear and tear on equipment, plus excessive noise to the surrounding community. Implement cost-effective energy conservation and efficiency measures (ECMs & EEMs). This deficiency budget for audit and controls tune up only. ECMs might be on the order of \$150K to improve envelope, retrofit pool room heat recovery dehumidification, or similar.

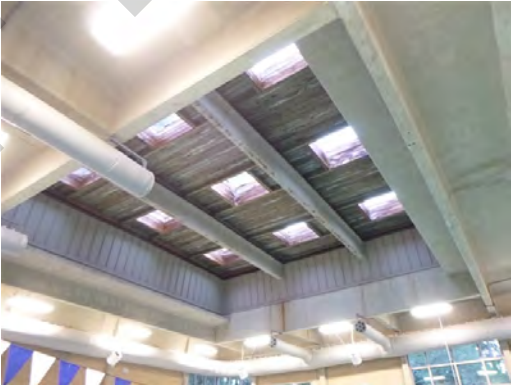
Deficient Material: Fire Sprinkler System
No fire sprinkler.

Remedial Action:
Install fire sprinkler.

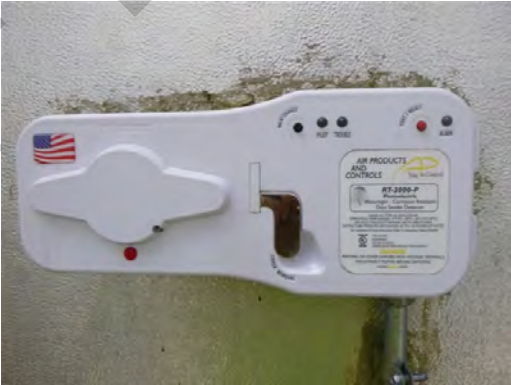
Deficient Material: Duct smoke detector
Failed main air handling unit return air duct smoke detector. Reportedly, this issue has persisted through nearly one dozen repairs and/or replacements.

Remedial Action:
Fully investigate the root cause of duct smoke detector failure and replace with a more robust detection system considering pool room HVAC service environment with high humidity and trace airborne chemical contaminants.

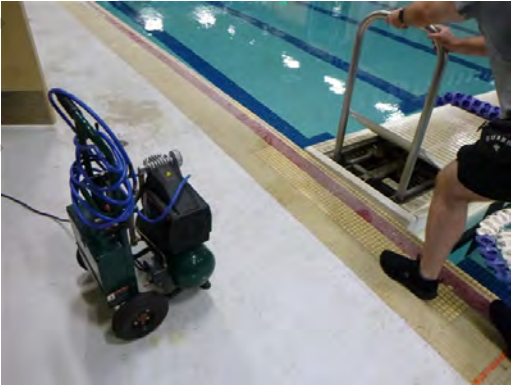
Deficient Material: Pool divider
Aging pool divider increasingly difficult to float and move.

Remedial Action:
Renew pool divider.

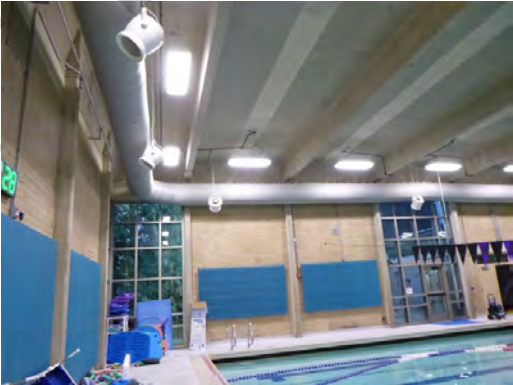
Deficient Material: Pool Equipment Storage
Limited pool program equipment storage.

Remedial Action:
Provide convenient, safe, and secure pool program equipment storage, such as a small modular building directly connected to the pool building.

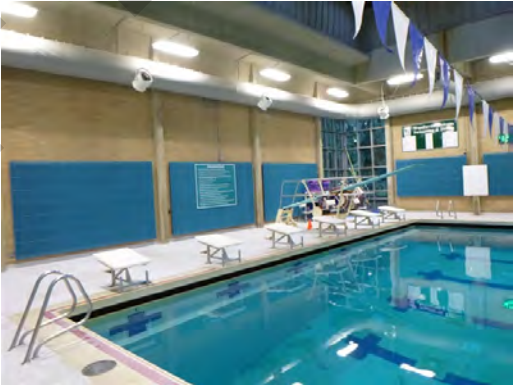
Deficient Material: Diving Board
The existing one-meter diving board was previously reported as corroded and appears still closed to use.

Remedial Action:
Analyze if the pool diving profile meets current code and replace the diving board.

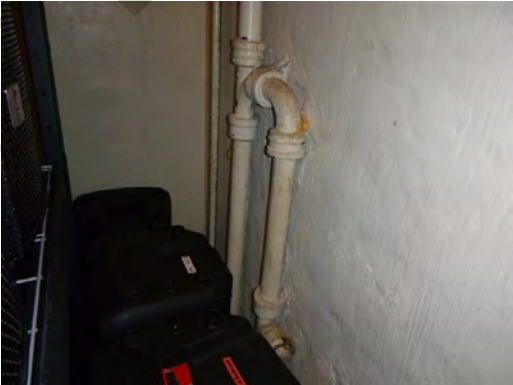
Deficient Material: Waste piping
Aged waste piping with several slow draining and flushing fixtures and reports of failing waste piping under the floor slab.

Remedial Action:
Renew drain, waste, and vent piping system.

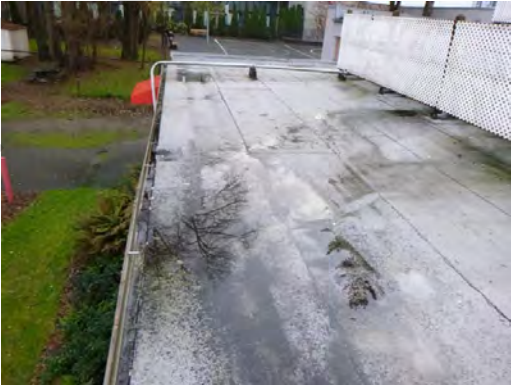
Deficient Material: Gutter and Downspout
Damaged gutters and downspouts.

Remedial Action:
Replace gutters and downspouts.

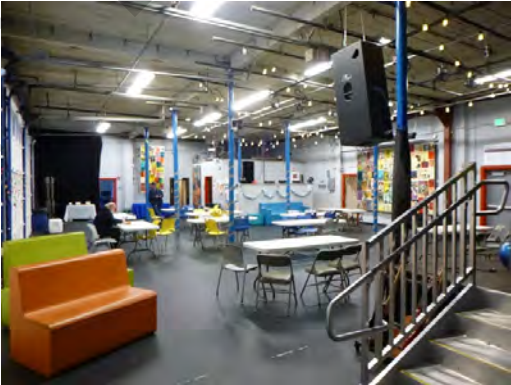
Deficient Material: Cooling
No permanent cooling or ventilation for the high-bay event space; large portable fans used, creating safety and trip hazards.

Remedial Action:
Install ceiling fans and ventilation cooling system, for example with natural ventilation exhaust up through hose tower.

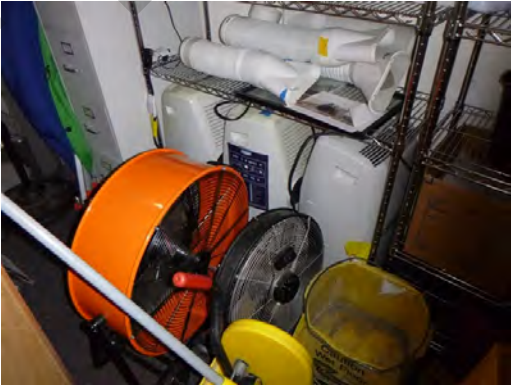
Deficient Material: Cooling
No permanent cooling for administration, support, and activity areas; portable cooling in use during summer months.

Remedial Action:
Install permanent cooling system for office, support, and activity area spaces; for example, ductless split-Dx.
