City of Redmond

Agenda Study Session

Facilities Condition Assessment Update

Facility Condition Assessment

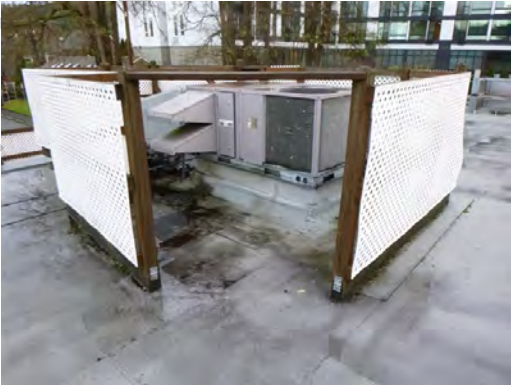
Deficient Material: Rooftop Units
Aging rooftop unit serving studio space.

Remedial Action:
Budget to replace upon failure.

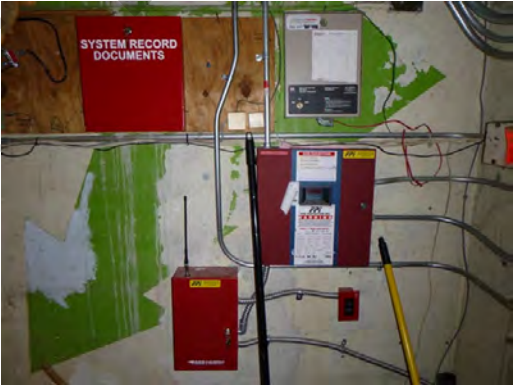
Deficient Material: Fire Alarm
Obsolete zoned fire alarm system.

Remedial Action:
Upgrade to modern addressable system.

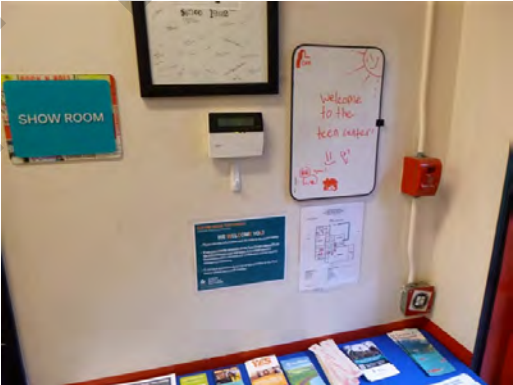
Deficient Material: Electronic security
Aged burglar alarm system with no card-key access or CCTV.

Remedial Action:
Upgrade to city standard electronic security system with access control, intrusion detection, and CCTV monitoring.

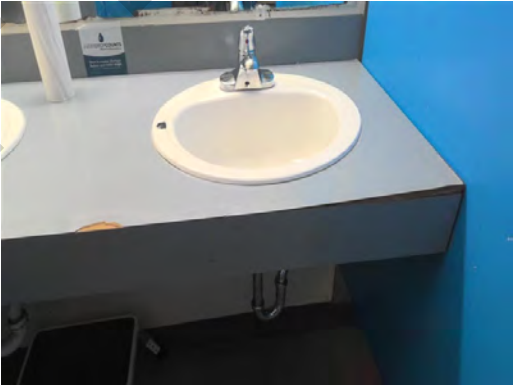
Deficient Material: Casework
Plastic laminate on wood counter and vanity aged and delaminating.

Remedial Action:
Demo and replace vanities.

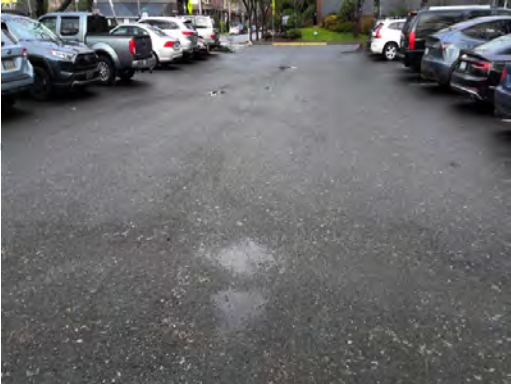
Deficient Material: Parking Lot
Pitting of north parking lot and some potholes. Paint striping has faded.

Remedial Action:
Fill potholes, top coat, and repaint stripes in lot.

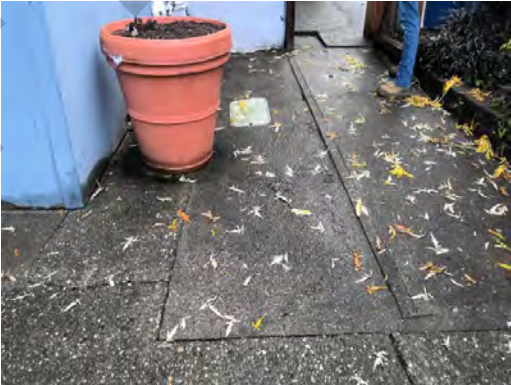
Deficient Material: Concrete Sidewalk
Concrete slab settlement and trip hazards near front entry and outdoor yard.

Remedial Action:
Saw cut, demo, and repave entry plaza.

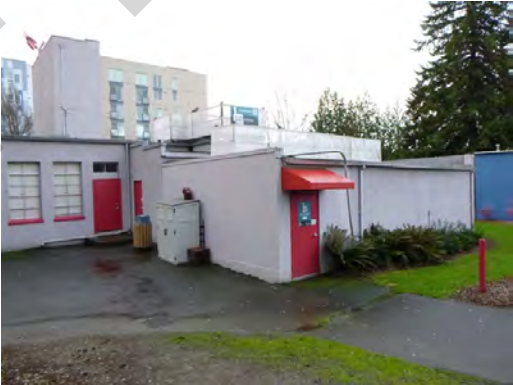
Deficient Material: Sanitary Sewer
Sanitary side sewer reportedly failing with dirt and debris in partially collapsed line.

Remedial Action:
Replace side sewer.

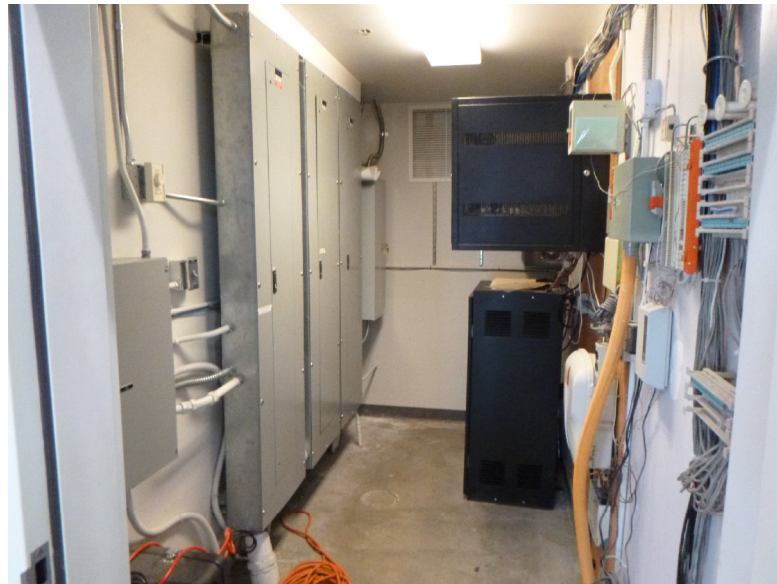
Lack of Cooling in
Telecom Room
(Fire Station 11)

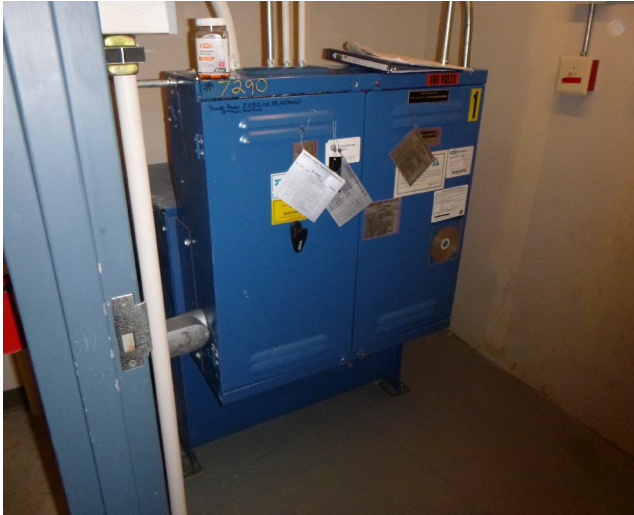
Renew Elevators
\$1.4M

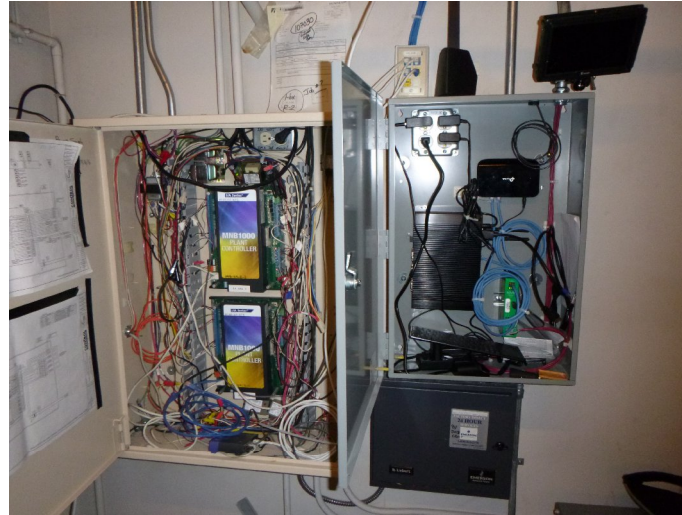
Controls Systems
\$974K

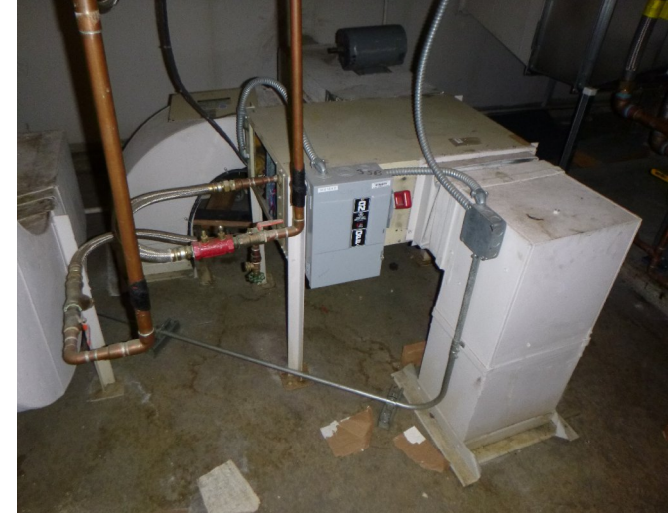
Water-Source Heat
Pumps
\$760K

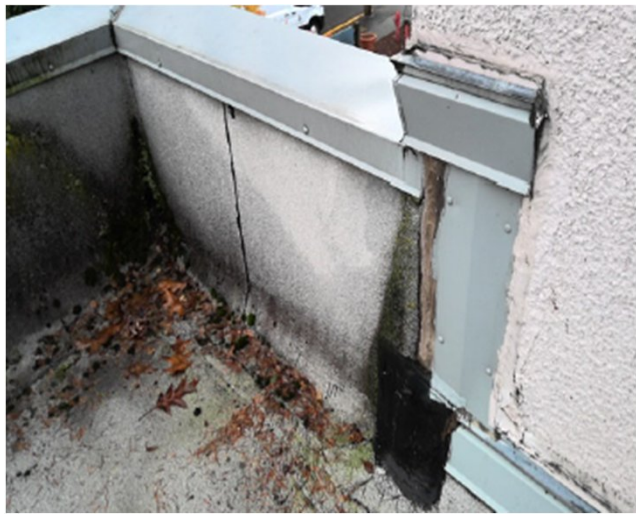
Roof Covering
\$539K

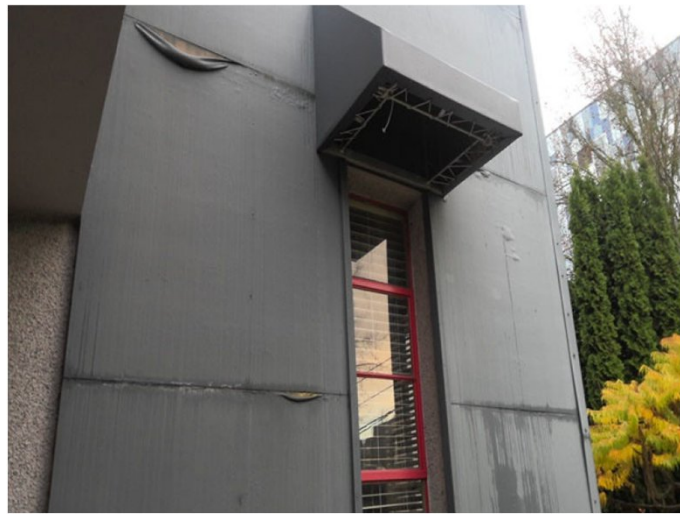
Exterior Walls & Windows
\$338K

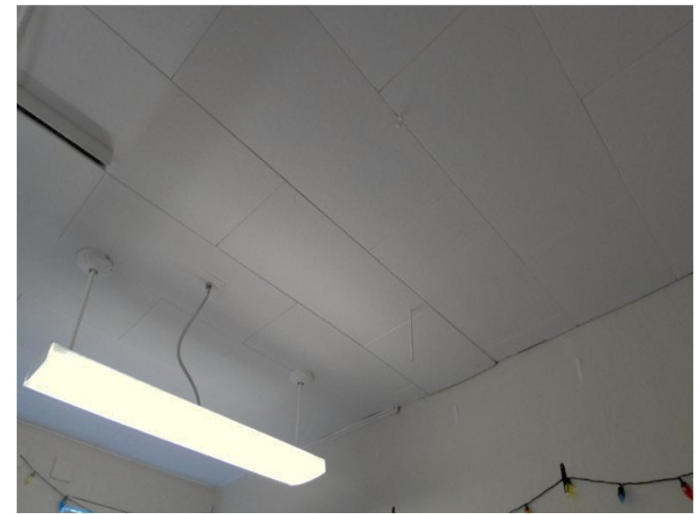
Ceiling Tiles
\$78K

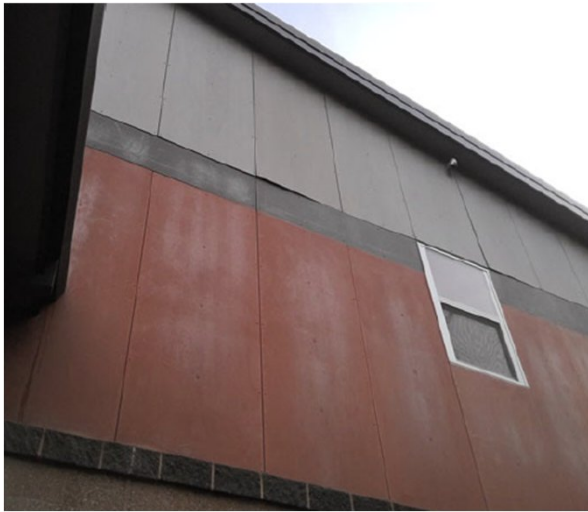
Exterior Cladding
\$934K

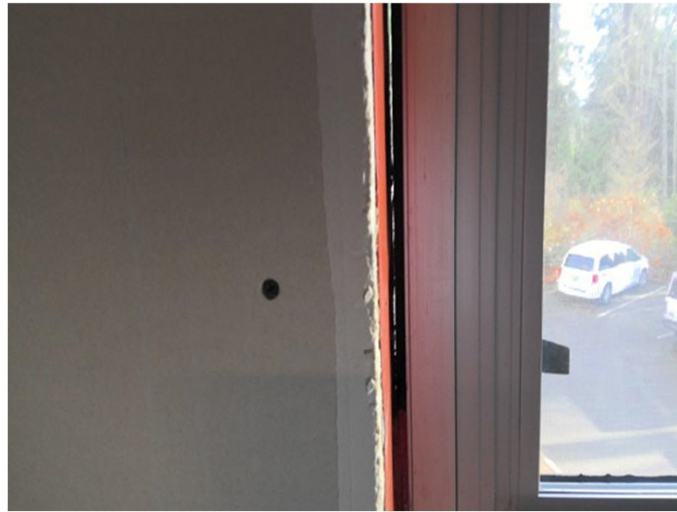
Exterior Windows
\$202K

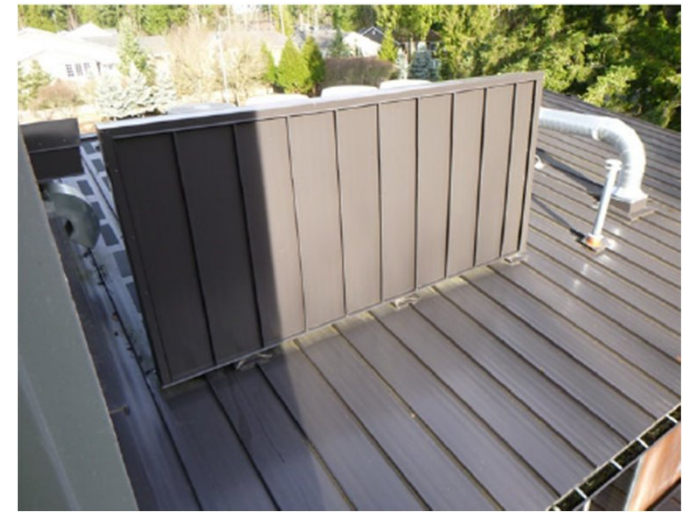
Cooling System
\$196K
