City of Redmond

Facility Condition Assessment

Facility Details Report

Prepared by MENG Analysis - March 6, 2024

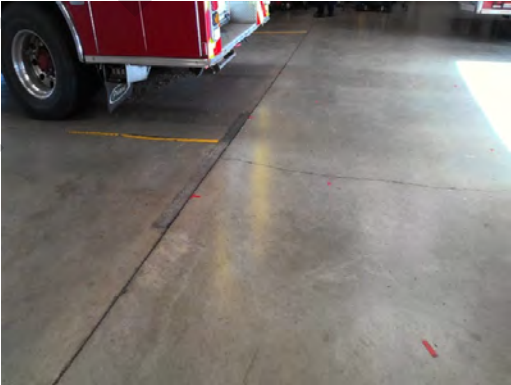
Deficient Material: Concrete Slab on Grade
Apparatus bay slab on grade has several wide cracks. Slab on grade has cupping/lifting at center joint. No control joints originally provided.

Remedial Action:
Remove/replace slab on grade with 8-inch-thick concrete slab with concrete joints at 30 feet on center or at each apparatus bay and at drainage wells.

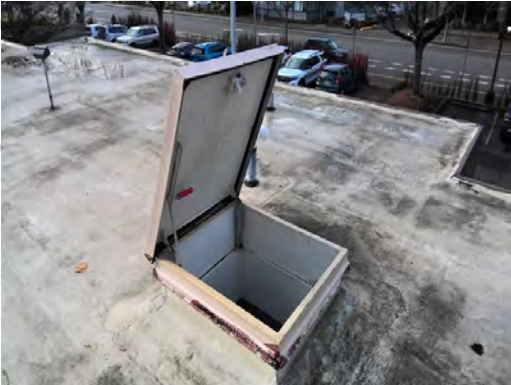
Deficient Material: **Roof Hatch**
Ladder length is short, no safety handle extension at either hatch, and no safety fall protection guard or gate.

Remedial Action:
Extend steel ladder and provide collapsible safety handle extension. Install rooftop fall protection guard and gate around access hatches.

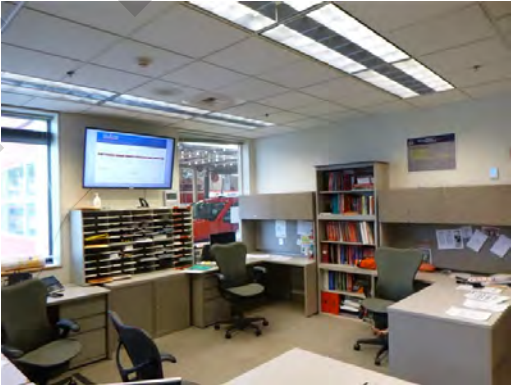
Deficient Material: **Air Flow Balance**
Unclear air flow balance throughout, except apparatus bays.

Remedial Action:
Conduct re-TAB (test, adjust, and balance) throughout, ideally in conjunction with other work such as new rooftop units, duct cleaning, and/or rezoning.

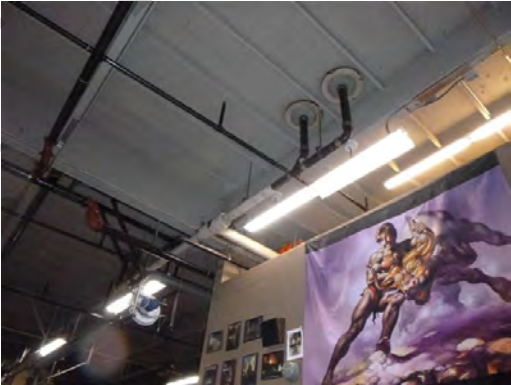
Deficient Material: Rood drain insulation

Insulate roof drain bodies and rain leaders where not already insulated; repair moisture damage from past condensate dripping.

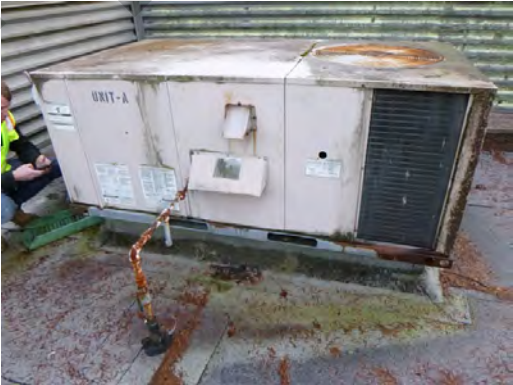
Deficient Material: Rooftop Units
Station house rooftop gas-pack units at end of life with rust and corrosion. Repair parts are becoming increasingly difficult to obtain.

Remedial Action:
Replace rooftop units with modern high-efficiency type.

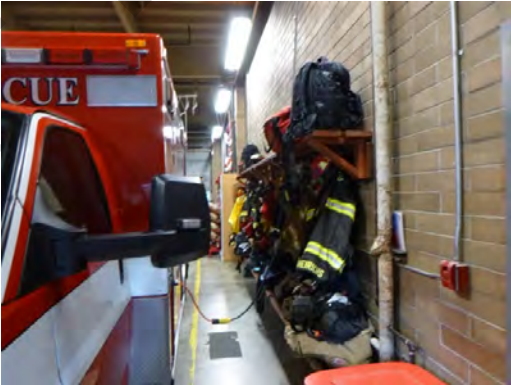
Deficient Material: Bunker gear drying
Bunker gear is dried on racks along apparatus bay walls, but the apparatus bay has no outside air ventilation.

Remedial Action:
Form a new bunker gear drying room to include both heat and ventilation to remove humidity as the gear dries.

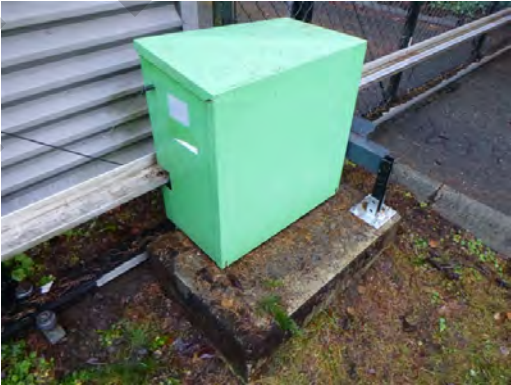
Deficient Material: Gate operator
Motorized gate operator failing with increasingly erratic control behavior.

Remedial Action:
Replace gate motor operator.

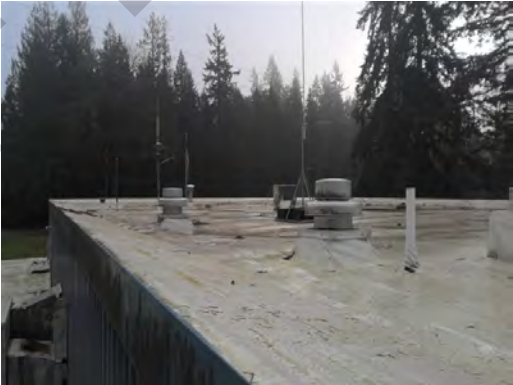
Deficient Material: Wood Decking

Past water damage concerns and soft springy deck. Plywood on wood joists at firehouse addition with unfaced batt insulation on underside of deck (no vapor barrier, unclear how airspace provided, and no evidence of airspace ventilation provided). Roof deck has elevation differences and angled edges; some places are up to 3/4-inch difference. Deck is not smooth or flush. No fall restraint. No fixed access transfer to high apparatus bay roof. No seismic upgrade has occurred.

Install fall restraint and access system. With diaphragm repairs, include seismic upgrade and add plywood decking to strengthen. Add rigid insulation below roof membrane to meet or exceed energy code and move dew point to outside of roof diaphragm.

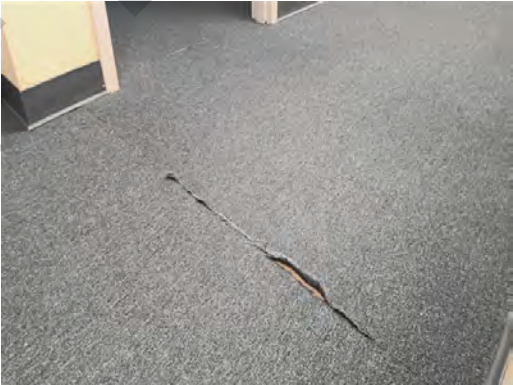
Deficient Material: Floor Finishes
Carpeting is worn and stained in most areas. Sheet vinyl in laundry area is worn and stained with seams failing.

Remedial Action:
Remove carpet and replace with new carpet. Remove vinyl flooring and replace with commercial-grade vinyl flooring.

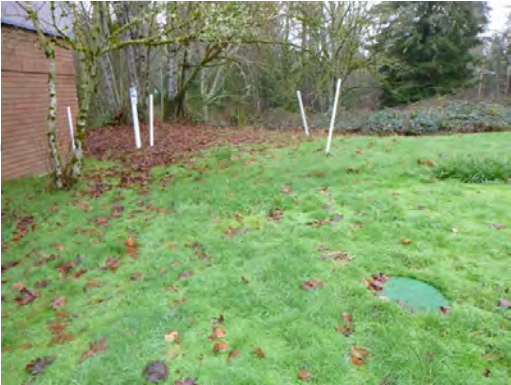
Deficient Material: Septic System
Aging septic system with design for replacement currently underway.

Remedial Action:
Renew septic system prior to failure.

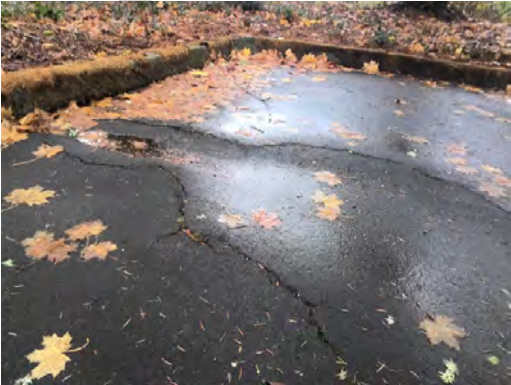
Deficient Material: Asphalt Parking
Tree root uplift buckling of two stalls near center island.

Remedial Action:
Cut asphalt and trim roots. Repair and patch asphalt.

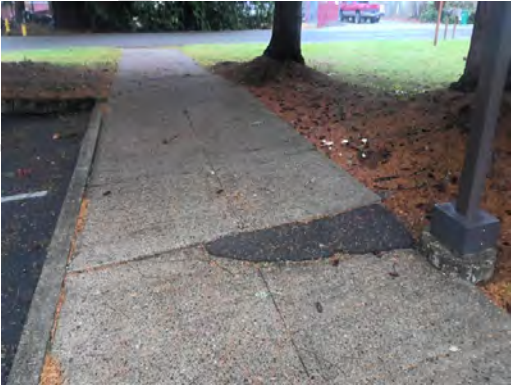
Deficient Material: Concrete Sidewalk
The sidewalk from the right-of-way has sections of root uplift and settlement of the concrete walk in numerous panels, presenting growing trip hazards.

Remedial Action:
Demo sidewalk, trim tree roots, regrade, and repour concrete walk to public right-of-way.

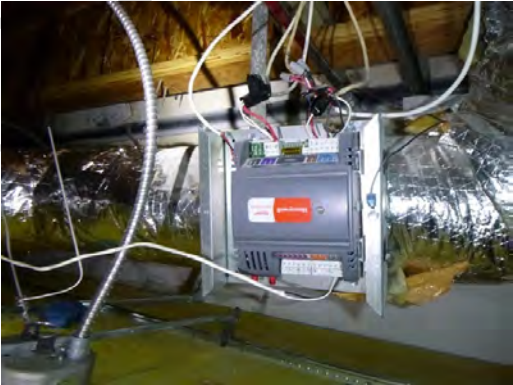
Deficient Material: Commissioning
All four station house rooftop units were replaced in 2021 and duct heaters added to the dormitory system in 2022, with reported safety issues, and unclear programming and safety.

Remedial Action:
Complete independent third-party commissioning of the four new rooftop units, including control system programming, the dormitory variable volume and temperature system, and the new electric duct heaters.

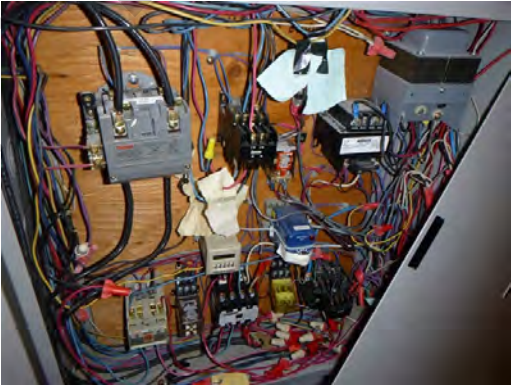
Deficient Material: Location
Aged and poorly wired locution system.

Remedial Action:
Renew.

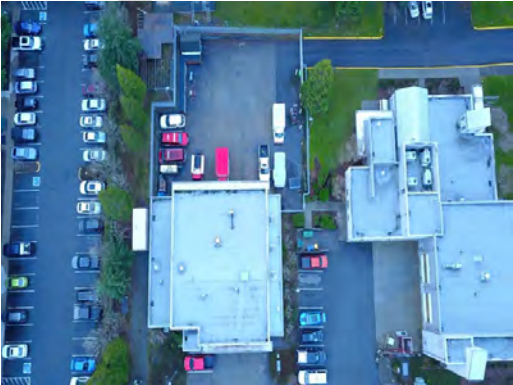
Deficient Material: Fall Protection
There is no fall protection on the roof to facilitate safe maintenance.

Remedial Action:
Install fall protection system. (See also System B3020 - Roof Openings opportunity to provide roof access.)

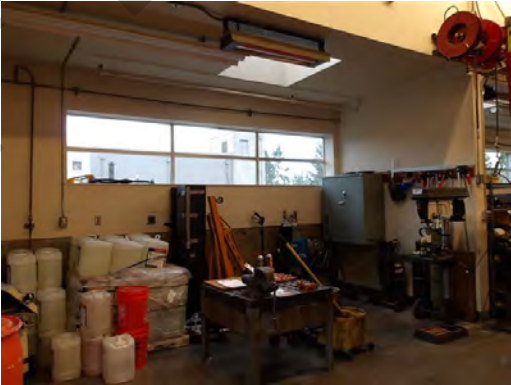
Deficient Material: Welding Exhaust
No welding exhaust system.

Remedial Action:
Install welding exhaust system.

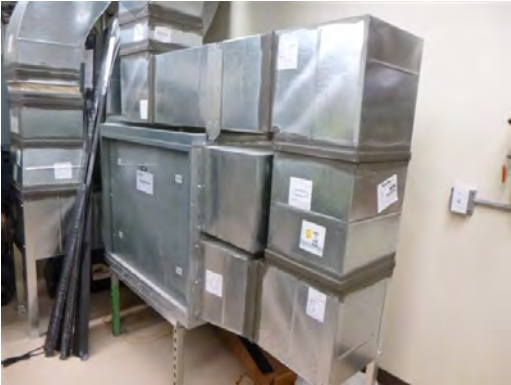
Deficient Material: Heat Recovery Ventilation

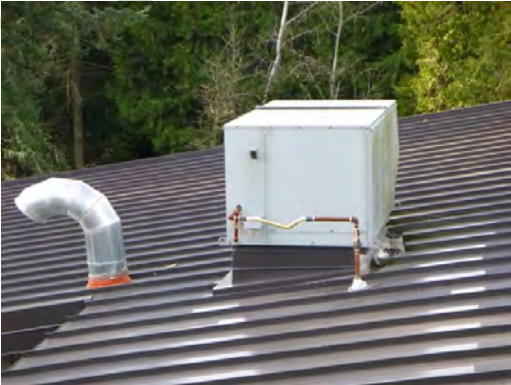
Deficient Material: Make-up Air Units
Unclear make-up air unit operability, with control panels blank.

Remedial Action:
Fully service, test, and restore operability to the three make-up air units.

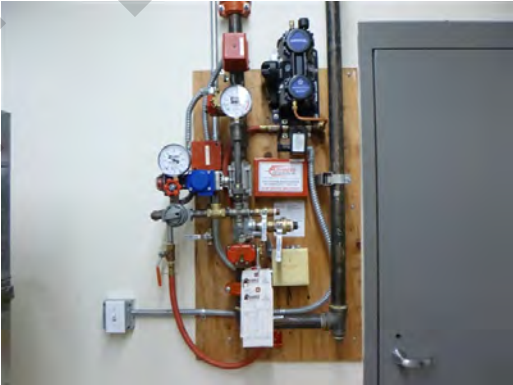
Deficient Material: Dry-pipe Sprinkler
Failed hose tower proprietary dry-pipe fire sprinkler system.

Remedial Action:
Replace with non-proprietary system and restore protection ASAP.

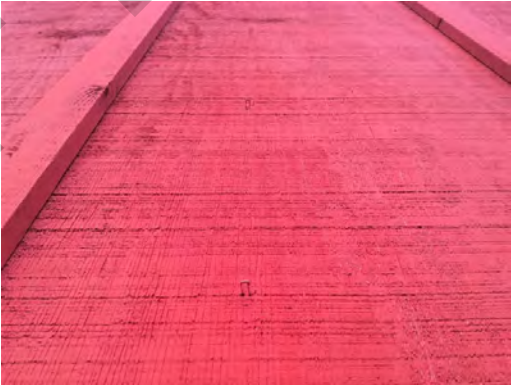
Deficient Material: Wood Siding
Wood lap siding improperly attached with roofing face staples, staples are popping out and panels are loose.

Remedial Action:
Screw panels into sheathing, paint heads to match siding.

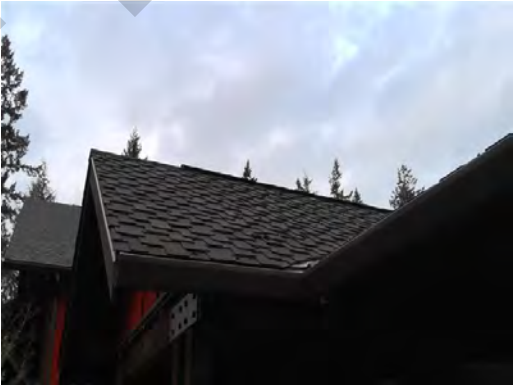
Deficient Material: Asphalt Shingles
Composite architectural asphalt shingle roofing nearing end of life. Bare tar exposed and loose granules. No fall restraint except for untested and non-certified D-rings on high-bay peak. No roof access provided.

Remedial Action:
Remove roofing, install certified fall restraint system and new roofing, including new ice and water shield flashings if not present or of expected quality, and synthetic subroofing. Investigate opportunity to provide permanent roof access.

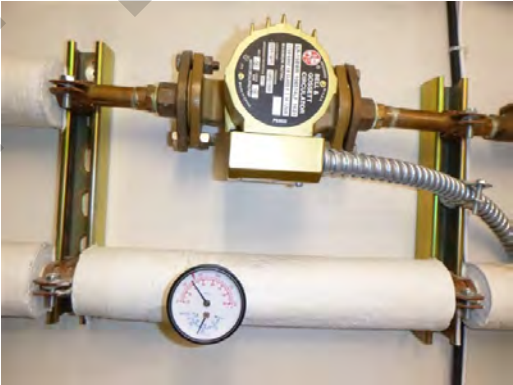
Deficient Material: Hot water piping
Hot water pipe leaks due to unusually high system temperature and light-duty residential Type M copper tubing.

Remedial Action:
Replace light-duty copper tubing with medium-duty copper and/or PEX tubing and reduce system hot water temperature to 120 to 130 deg F.

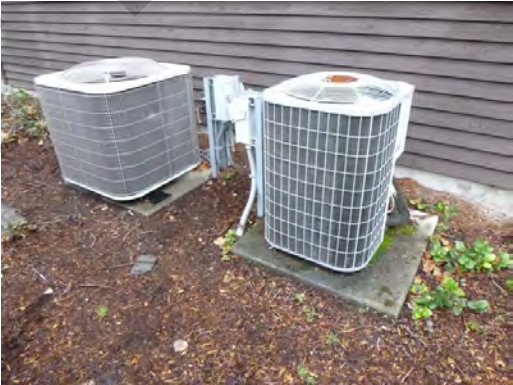
Deficient Material: Condensing Unit (CU)
Police precinct air conditioning outside condensing unit has failed and is being replaced. Station house condensing unit is aged and could fail at any time.

Remedial Action:
Complete replacement of police precinct condensing unit, and budget to replace the station house condensing unit upon failure.

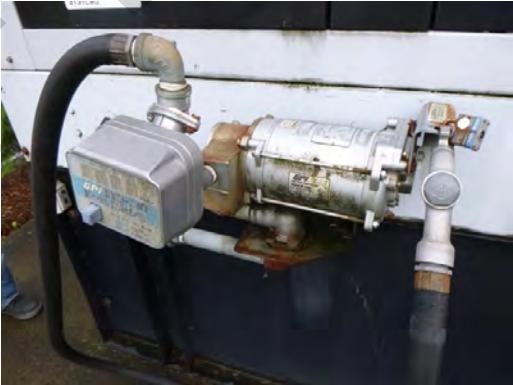
Deficient Material: Fuel oil tank controls
Diesel generator fuel tank vehicle fill pump is locked out due to lack of fuel conservation control.

Remedial Action:
Install fuel conservation system to lock out the vehicle fill pump when the minimum safe diesel tank level is reached.

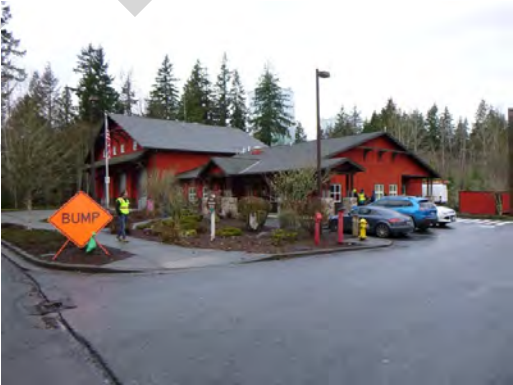
Deficient Material: High-speed data
Inconsistent and unreliable data service.

Remedial Action:
Modernize telecom services.

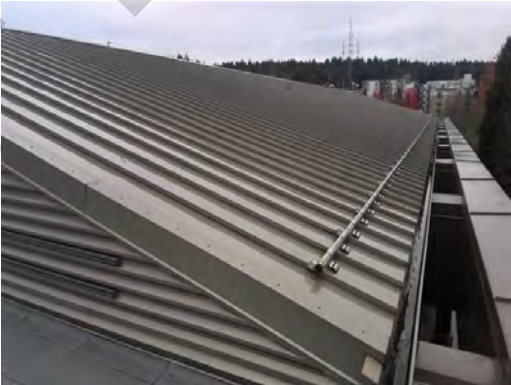
Deficient Material: Roof Access

Gutters on sloped roofs are inaccessible for maintenance. While there is a fall restraint cable near the ridge of the steep and slick standing seam roof, it is neither reasonably nor readily accessible. As a result, gutters cannot be safely or regularly cleaned and now have significant plant growth. Recent renovations removed parapet fall protection pathway to access scuppers over the north roof section over the training room, making it unsafe to access for maintenance and drain cleaning.

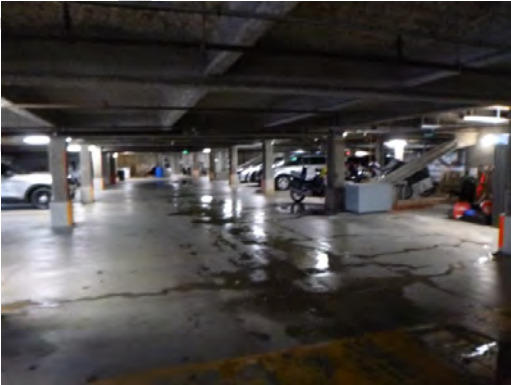
Deficient Material: Piping Insulation
No drain, waste, and vent piping insulation and heat trace system in the unconditioned parking garage.

Remedial Action:
Heat trace and insulate parking garage exposed waste piping.

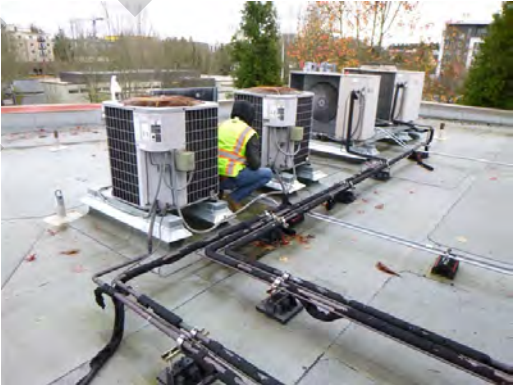
Deficient Material: Condensing Unit
Several older condensing units and inside units for mission-critical spaces, including for intermediate distribution frame and back-up to other systems (N+X).

Remedial Action:
Replace aging mission-critical space split-Dx cooling systems prior to failure.

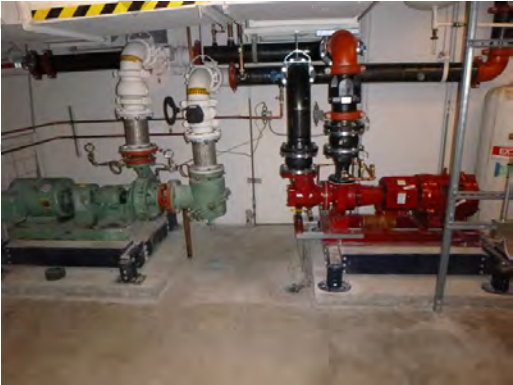
Deficient Material: Pumps
One of two condenser water pumps is original and aged.

Remedial Action:
Renew condenser water pump.

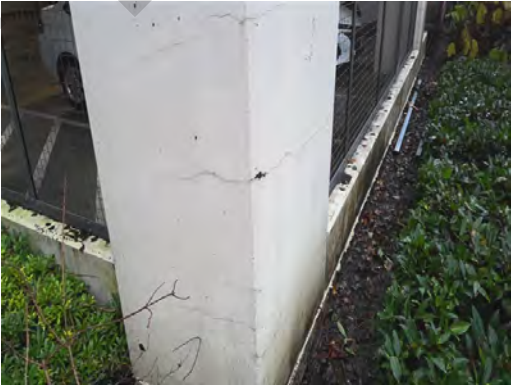
Deficient Material: Concrete Paint
Paint is fading, chipped, and shows some damage. (See also B1010 Floor Construction for stress cracking issues.)

Remedial Action:
Strip paint. Seal cracks to thwart moisture intrusion per B1010 Floor Construction. Prep and repaint exterior.

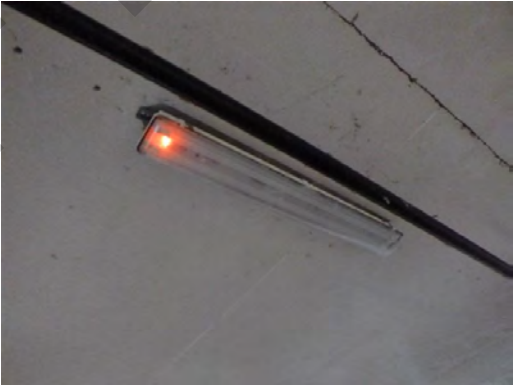
Deficient Material: Emergency lighting
Failed batteries for most tested emergency light fixtures.

Remedial Action:
Replace batteries.

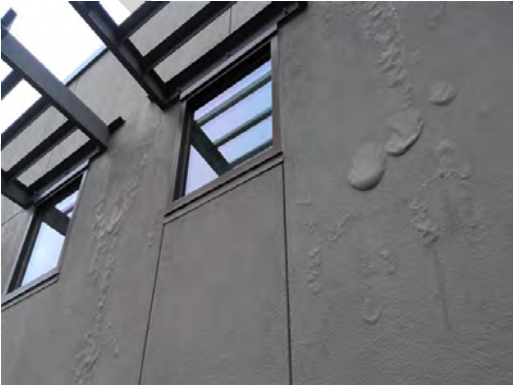
Deficient Material: Cement plaster siding
Significant moisture intrusion issues with stucco cladding details leading to paint blistering and peeling off stucco siding.

Remedial Action:
Investigate flashings and joint detailing. Strip finishes and reseal joints, add head flashings as needed, prime, and coat with compatible elastomeric paint system. Alternatively, clad with metal rain screen cladding to match recent work on main building (adding drip flashing details).

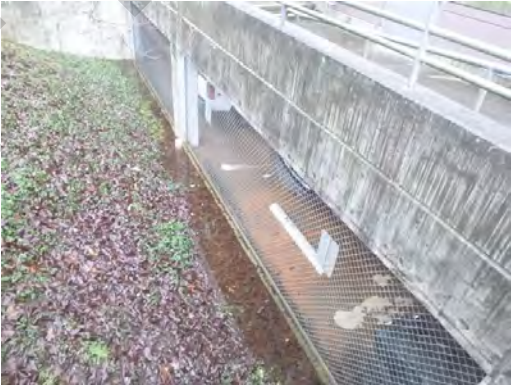
Deficient Material: Storm Service

Supplement drainage of ditches with additional overflow sump and pumps to extract excess storm water away from building in high-flow conditions.

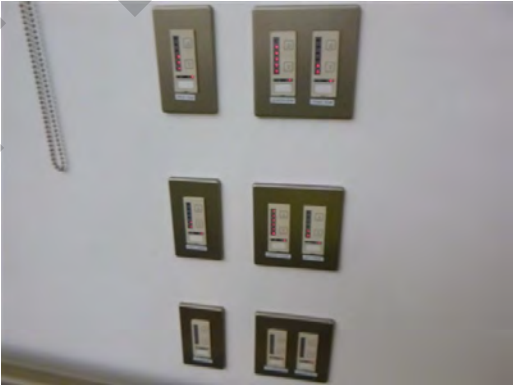
Deficient Material: Lighting control
No direct factory support for lighting control system, with costly-to-replace devices.

Remedial Action:
Replace lighting control system with a factory-supported system.

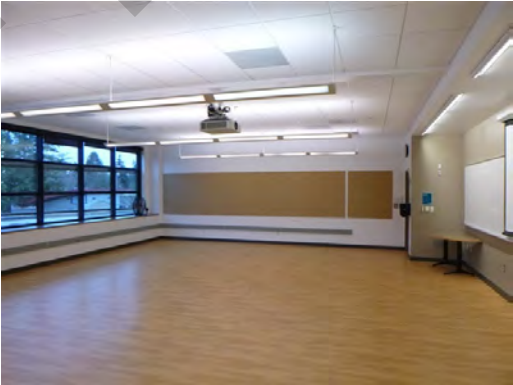
Deficient Material: Audio/video
A/V projectors are failing and A/V equipment is not user-friendly.

Remedial Action:
Replace failing A/V projectors and simplify A/V equipment configuration to be more user-friendly.

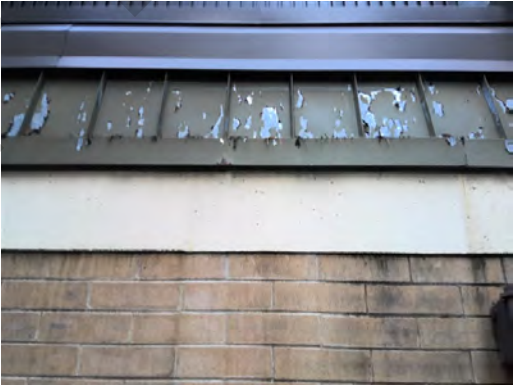
Deficient Material: Metal Siding
Areas of high standing seam cladding with paint finish peeling and failing.

Remedial Action:
Strip, prime, and repaint with exterior rated metal industrial paint coating.

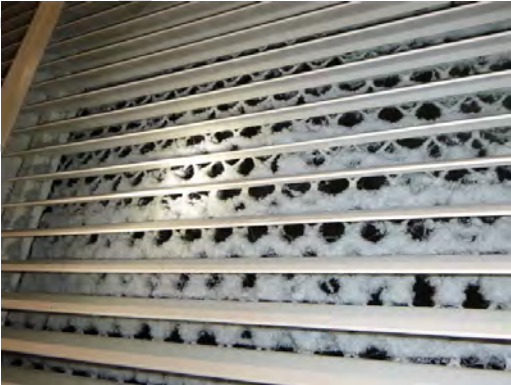
Deficient Material: Pool HVAC

Clean and maintain pool room HVAC system, including cleaning AHU-1 heat recovery core where contaminated from failed filters. Correct AHU-1 fan controls to operate fans within safe limits. Investigate air quality at pool surface. Check flexible duct for proper air distribution and adjust air cannon use accordingly.

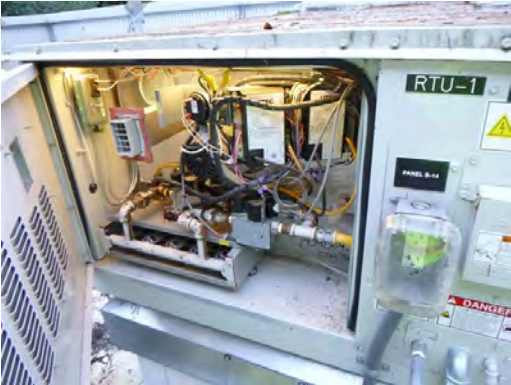
The two lobby, office, and locker room rooftop units were installed, then reportedly left in place without being laid-up for one to two years, and have had controls and other internal component failures since.

Fully factory service RTU-1 and -2 and restore to like-new condition.

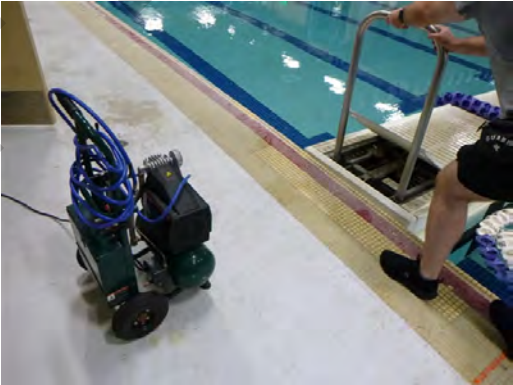
Deficient Material: Pool divider
Aging pool divider increasingly difficult to float and move.

Remedial Action:
Renew pool divider.

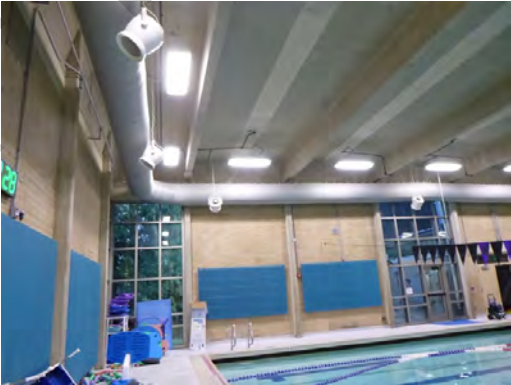
Deficient Material: Pool Equipment Storage
Limited pool program equipment storage.

Remedial Action:
Provide convenient, safe, and secure pool program equipment storage, such as a small modular building directly connected to the pool building.

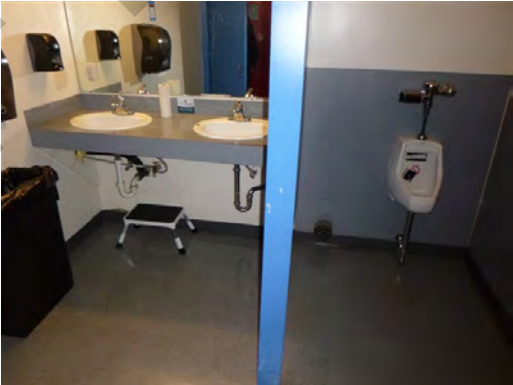
Deficient Material: Plumbing Fixtures
Some fixtures aged and worn.

Remedial Action:
Replace aged and worn fixtures.

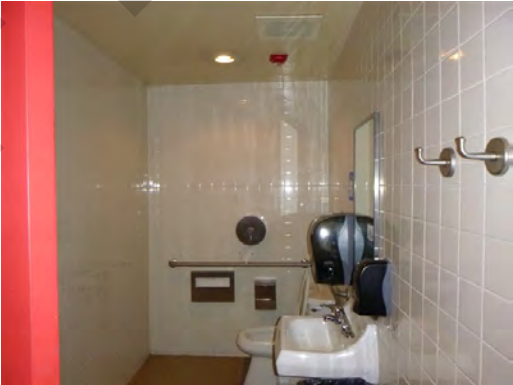
Deficient Material: Drain, Waste, and Vent
Suspected segments of original galvanized piping in concealed spaces.

Remedial Action:
Replace with copper and/or PEX.

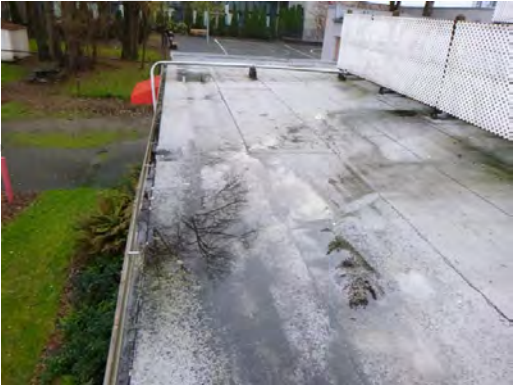
Deficient Material: Gutter and Downspout
Damaged gutters and downspouts.

Remedial Action:
Replace gutters and downspouts.

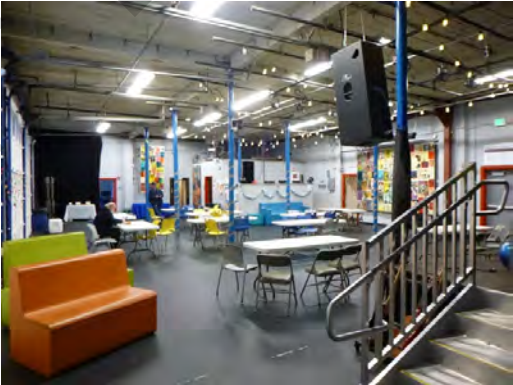
Deficient Material: Cooling
No permanent cooling or ventilation for the high-bay event space; large portable fans used, creating safety and trip hazards.

Remedial Action:
Install ceiling fans and ventilation cooling system, for example with natural ventilation exhaust up through hose tower.

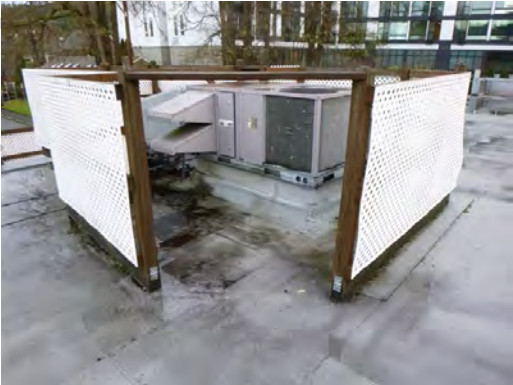
Deficient Material: Rooftop Units
Aging rooftop unit serving studio space.

Remedial Action:
Budget to replace upon failure.

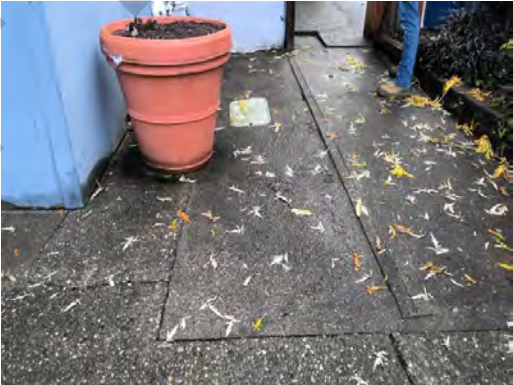
Deficient Material: Concrete Sidewalk
Concrete slab settlement and trip hazards near front entry and outdoor yard.

Remedial Action:
Saw cut, demo, and repave entry plaza.
