Redmond Senior Center Final Building Investigation Report

City of Redmond Senior Center Building

8703 160th Ave NE, Redmond WA 98052 November 25, 2019

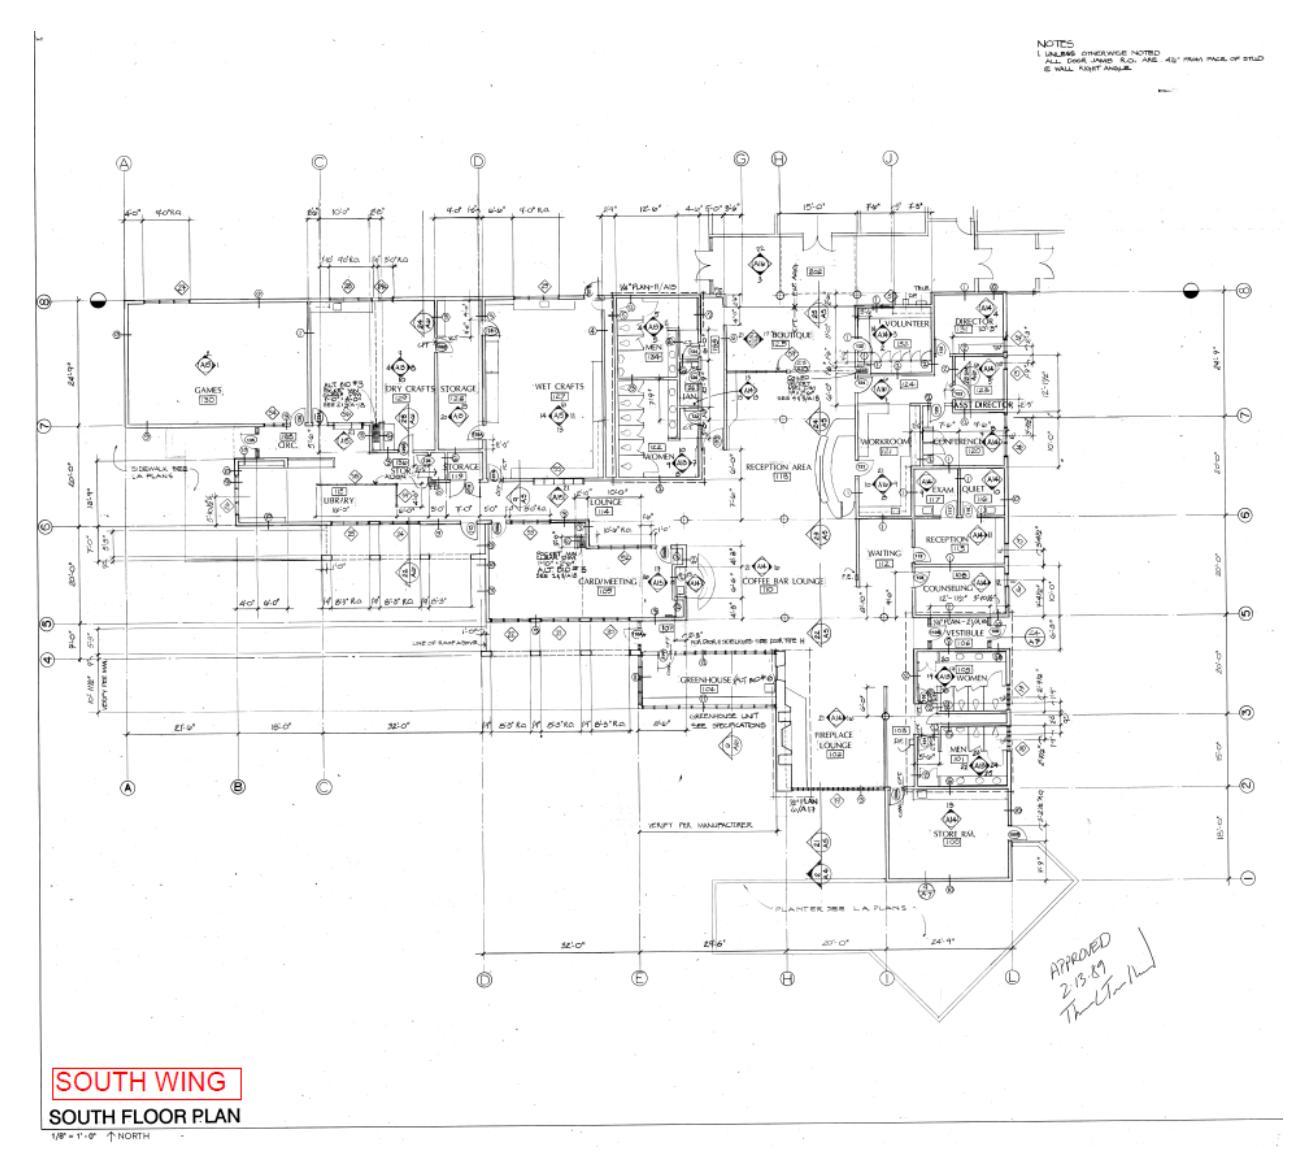
Figure 5. South wing floor plan

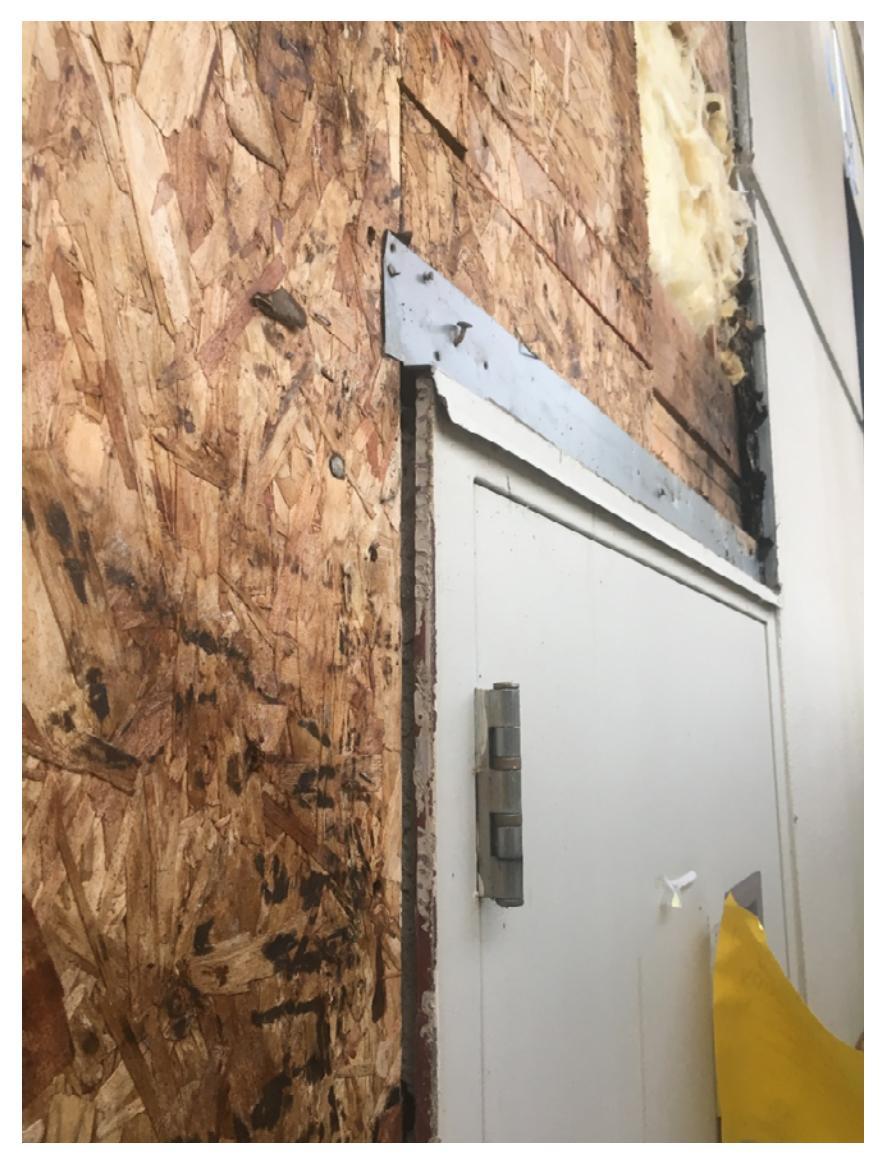
The NWCB is the trade association for Portland cement plaster (stucco) and is the recognized technical authority for contractors in this field. Per NWCB, head flashings are required at all window, door and louver openings in exterior walls. The head flashings must extend ³/₄-inch minimum past the jamb. The RSC has head flashings, but they do not extend far enough past the jamb opening and they do not have end dams. As the existing head flashings are not correct, it is allowing moisture to enter at the intersection of the end of the stucco and the window, door, and louver jambs, causing moisture/dry rot damage to the sheathing and framing below.

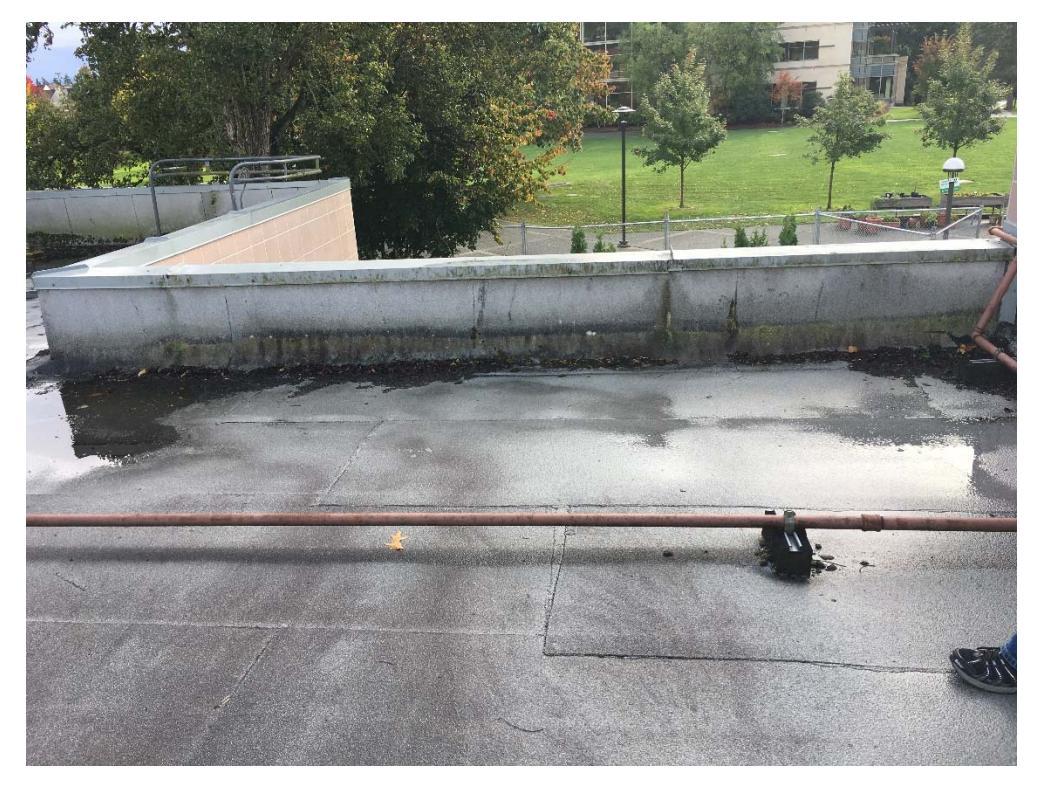
HDR was asked to look at the roof membrane, parapets, coping, roof structure and roof framing as part of the building investigation. HDR was assisted by Rick Hall with KPG, who performed multiple test cuts in the building membrane roof. The test cuts only found evidence of water in one location (which was repaired) and overall the roof deck showed no rot or structural damage as was found on the building exterior. In discussion with the City on the performance of the roof, City staff noted ponding and slow drainage.

The City also voiced concerns about the number of roof drains on the low slope area of the building. While HDR did not calculate the capacity of the existing roof drains, we did review the original building drawings. These drawings (A-19, 1.5.89) show roof crickets throughout the roof area. Crickets are typically composed of tapered insulation that are installed under the roof membrane and above the roof deck. By the nature of their shape, the roof crickets direct water flow that collects toward the nearest drain due to their positive slope. While not required by the building code, they are a recommended practice by the National Roofing Contractors Association (NRCA) *Roofing and Waterproofing Manual*. Crickets are not currently found on the roof. It is unknown why the crickets are shown in the original building drawings but not in evidence on the roof. The City noted that the original roof, constructed in 1990, was replaced in 2003. The crickets in the original drawings may have been removed during the re-roof. The addition of crickets in any future re-roof project for RSC should be strongly considered and will help alleviate future drainage problems on the roof.
