City of Redmond

Facility Condition Assessment

Summary Report

Prepared by MENG Analysis - April 10, 2024

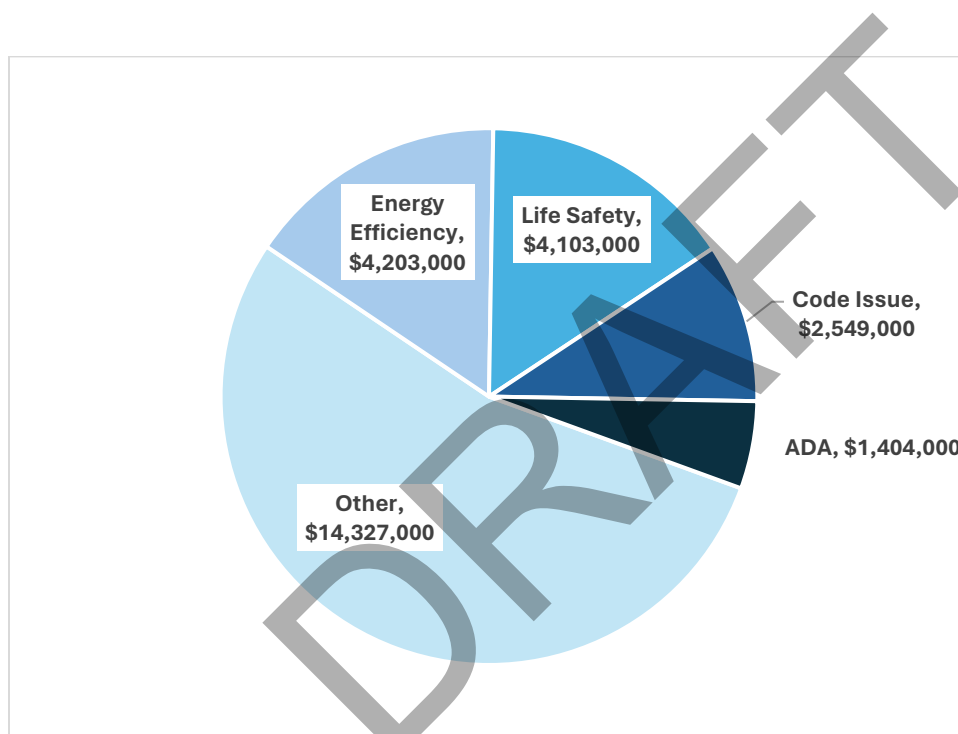
Figure 1. Deficiencies by Action Type

As seen in Figure 1, the majority of the facilities' deficiencies fall under the “Other” category. This is the broadest category type and captures many aesthetic and general building issues, such as worn or stained carpet, stained or damaged ceiling tiles, worn or scratched doors and walls, aged roofing and plumbing, and many other others. The largest deficiency in this category is related to the siding at Fire Station 17. The City is aware of this issue and has a team under contract to correct it over the spring-summer of 2024.

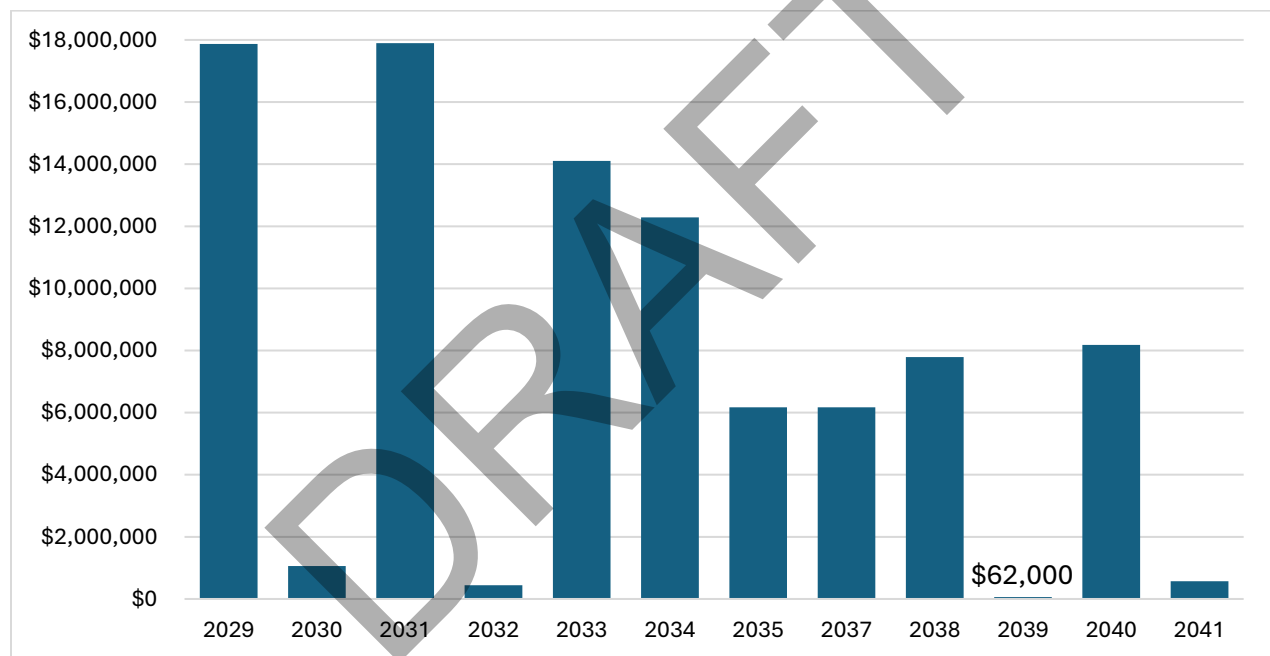
Figure 2. Predicted Renewals Per Year

For the period of 2029 – 2042, the estimated PR cost is approximately \$97M. The highest cost years are expected to be 2029 and 2031; each just under \$18M. Years omitted from the chart below have no predicted renewals occurring in that year. 2039's PR total is approximately \$62K.

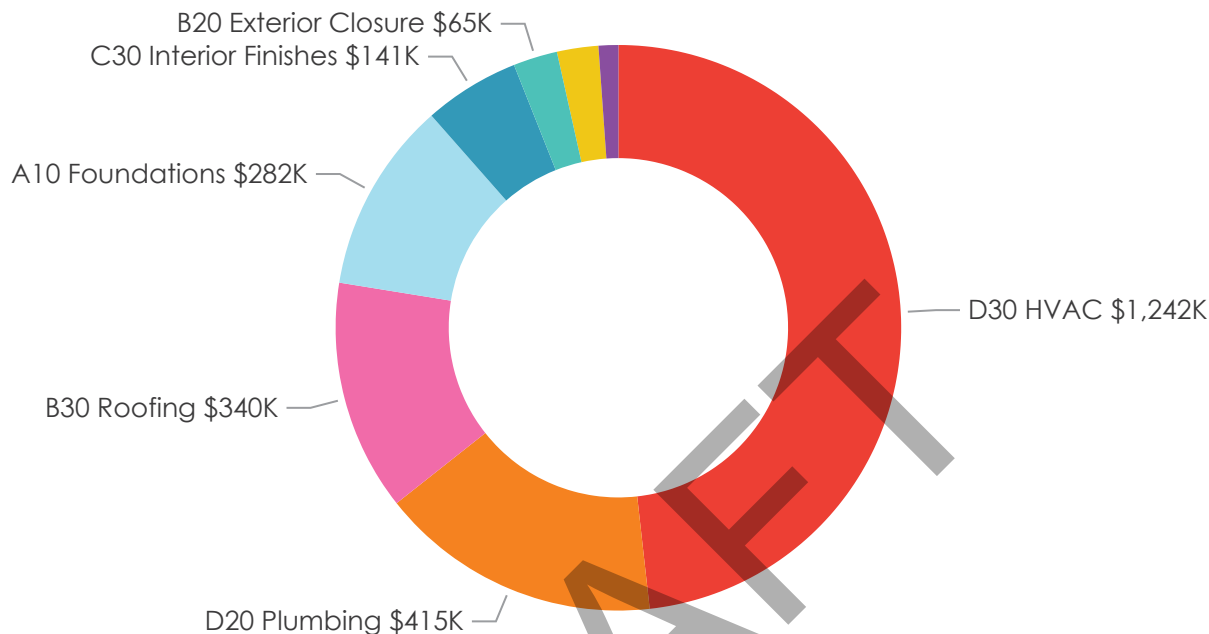
Figure 3. Fire Station 11 Building

Deficiencies by System Level

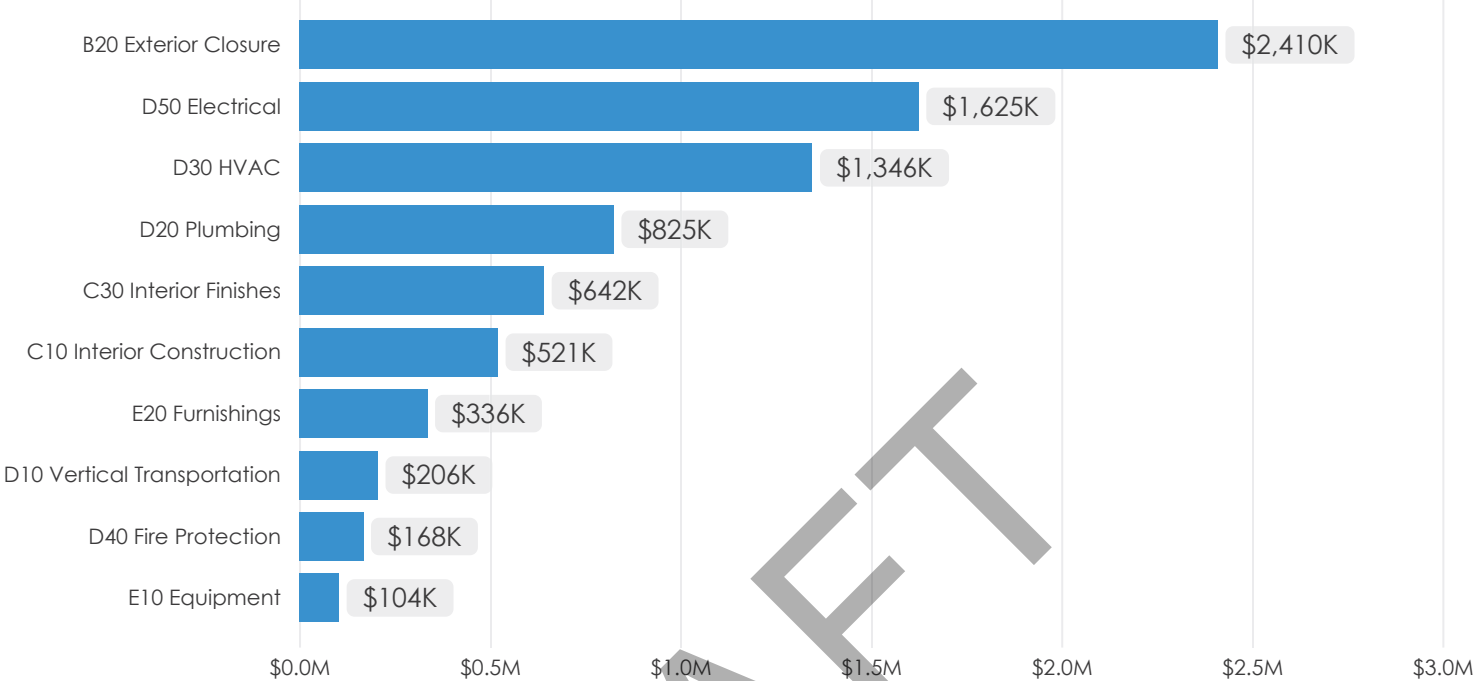
Figure 20. Fire Station 11 Building

Pages 24 to 32 show a graphic representation of the total predicted renewals by site, broken out by Unifomat Level 2 categories.

Predicted Renewals at System Level
