**FACILITY
CONDITION
ASSESSMENT**

To
City of Redmond

For
Old Fire House Teen
Center
16510 NE 79th St.
Redmond, WA 98052

Dated
July 9, 2025

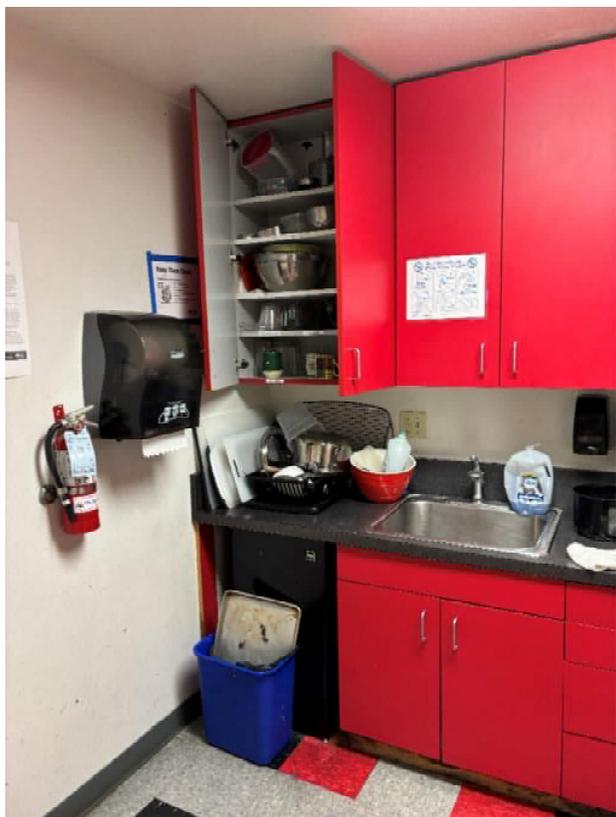
Image I.9 Kitchen

Most of the kitchen cabinetry is non-compliant. Overall layout, clearances, hardware and more are not up to current code. Exposed pipes lack insulation or abrasive surfaces are present beneath the sink. Many appliances are outdated, such as the stove which does not comply because operation requires reaching across the burners.

Replace and upgrade all cabinetry and appliance with commercial grade equipment and accessible layout.

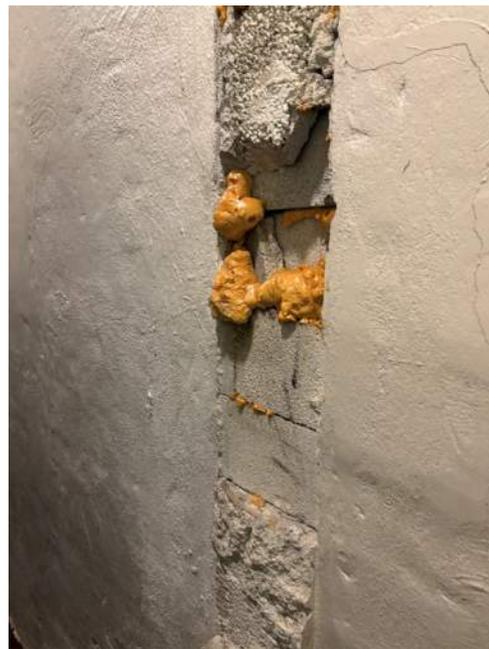
Image VI.2 Demolished Wall

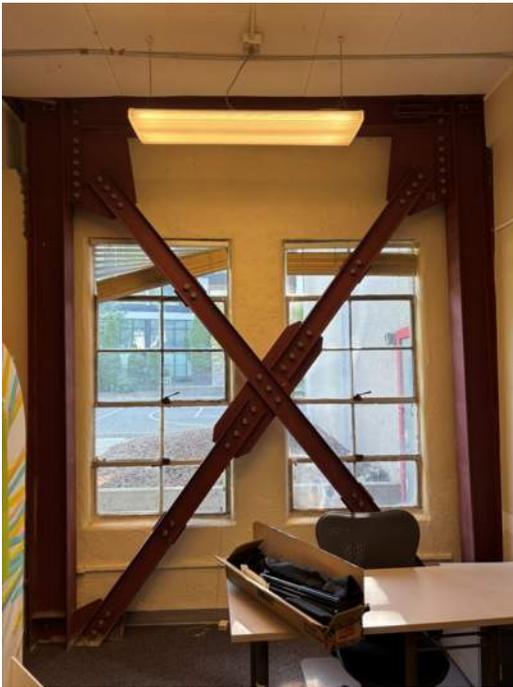
Image VI.3 Braced Frame on GL 5

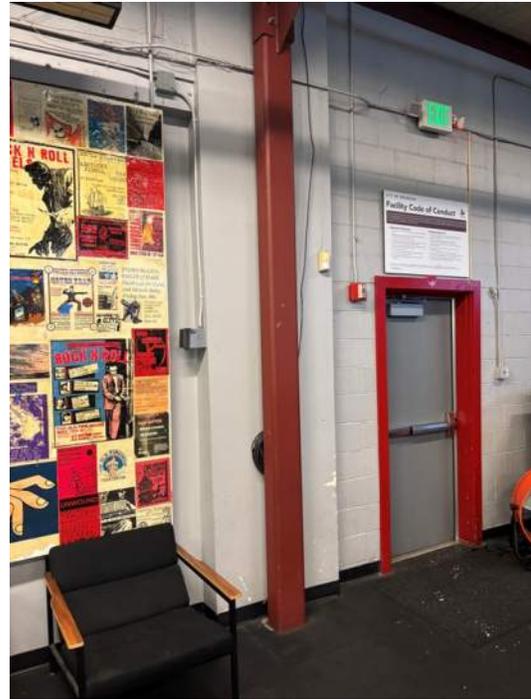
Image VI.4 Steel column and wood framed wall in Showroom

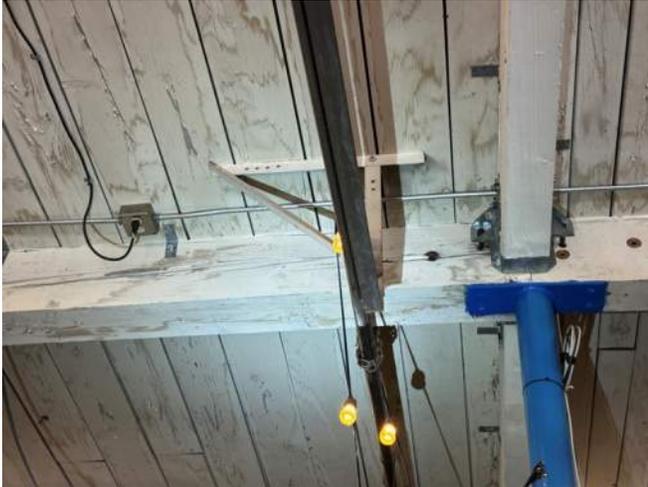
Image VI.7 Beam with large wood check in Showroom

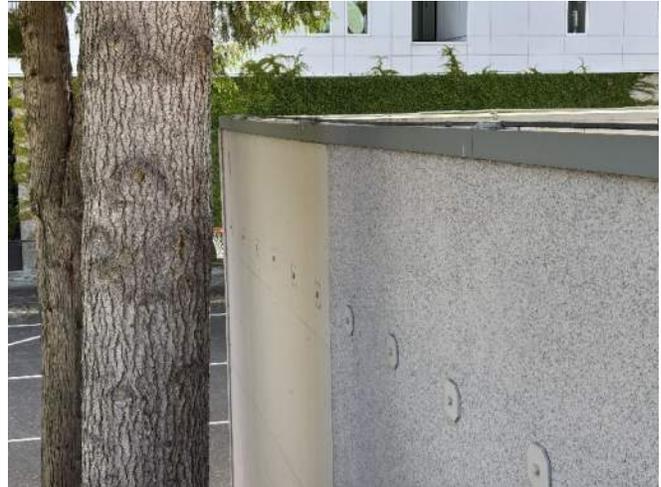
Image VI.8 Exterior roof to wall anchorage

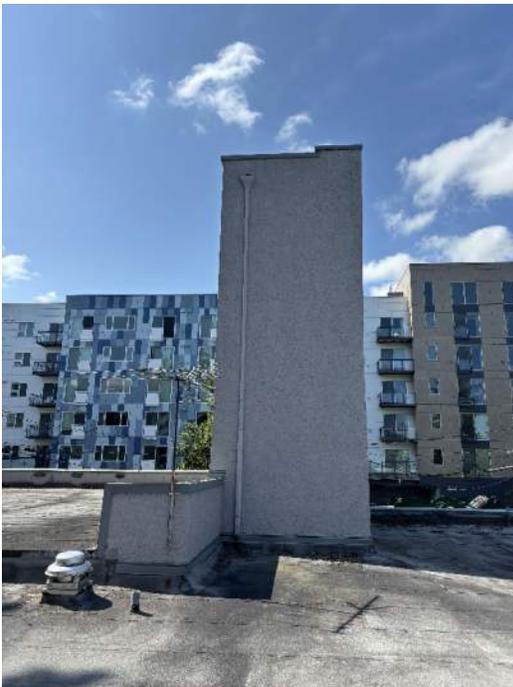
Image VI.9 East Elevation of hose tower

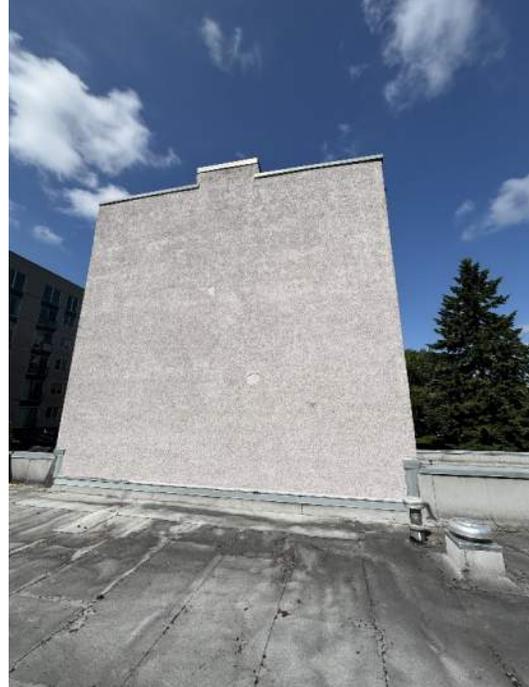
Image VI.10 South Elevation of hose tower

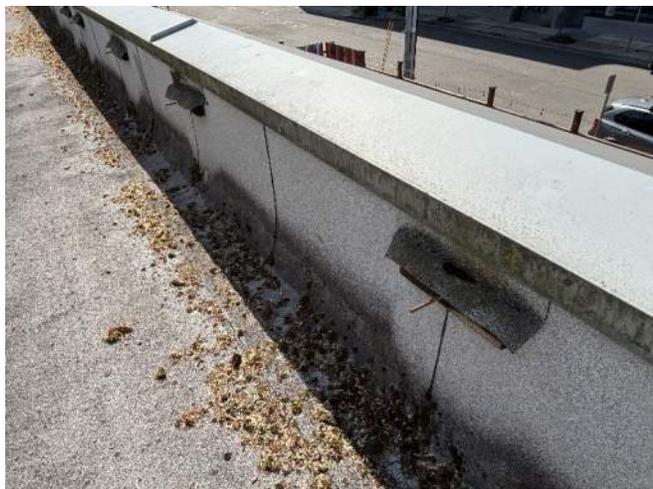
Image VI.11 Canopy anchorage on GL F

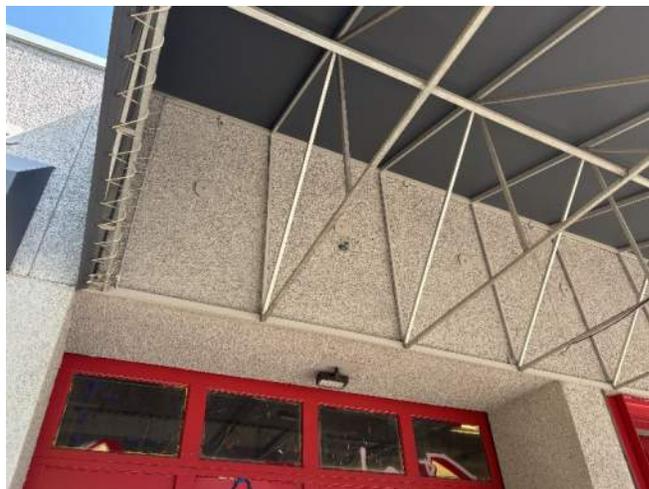
Image VI.12 Exterior canopy

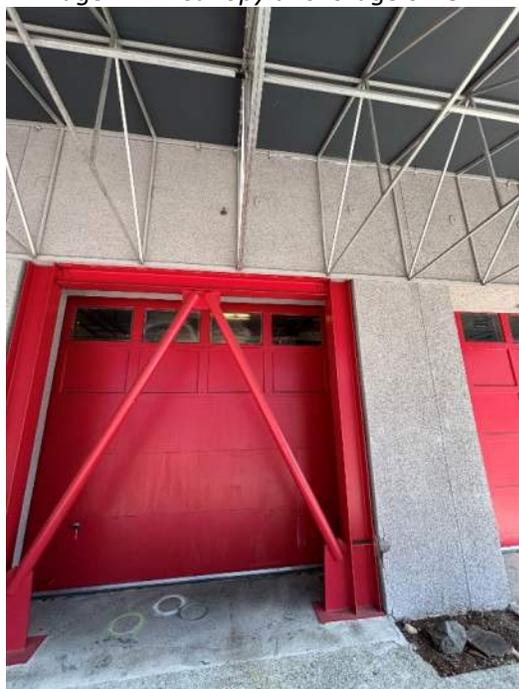
Image VI.13 Braced Frame on GL F

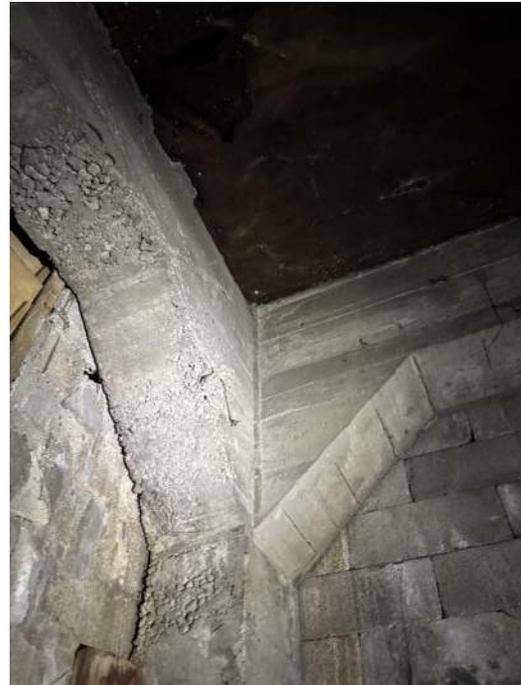
Image VI.16 Hose Tower concrete frame with poor consolidation

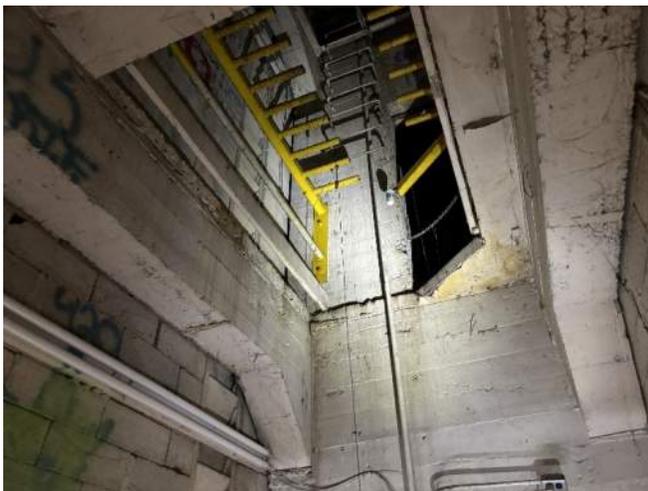
Image VI.17 Interior of hose tower from second floor

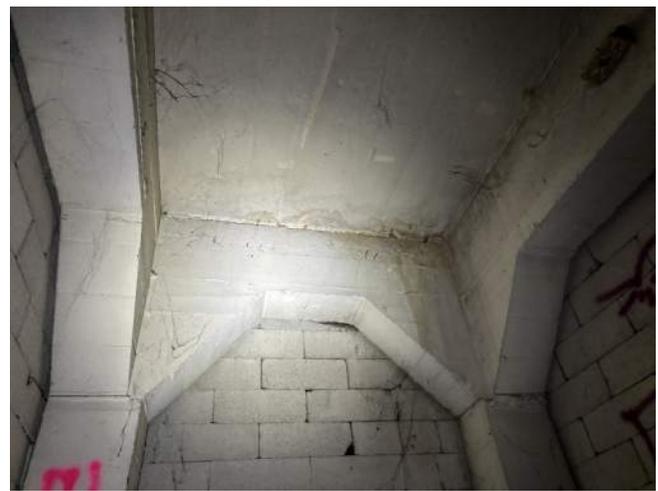
Image VI.18 Hose Tower concrete frame

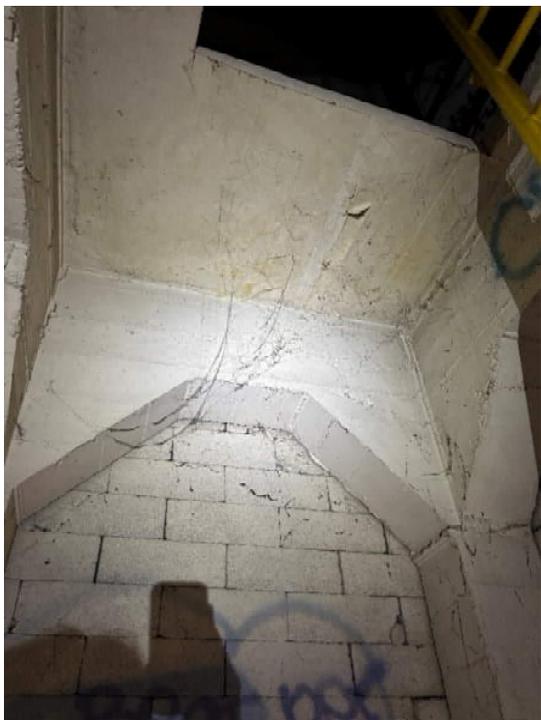
Image VI.19 Hose Tower concrete frame

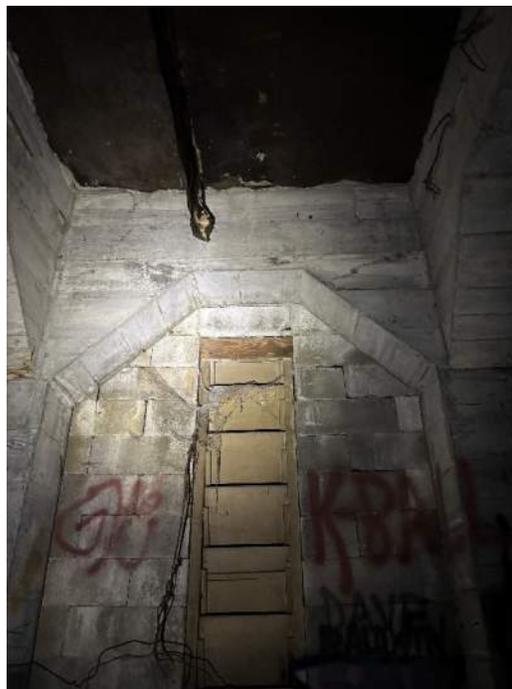
Image VI.20 Hose Tower and louver in CMU wall

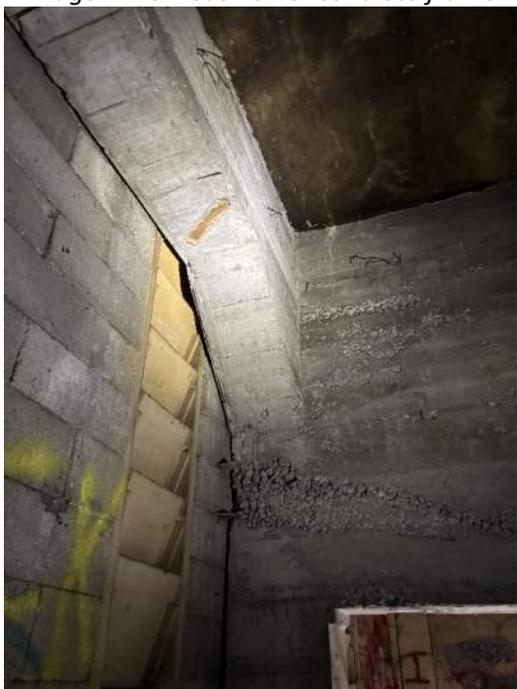
Image VI.21 Hose Tower and louver in CMU wall

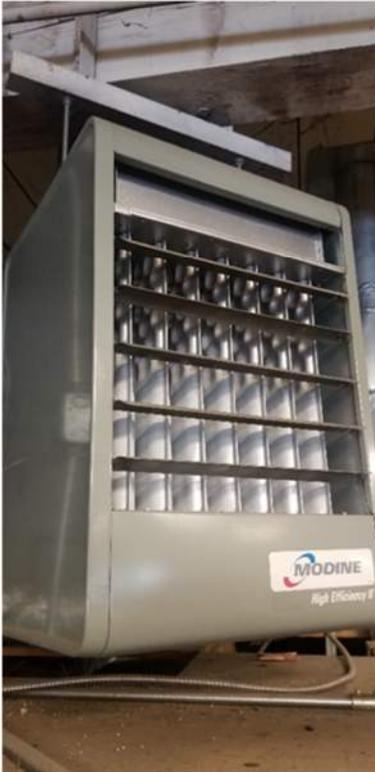
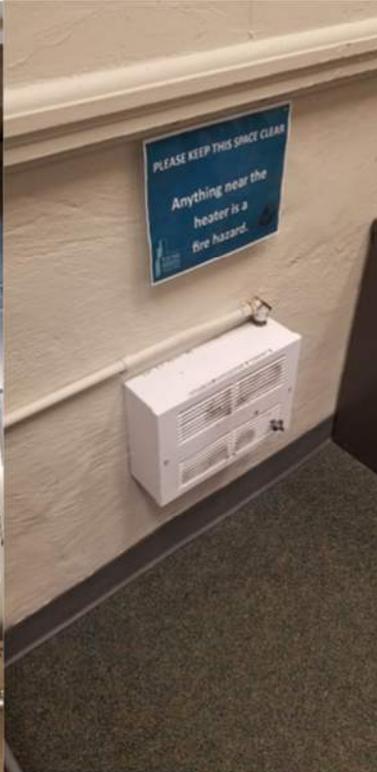
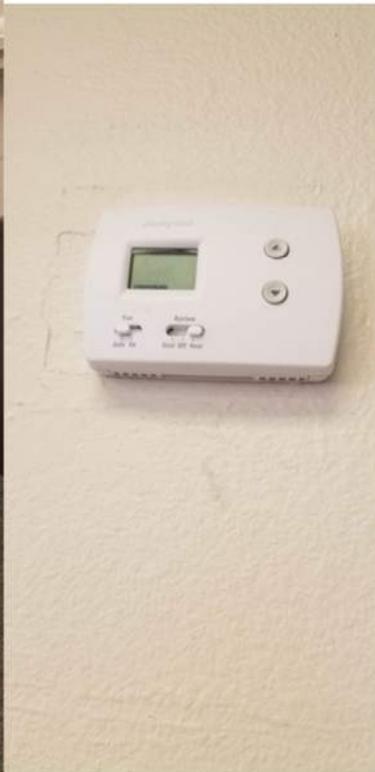
Figure M5 – Packaged HVAC unit

Figure M6 – HVAC unit Exterior Ducting

Figure M7 – Gas Furnace

Figure M8 – Wall Heater

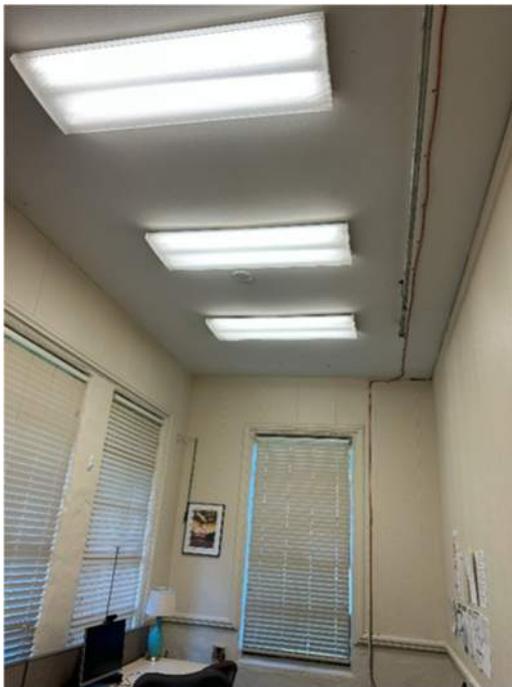
Figure E2 – Light Fixtures

Interior light fixtures are predominantly fluorescent surface or lay-in using T8 lamps. Overall lighting distribution is adequate. Interior lighting controls are through manual on/off switching. Automatic occupancy sensor or dimming controls are not installed. Exterior light fixtures consist of wallpacks surrounding the building and surface mount fixtures along front of building. Specific exterior fixture lamp types or functionality was not reviewed. Distribution of perimeter lighting appears adequate. Electromagnetic timeclocks for site lighting are located in the electrical room. Functionality is not known.

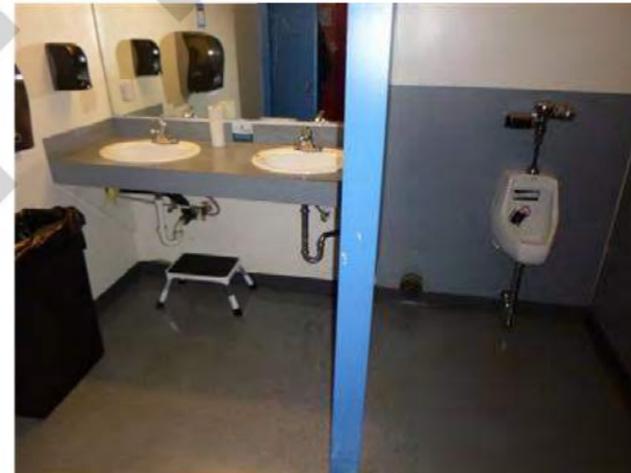
Deficient Material: Drain, Waste, and Vent
 Suspected segments of original galvanized piping in concealed spaces.

Remedial Action:
 Replace with copper and/or PEX.

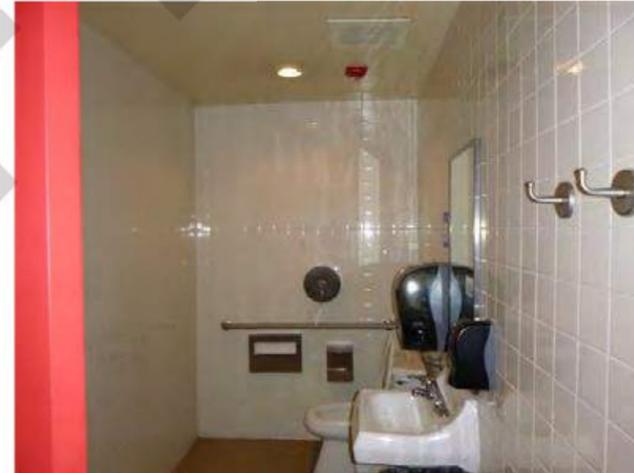
Deficient Material: Waste piping

Aged waste piping with several slow draining and flushing fixtures and reports of failing waste piping under the floor slab.

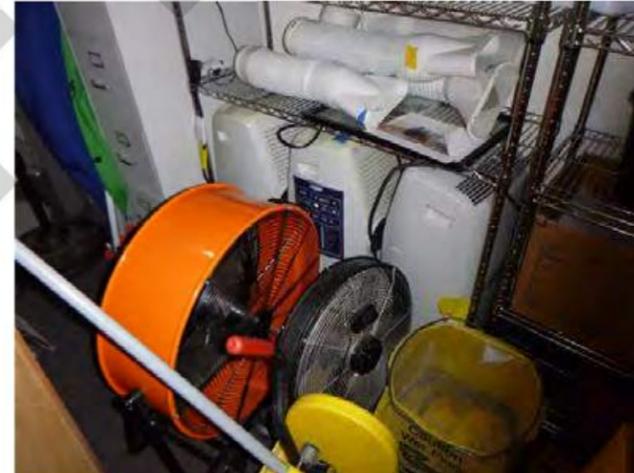
Deficient Material: Rooftop Units
Aging rooftop unit serving studio space.

Remedial Action:
Budget to replace upon failure.

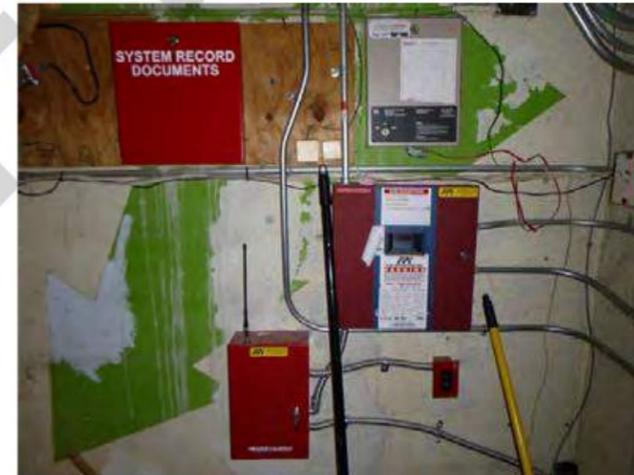
Deficient Material: **Electronic security**
Aged burglar alarm system with no card-key access or CCTV.

Remedial Action:
Upgrade to city standard electronic security system with access control, intrusion detection, and CCTV monitoring.

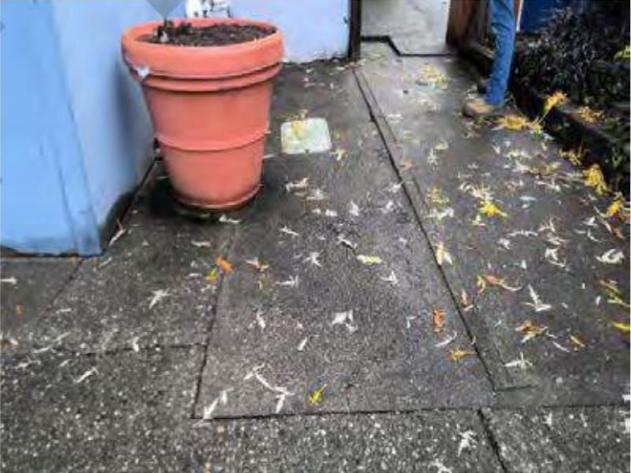
City of Redmond water, fire, sewer, and storm. Puget Sound Energy power and natural gas. Local purveyors for telecom services. No site electronic security. The side sewer is aged and failing. No on-site renewable energy or electric vehicle charging stations.

Deficient Material: Sanitary Sewer
 Sanitary side sewer reportedly failing with dirt and debris in partially collapsed line.

Remedial Action:
 Replace side sewer.
